# Landing gear retraction overspeed involving Saab 340B, VH-ZRJ

Sydney Airport, New South Wales | 4 December 2014

**ATSB Transport Safety Report**  
Aviation Occurrence Investigation  
AO-2014-189  
Final – 7 June 2016

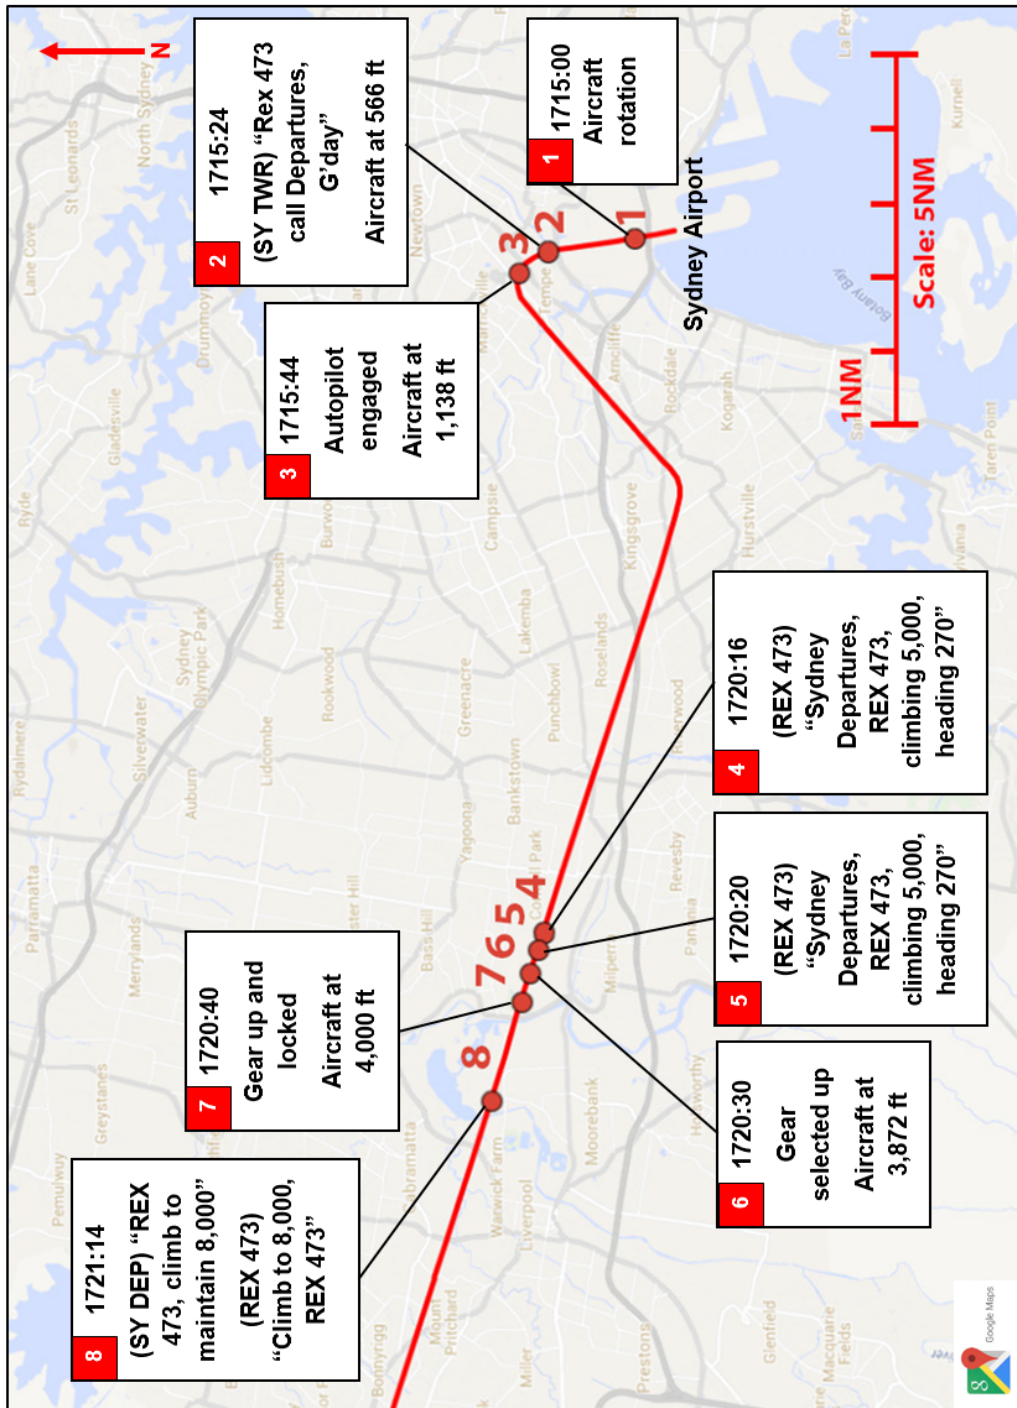
At about 1715, the aircraft departed from runway 34L (Figure 1). The captain reported that, after becoming airborne they<sup>4</sup> called 'positive rate, gear up'. The captain expected that on this command the first officer (FO) would retract the landing gear, and so looked out to the left of the aircraft to observe the thunderstorms to the west and north of the airport. The FO did not recall hearing the captain's call and the landing gear was not retracted, nor was the subsequent standard call 'selected' made by the FO. The FO reported also focusing on the weather in the area and, due to the FO's relative unfamiliarity with Sydney departures, on the requirement to turn at 600 ft. The FO selected the yaw damper<sup>5</sup> ON and recorded data indicated that the flaps were selected to zero and the flight director engaged.

Climbing through 3,800 ft, the captain called for the climb checklist and the FO read the first item, 'gear'. At that time, the crew identified that the gear was still down. The captain started to respond by saying 'up', but immediately revised their words to 'not up'. At the same time, the FO instinctively selected the gear up and then realised that the aircraft's airspeed was above the maximum landing gear retraction speed of 150 kt. The crew reported that the gear retracted normally.

Information from the flight data recorder showed that the landing gear retracted and locked into position about 5 minutes after take-off while climbing through 4,000 ft. The airspeed at that time was 182 kt, 32 kt above the maximum landing gear retraction speed.

Figure 1: ZRJ (REX473) departure track (in red) from Sydney towards Narrandera, with the key actions annotated

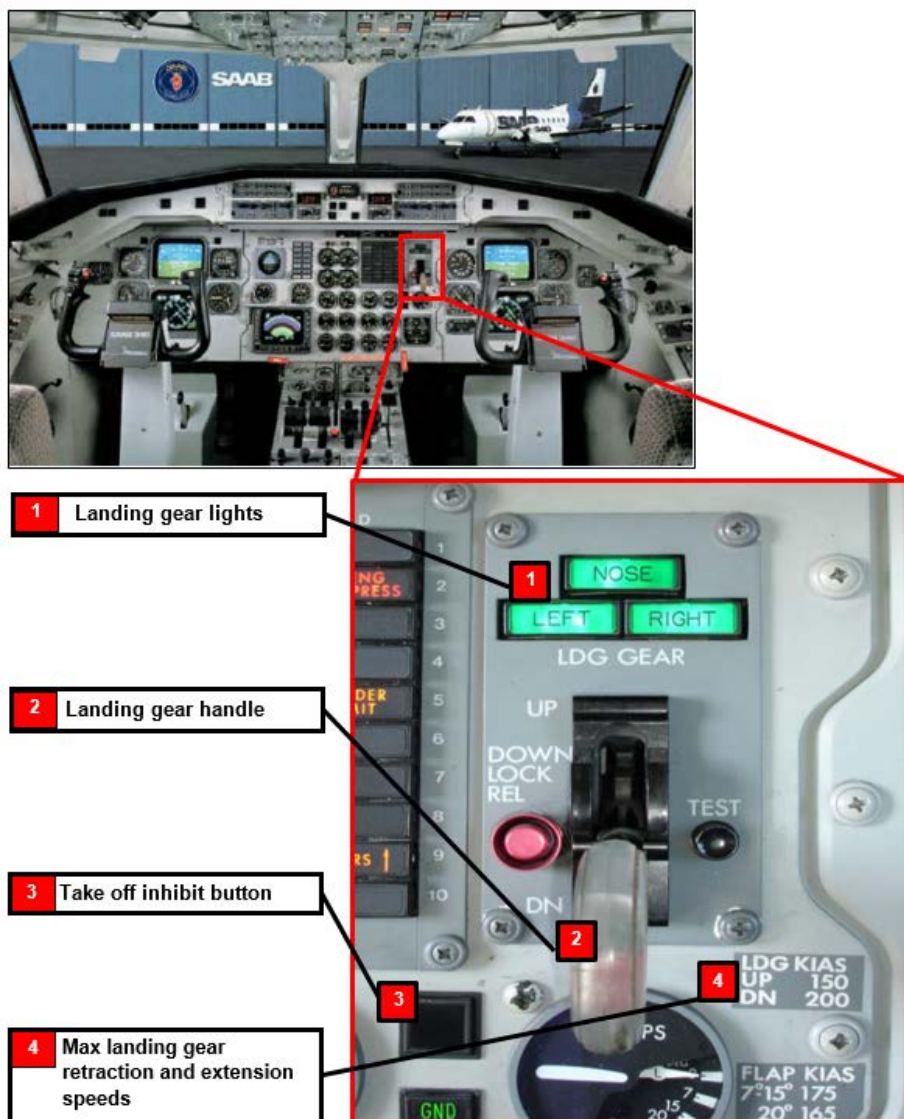
The aircraft is equipped with a retractable landing gear with the main and nose wheel gears retracting forward. The landing gear control panel is to the left of the FO (Figure 2). The panel incorporates three green indicator lights and the landing gear handle. When the landing gear is in the 'down' (DN) position, all three green down lock lights illuminate. The panel also displays the maximum landing gear retraction and extension speeds.

**Figure 2: Photograph of the Saab 340 flight deck (with the landing gear panel emphasised) showing the gear indicator lights and handle, and position of the take-off inhibit button. Note that the placard to the right of the handle annotates the maximum landing gear retraction speed is 150 kt and the maximum landing gear extension speed of 200 kt**

Amongst other methods, the take-off inhibit mode is reset automatically when the landing gear is retracted. The crew then confirm that the take-off inhibit light is extinguished as part of the climb checklist. As the landing gear remained extended after take-off on the occurrence flight, the take-off inhibit mode also remained active and the associated blue light illuminated.

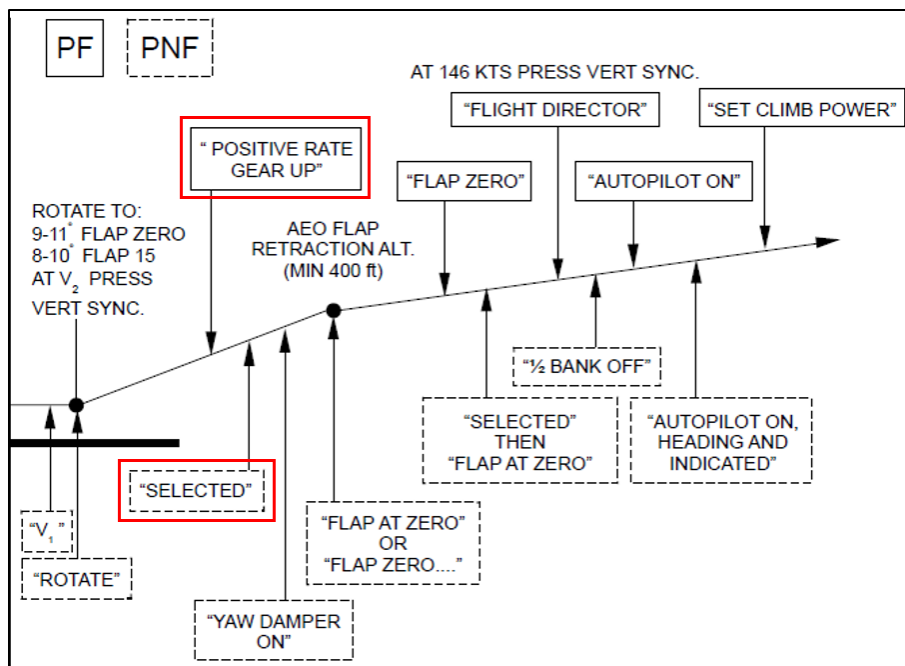
On the occurrence flight, the captain reportedly made the call 'positive rate, gear up', but the FO reported not hearing it or recall calling 'selected'. Through flight data and crew recollections, it appeared that all other calls and actions associated with the take-off sequence were completed. This included the retraction of the flaps, engaging the flight director and autopilot and setting climb power. The ATSB could not determine whether the call 'yaw damper on' was made or whether the heading bug was adjusted.

**Figure 4: The Rex normal take-off profile showing the actions to be taken by the PF (shown in a solid-lined box) and the PNF (shown in a dash-lined box) The PF calls 'positive rate, gear up', followed by the PNF calling 'selected' once the gear is up (both calls outlined in red)**
