Engine fire involving Fairchild SA227, VH-UZI

near Brisbane, Queensland, 22 March 2016

ATSB Transport Safety Report
Aviation Occurrence Investigation
AO-2016-026
Final – 27 July 2016

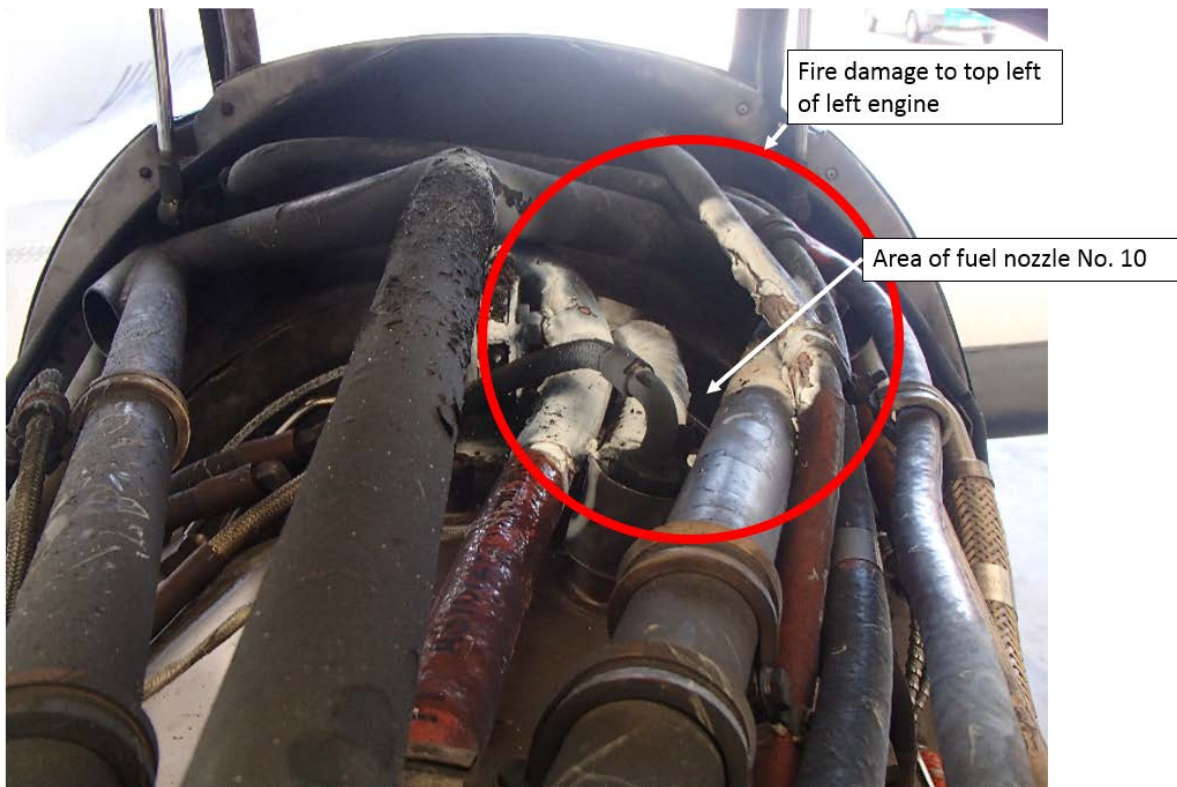
During a transit check of the aircraft, maintenance personnel at Brisbane Airport found evidence of a substantial fuel leak in the left wheel well of the aircraft. Further investigation found fuel pooling in the cowls, and about 400 ml of fuel spilled out when the cowls were opened. The maintainers found evidence of fire damage to the engine combustion case and a number of components forward of the firewall (Figure 1). The upper engine mount, fuel manifold, adjacent components and the engine frame had evidence of high temperature damage.

Figure 1: Fire damage to the left engine

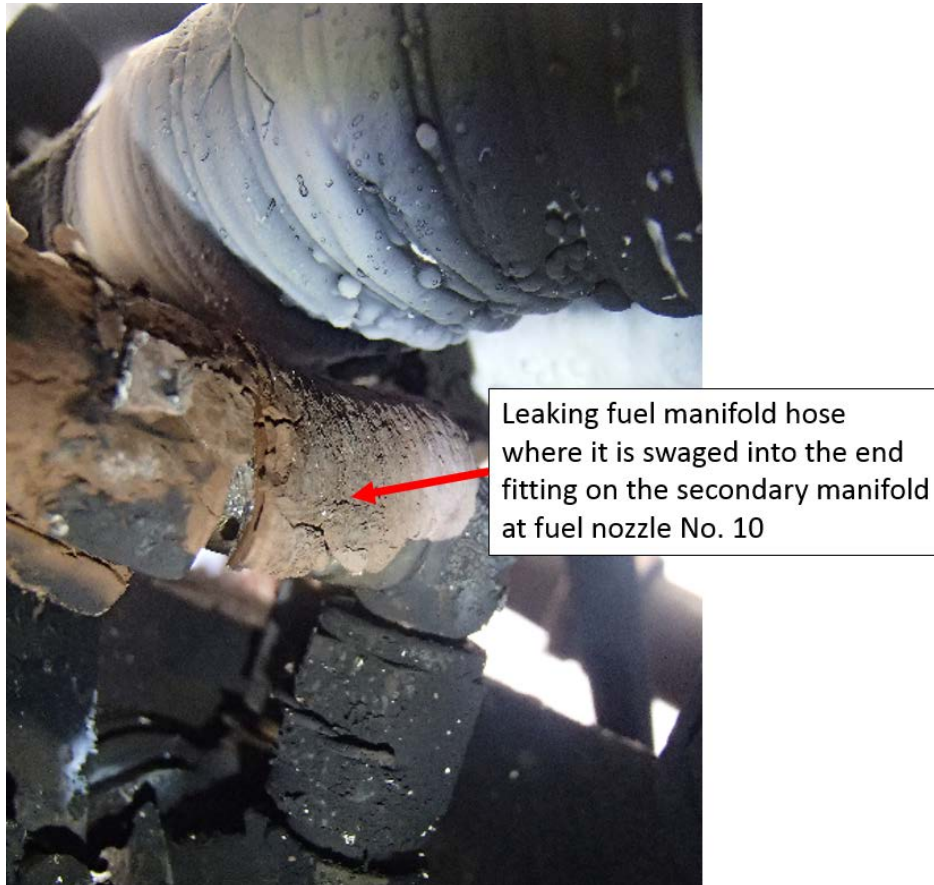
The post-incident inspection found evidence of fire in the area of the number 10 fuel nozzle. The fuel leak was due to a leaking flexible fuel manifold hose in the area where it is swaged¹ into the end fitting of the secondary manifold at the number 10 fuel nozzle (Figure 2).

Figure 2: Leaking flexible fuel manifold hose

The AWB commented that these manifolds did not have a life limit, but were subject to removal after a specified number of hours for a fuel nozzle inspection. That frequent removal may have contributed to cracks. The flexible portion of the manifold was concealed and could not be inspected visually.

The relevant maintenance inspections conducted by the operator prior to the incident covered the replacement of engine flammable fluid lines forward of the firewall (except the nozzle manifold hose which leaked in this incident), cleaning and testing of the fuel nozzles, fuel nozzle assembly inspection and a detailed inspection of the plumbing. The inspection included a visual check of fuel nozzle flexible manifold hoses for condition and ground run leak checks. The engine repair agency advised that periodic pressure leak testing of the manifolds was conducted after a maximum of 3,600 flight hours.

At the time of the incident, the operator's system of maintenance did not cover all aspects of the recommended practices specified in AWB 73-006. The operator did not find any evidence that they had carried out an assessment of that bulletin.

The aircraft operator has introduced procedures in accordance with the recommendations specified in Airworthiness Bulletin 73-006.
