Engine failure involving Jabiru J430, VH-SZQ

85 km WSW of Oakey Airport, Queensland, 19 November 2015

ATSB Transport Safety Report
Aviation Occurrence Investigation
AO-2015-138
Final –27 July 2016

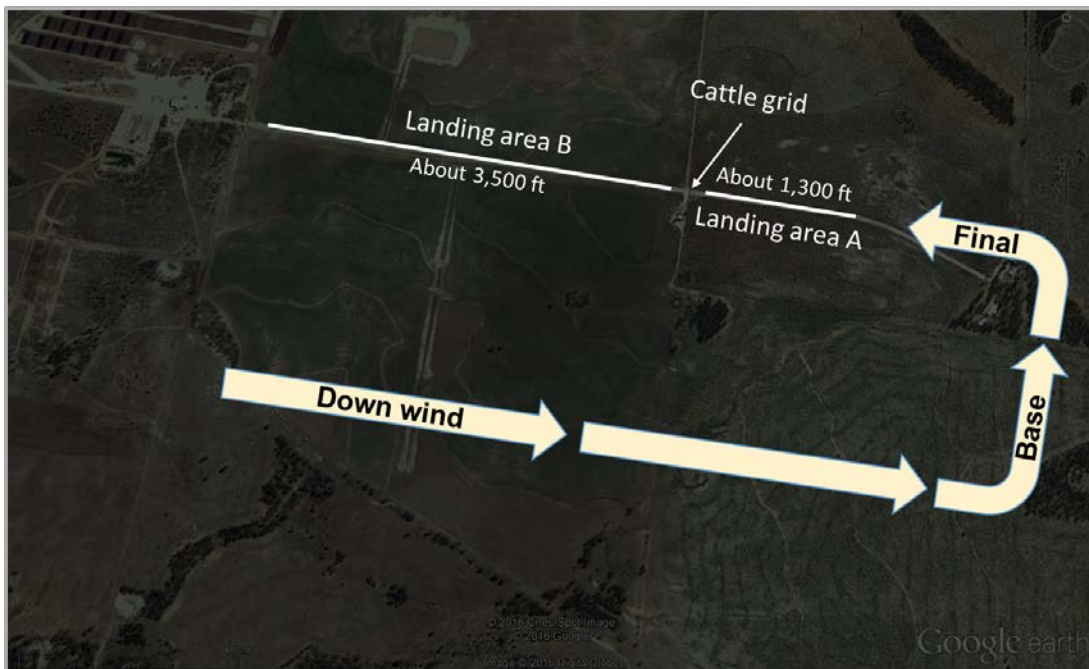
Figure 2: Diagram representing the circuit pattern and landing areas

At about 4,000 ft, the pilot selected a landing area on the road between the houses and a cattle grid (landing area A in Figure 2). SZQ entered on the downwind leg for a left circuit with the final approach towards the west. The pilot identified power lines close to the road (landing area A) and as they were unsure if they crossed the road, selected the road beyond the cattle grid as the land

At about 50 feet on final approach, the pilot was able to see that the power lines were far enough away from the road of landing area A that they would not be a hazard, and elected to land on the initial landing area selected. The pilot selected full flap and selected the electrical master switch off. The pilot side-slipped¹ the aircraft to descend quicker. Consequently, the pilot realised that the aircraft's speed was too fast to land on landing area A and extended to the second landing area, landing area B, and climbed slightly to clear the cattle grid.

The left main landing gear collided with the grid and failed, partially remaining attached to the aircraft. The pilot flared for a landing and the left landing gear dug into the ground and swung the aircraft to the left. The aircraft subsequently collided with a fence and came to a stop about 100 m beyond the cattle grid. The pilot exited the aircraft. The pilot was not injured. The aircraft was substantially damaged.

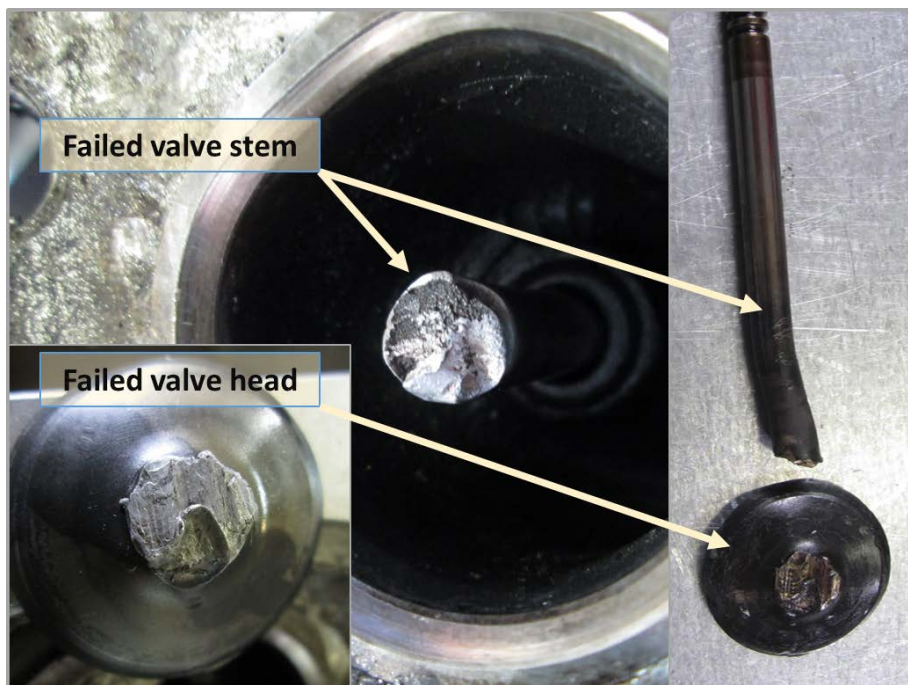
Figure 3: Failed valve head and valve stem

- In 2013, the original owner/builder was provided assistance to bulk strip/rebuild the engine (builder assist bulk strip/rebuild), and some CAMit Aero Engine (CAE) components were installed. This did not include replacing the pistons.
- The maintenance immediately prior to the engine failure was to fit new CAE cylinder barrels and rings and engine oil inhibiting jets to the intake ports. The new owner (not the original owner/builder) advised that the engine EGT was too high and a different carburettor main fuel jet was installed.
- The number 6 cylinder failed resulting in the engine stopping.
- The head of the number 6 exhaust valve was separated from the stem. The valve stem fracture area had severe mechanical damage after its separation but there was no sign of a fatigue fracture. The valve stem was 'S' bent in the semi-closed position which would indicate

that the valve was not fully open when a possible mechanical collision with the piston was encountered. There was no evidence of significant heat damage to the valve stem (Figure 3).

- It is most likely that an initial partial failure of the number 6 piston skirt allowed piston debris to lodge between one side of the head of the valve and the valve seat. The next stroke of the piston would then collide with the partially closed valve bending the valve head about the obstruction and generating enough leverage to fracture the head off the valve stem; initiating the final destruction of the cylinder components.

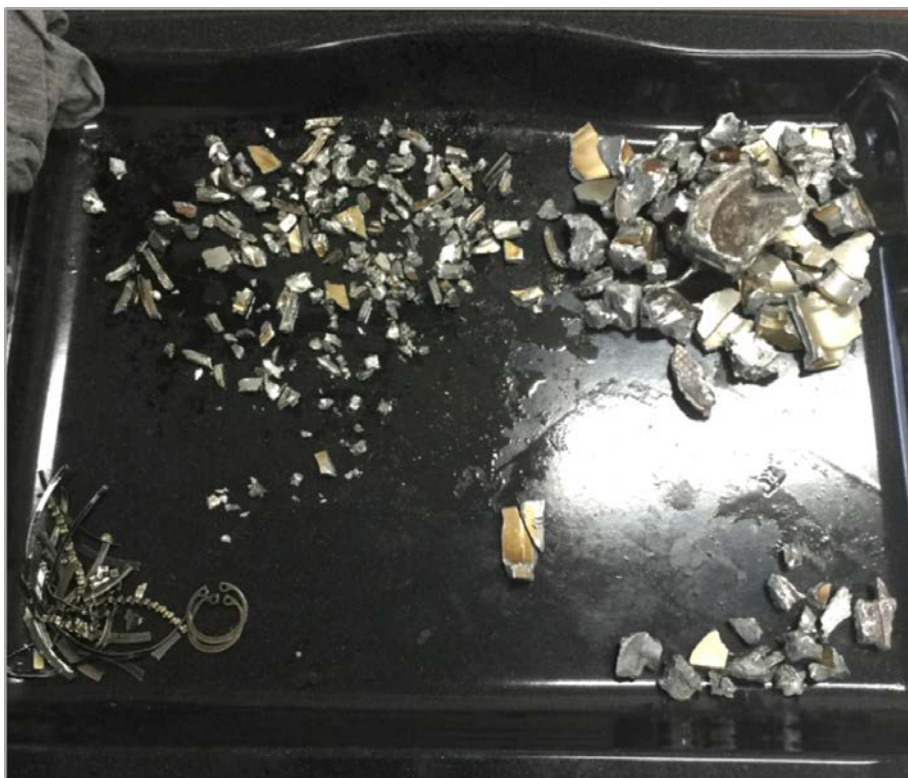
Figure 4: Recovered parts of the number 6 piston

- The number 6 piston had completely dis-integrated (Figure 4).

- Four small pieces of piston skirt were identified and showed signs that they were fractured before the failure. The shiny, peened surface of the fracture faces appeared to indicate cyclic compressive forces to a crack surface during engine operation.

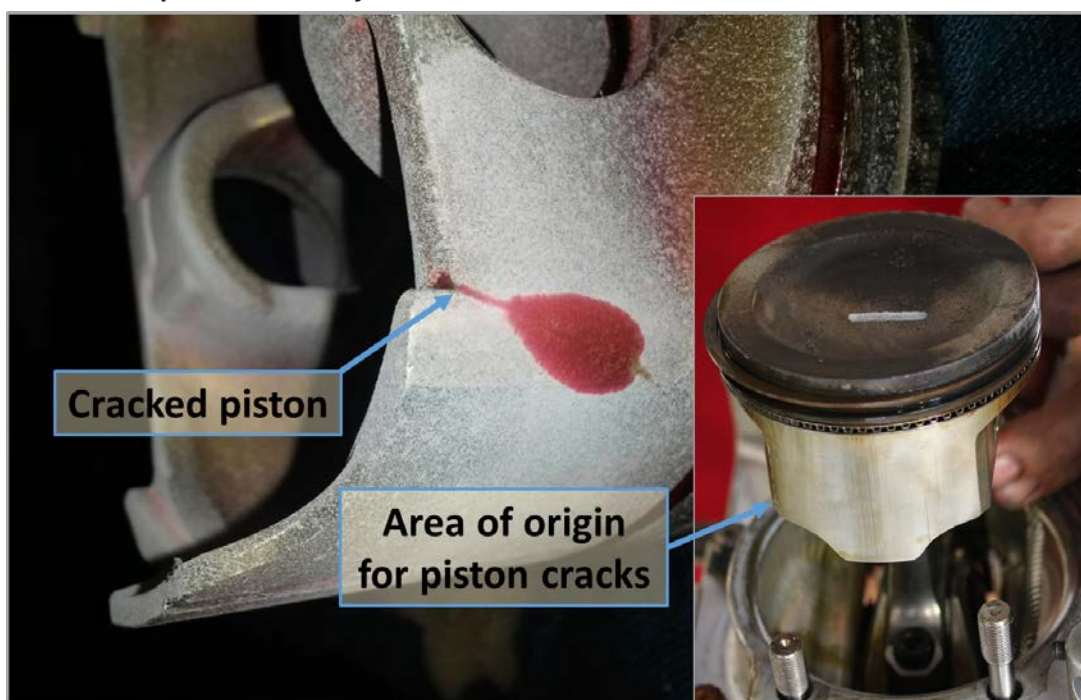
Figure 5: Location of crack detected in all five pistons and example of crack location shown on a piston assembly

- An inspection of the remaining pistons for evidence of cracks revealed that the five other pistons were also cracked before the engine failed (Figure 5). The cracks all initiate at a stress raiser between the piston skirt and the piston-pin boss web. This stress raiser is machined into the piston during original manufacture for jiggging purposes.

- The high EGTs reported would indicate that detonation² could have been encountered on multiple occasions, which would apply excessive stress at the stress raisers on the piston skirts.

The organisation that assisted in the last maintenance indicated that it is possible that light detonation on previous flights may have overstressed the piston at the stress raiser and initiate a fatigue failure of the number 6 piston. The examination of the engine pistons and cylinders did not extend to analysing the combustion deposits for evidence of detonation from previous flights.

- All CAE pistons will be modified to minimise the stress raiser that was found in the non-CAE pistons installed on SZQs engine, which will reduce the detonation sensitivity of the pistons.
- A survey of CAE engine owners will be conducted asking questions relating to their engine EGTs to gauge the risk of similar failures.
- Maintenance advice to check all reused pistons for cracks and to modify the stress raiser will become standard practice.
- A test engine has been subjected to similar conditions to enable more accurate failure mode analysis in the future.
