Aviation Short Investigations Bulletin

Issue 49

ATSB Transport Safety Report
Aviation Short Investigations
AB-2016-068
Final – 27 July 2016

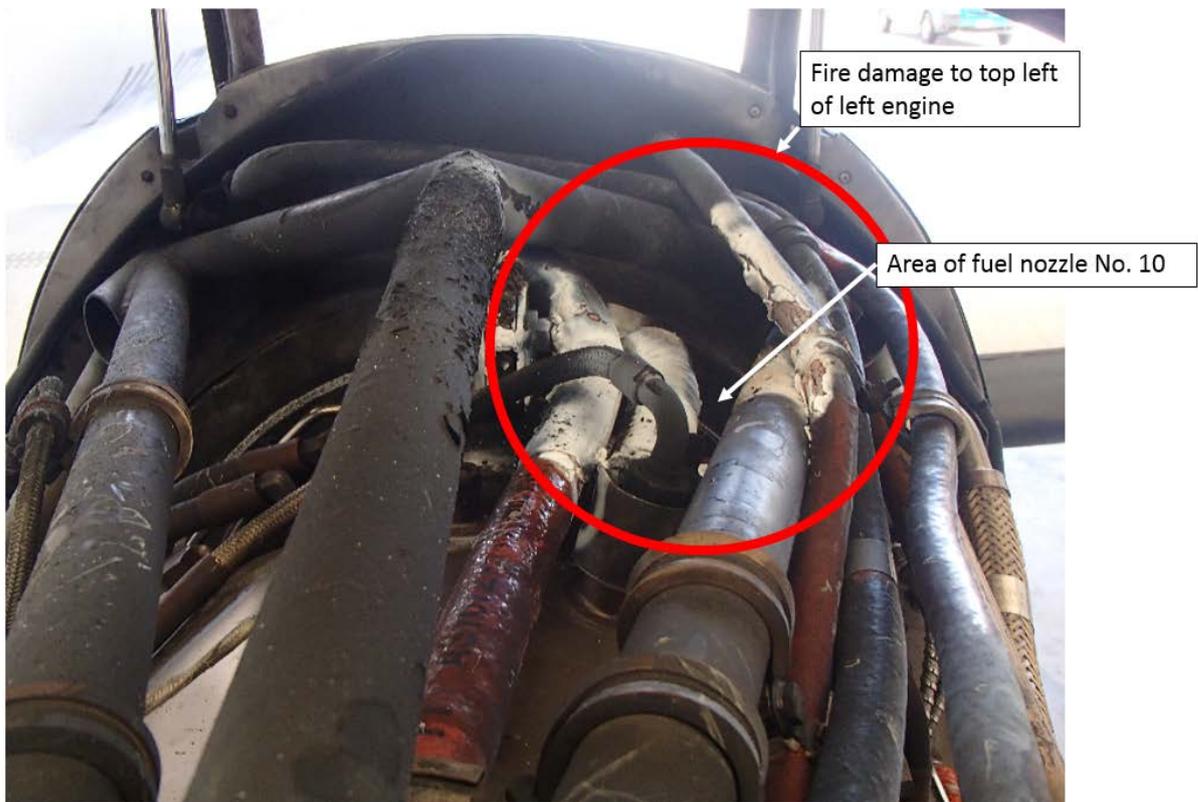
Figure 1: Fire damage to the left engine

During a transit check of the aircraft, maintenance personnel at Brisbane Airport found evidence of a substantial fuel leak in the left wheel well of the aircraft. Further investigation found fuel pooling in the cowls, and about 400 ml of fuel spilled out when the cowls were opened. The maintainers found evidence of fire damage to the engine combustion case and a number of components forward of the firewall (Figure 1). The upper engine mount, fuel manifold, adjacent components and the engine frame had evidence of high temperature damage.

The post-incident inspection found evidence of fire in the area of the number 10 fuel nozzle. The fuel leak was due to a leaking flexible fuel manifold hose in the area where it is swaged¹ into the end fitting of the secondary manifold at the number 10 fuel nozzle (Figure 2).

The aircraft operator has introduced procedures in accordance with the recommendations specified in Airworthiness Bulletin 73-006.

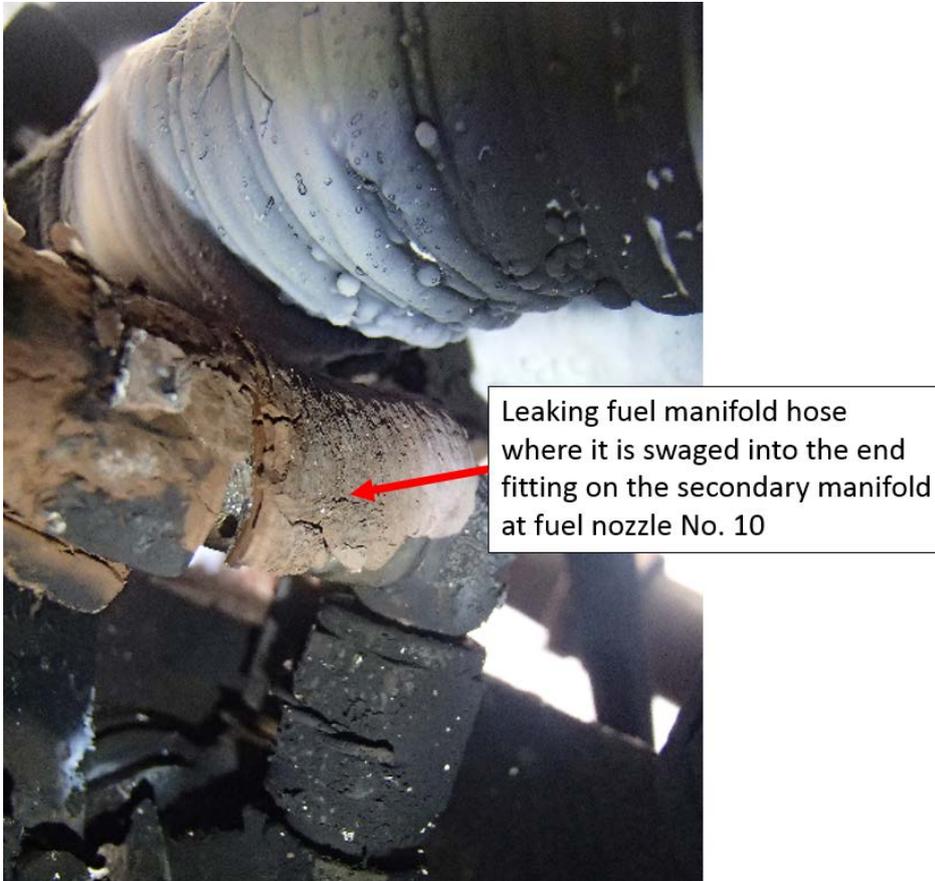
Figure 2: Leaking flexible fuel manifold hose

The Civil Aviation Safety Authority issued [Airworthiness Bulletin \(AWB\) 73-006](#) in August 2011. This was in response to three service difficulty reports regarding fuel leaks from the fuel manifold hose, and one associated engine fire. Another 14 fuel leaks and 3 engine fires due to the failure of the same hose had been reported to the equivalent US and Canadian authorities since 1990.

The AWB commented that these manifolds did not have a life limit, but were subject to removal after a specified number of hours for a fuel nozzle inspection. That frequent removal may have contributed to cracks. The flexible portion of the manifold was concealed and could not be inspected visually.

At the time of the incident, the operator's system of maintenance did not cover all aspects of the recommended practices specified in AWB 73-006. The operator did not find any evidence that they had carried out an assessment of that bulletin.

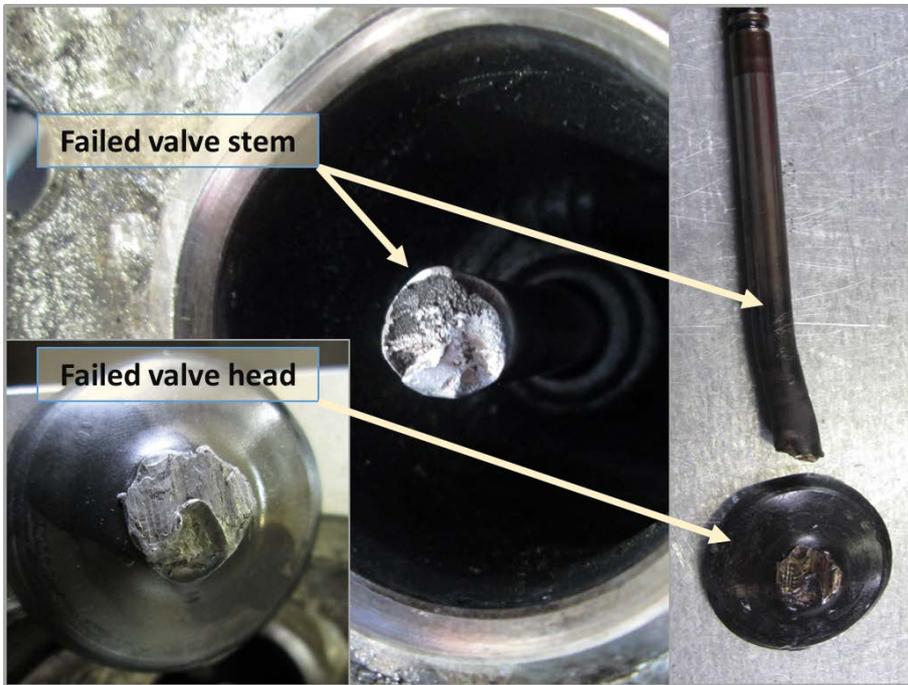
Figure 3: Failed valve head and valve stem

- In 2013, the original owner/builder was provided assistance to bulk strip/rebuild the engine (builder assist bulk strip/rebuild), and some CAMit Aero Engine (CAE) components were installed. This did not include replacing the pistons.
- The maintenance immediately prior to the engine failure was to fit new CAE cylinder barrels and rings and engine oil inhibiting jets to the intake ports. The new owner (not the original owner/builder) advised that the engine EGT was too high and a different carburettor main fuel jet was installed.
- The number 6 cylinder failed resulting in the engine stopping.
- The head of the number 6 exhaust valve was separated from the stem. The valve stem fracture area had severe mechanical damage after its separation but there was no sign of a fatigue fracture. The valve stem was 'S' bent in the semi-closed position which would indicate

that the valve was not fully open when a possible mechanical collision with the piston was encountered. There was no evidence of significant heat damage to the valve stem (Figure 3).

- It is most likely that an initial partial failure of the number 6 piston skirt allowed piston debris to lodge between one side of the head of the valve and the valve seat. The next stroke of the piston would then collide with the partially closed valve bending the valve head about the obstruction and generating enough leverage to fracture the head off the valve stem; initiating the final destruction of the cylinder components.

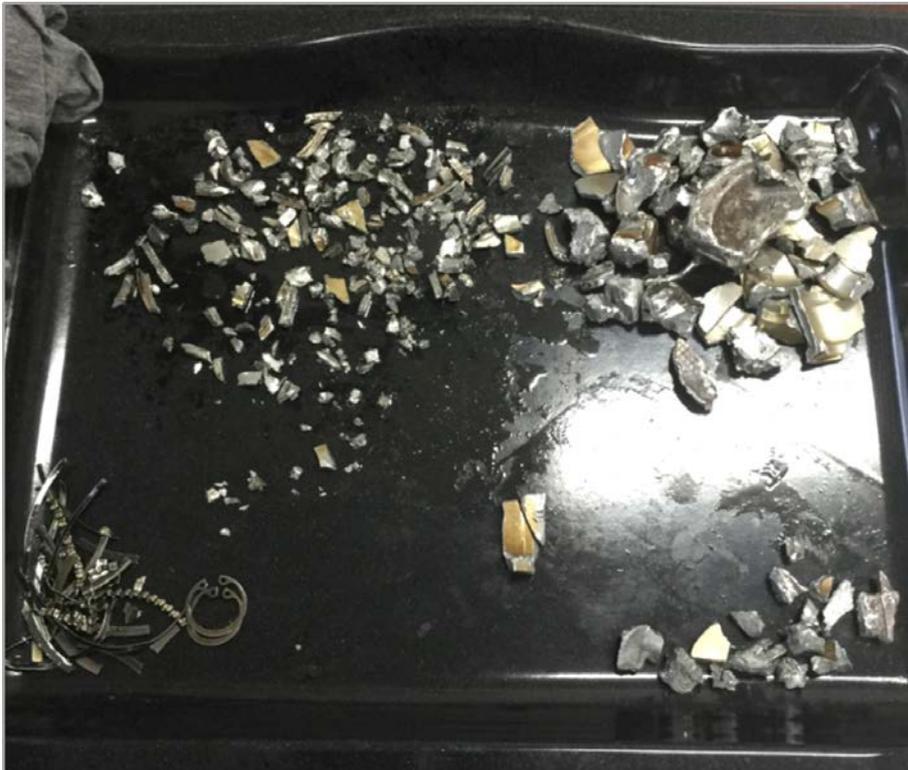
Figure 4: Recovered parts of the number 6 piston

- The number 6 piston had completely dis-integrated (Figure 4).

- Four small pieces of piston skirt were identified and showed signs that they were fractured before the failure. The shiny, peened surface of the fracture faces appeared to indicate cyclic compressive forces to a crack surface during engine operation.

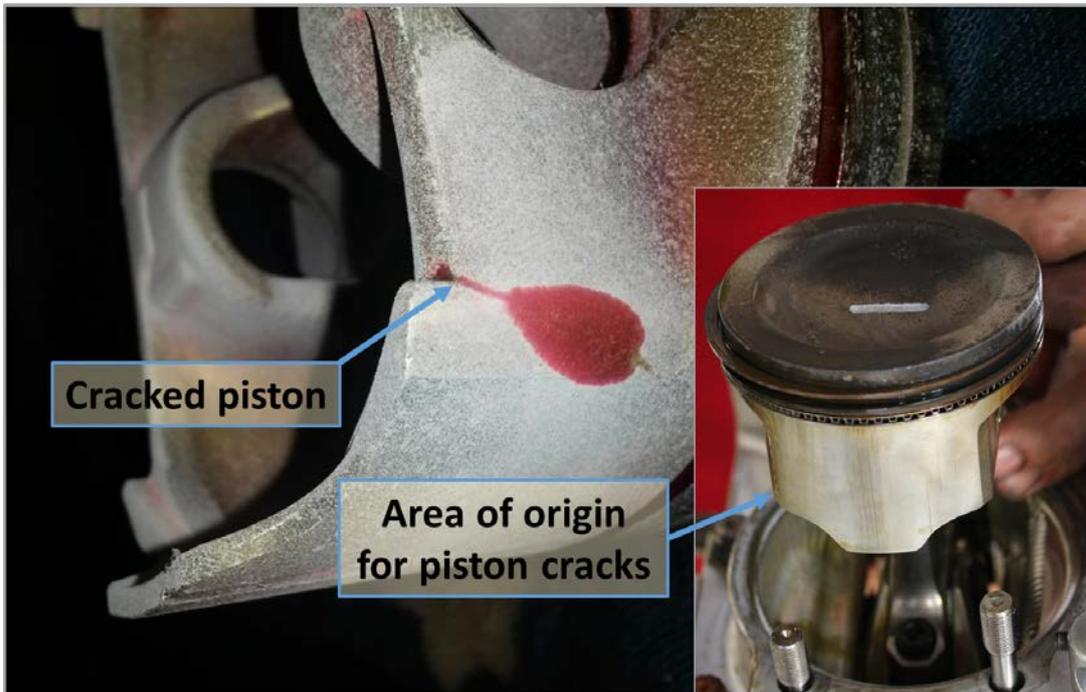
Figure 5: Location of crack detected in all five pistons and example of crack location shown on a piston assembly

- An inspection of the remaining pistons for evidence of cracks revealed that the five other pistons were also cracked before the engine failed (Figure 5). The cracks all initiate at a stress raiser between the piston skirt and the piston-pin boss web. This stress raiser is machined into the piston during original manufacture for jigging purposes.

- The high EGTs reported would indicate that detonation² could have been encountered on multiple occasions, which would apply excessive stress at the stress raisers on the piston skirts.

The organisation that assisted in the last maintenance indicated that it is possible that light detonation on previous flights may have overstressed the piston at the stress raiser and initiate a fatigue failure of the number 6 piston. The examination of the engine pistons and cylinders did not extend to analysing the combustion deposits for evidence of detonation from previous flights.

- All CAE pistons will be modified to minimise the stress raiser that was found in the non-CAE pistons installed on SZQs engine, which will reduce the detonation sensitivity of the pistons.
- A survey of CAE engine owners will be conducted asking questions relating to their engine EGTs to gauge the risk of similar failures.
- Maintenance advice to check all reused pistons for cracks and to modify the stress raiser will become standard practice.
- A test engine has been subjected to similar conditions to enable more accurate failure mode analysis in the future.

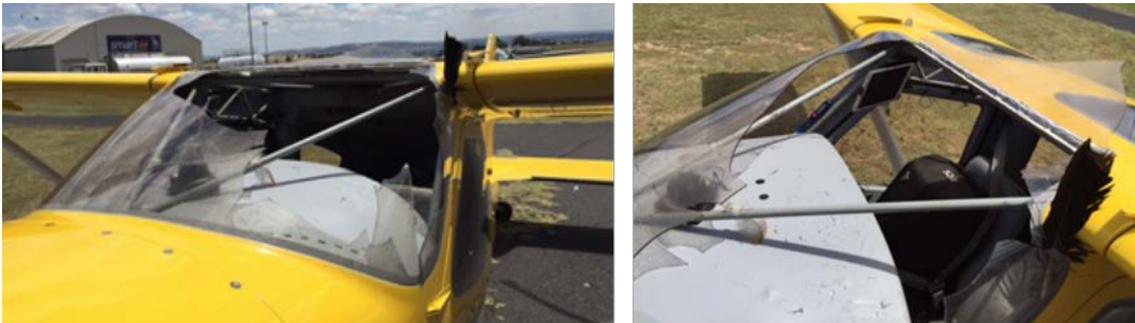
Figure 1: Damage to the aircraft windscreen

The bird broke through the windscreen on the left side of the aircraft and struck the pilot. The collision left the pilot with serious facial injuries and they were temporarily unable to see (due to the effects of the impact). The pilot had been wearing a headset and spectacles, which were both dislodged and damaged during the collision.

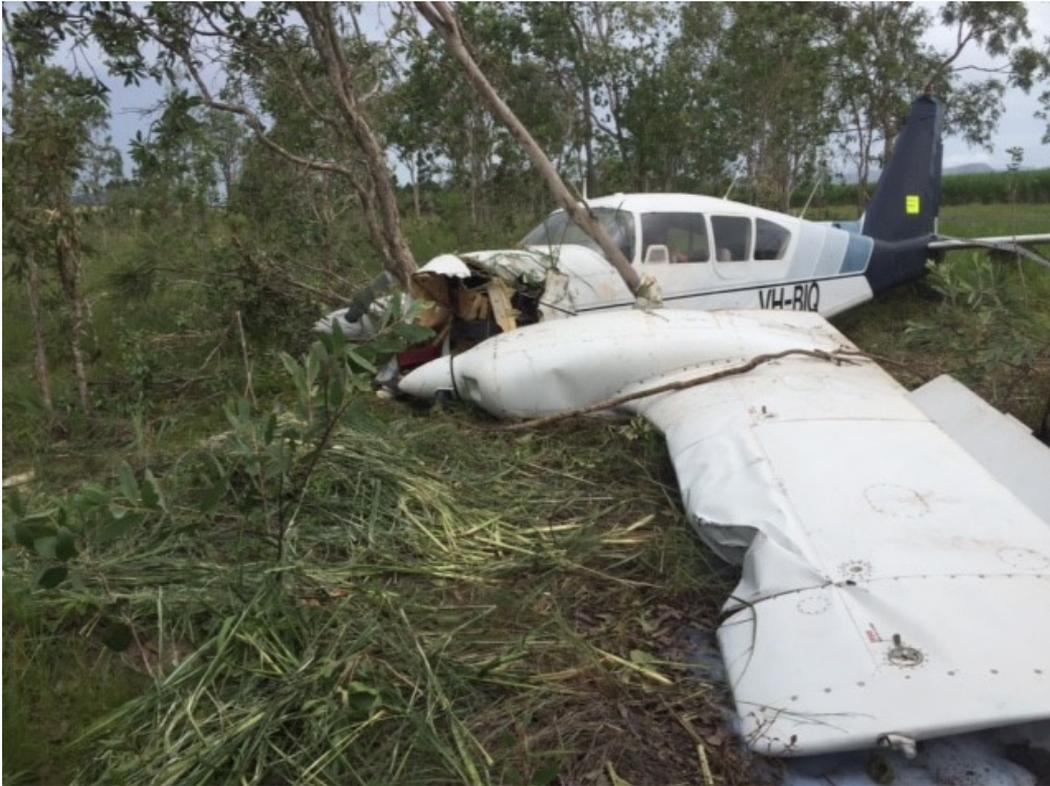
Figure 1: Accident site showing damage to VH-BIQ

- The temperature was 33 °C, with light rain falling, and the aerodrome was at an elevation of 1,560 ft AMSL. These conditions may have contributed to the aircraft being unable to maintain altitude even while the right engine continued to produce normal power. The pilot also elected not to feather the left propeller as the engine was still producing some power. The extended landing gear created substantial drag and further reduced the aircraft's ability to maintain altitude.
- Some debris may have been present in the fuel that blocked the injectors, resulting in partial loss of power. It was possible that fuel had dried out in the distributor valve, creating a gum, which was then loosened and picked up in the fuel.

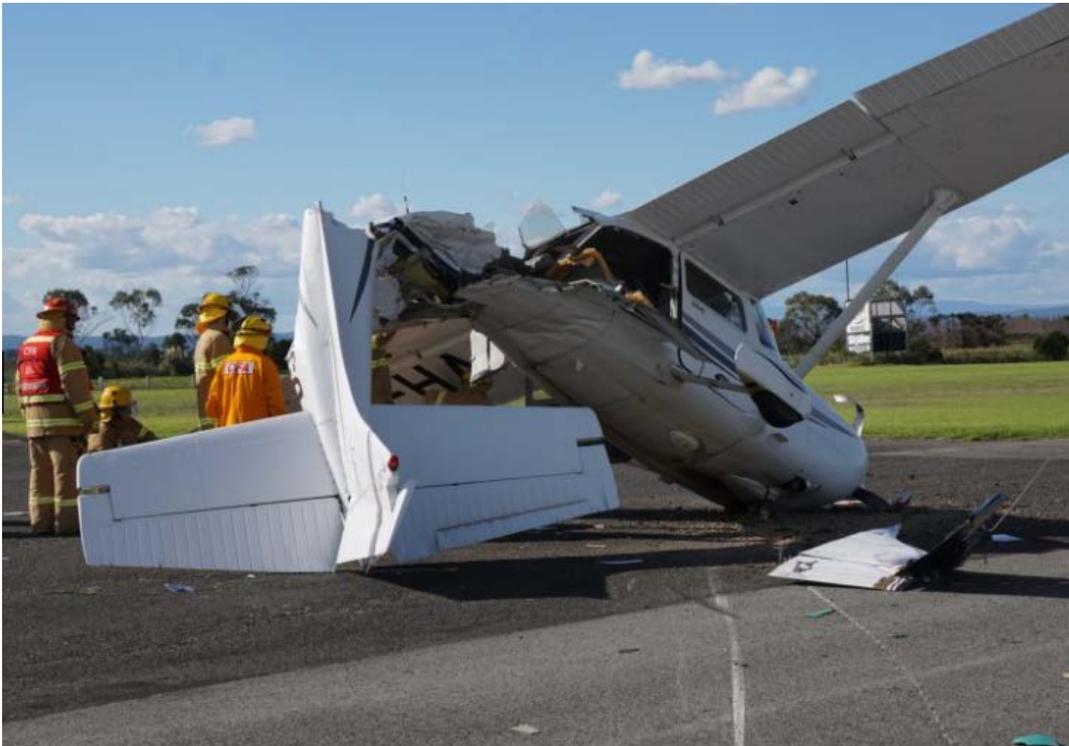
Figure 2: Accident site showing damage to VH-PCO

The aircraft sustained substantial damage and the pilot and passengers were uninjured (Figure 2).

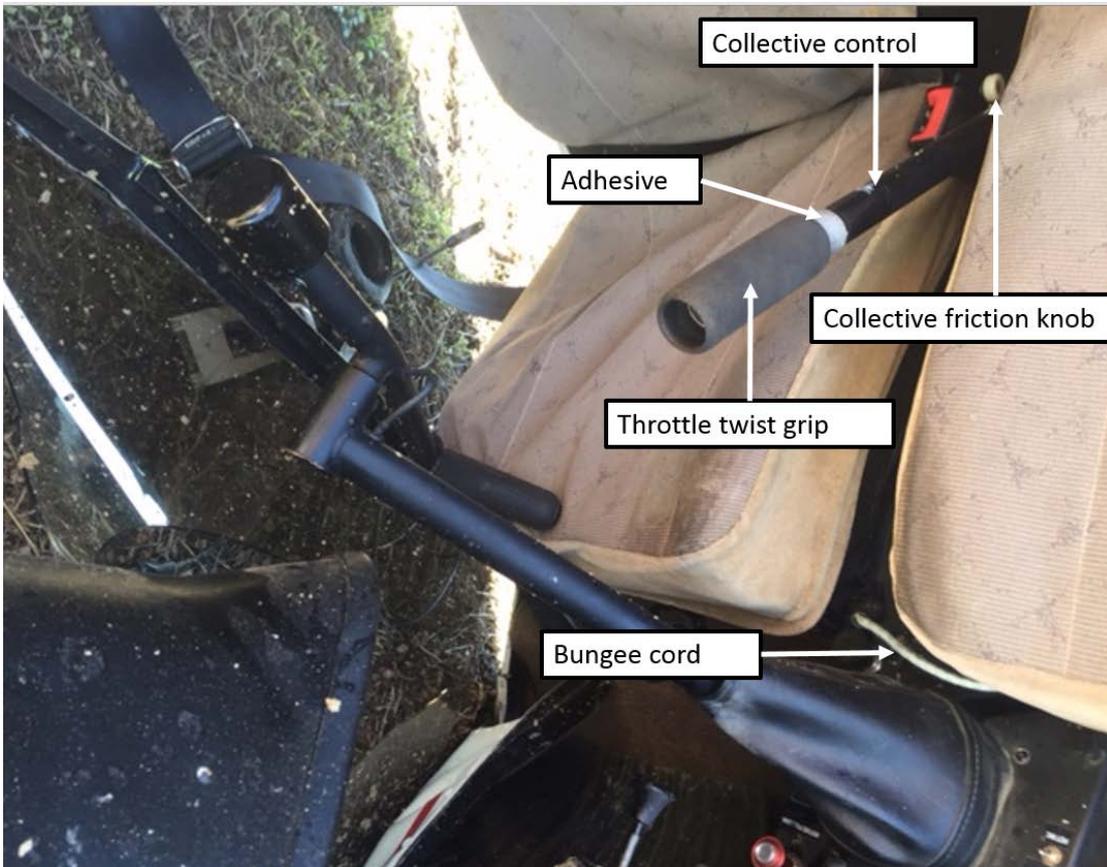
Figure 1: Cockpit of Robinson R22, VH-RGY, after the accident

As the pilot rolled the throttle on to start the helicopter's engine, the pilot discovered the adhesive holding the foam cover of the throttle twist grip had deteriorated and become like grease (Figure 1). The pilot then slid the cover forwards on the collective¹ control to grip the steel column.

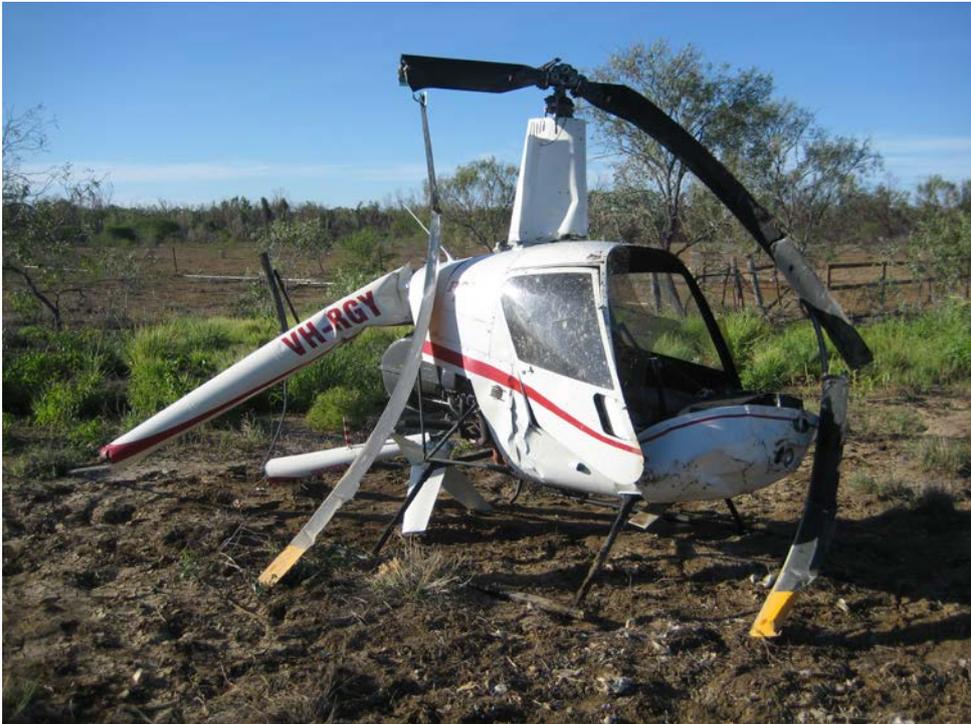
Figure 2: Damage to VH-RGY (after removal from accident site)

The helicopter sustained substantial damage (Figure 2). The pilot, who was outside of the helicopter was uninjured.
