# Collision with terrain involving Robinson R22, VH-RGY

Richmond Airport, Queensland, 21 March 2016

**ATSB Transport Safety Report**  
Aviation Occurrence Investigation  
AO-2016-025  
Final – 27 July 2016

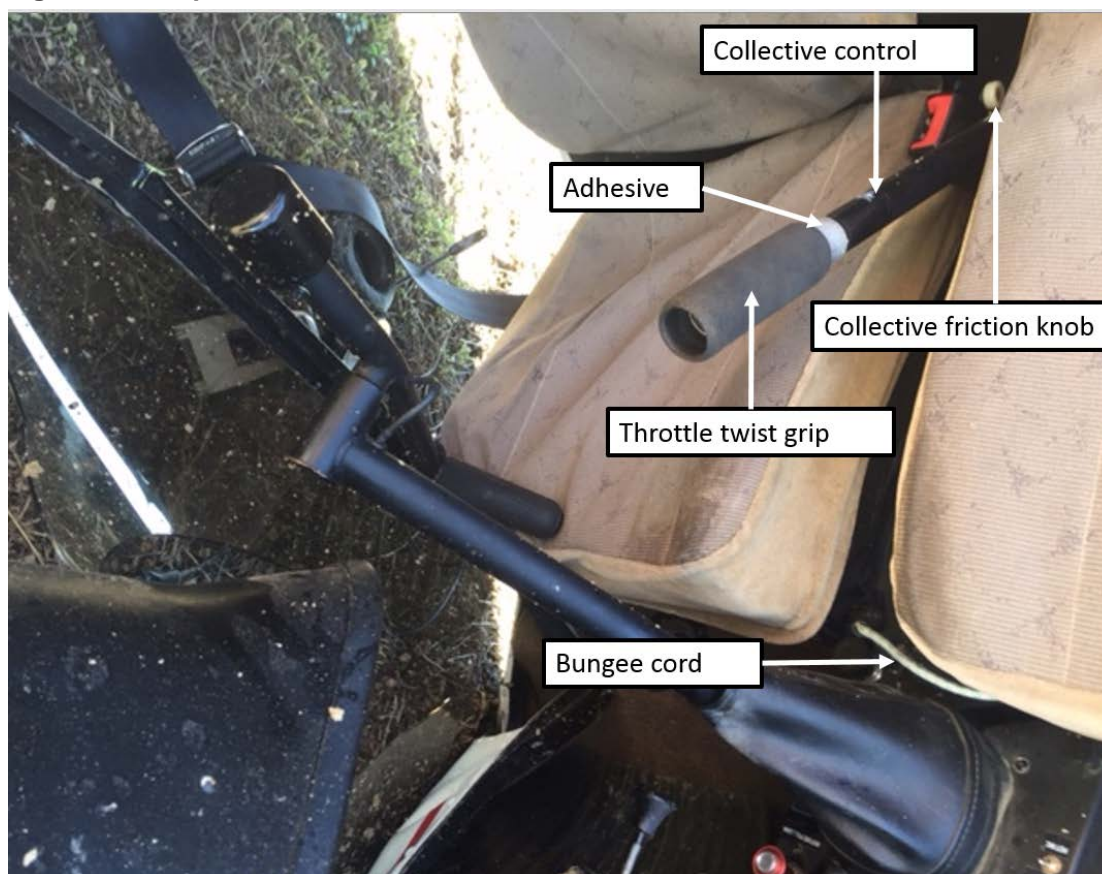
**Figure 1: Cockpit of VH-RGY**

As the pilot rolled the throttle on to start the helicopter's engine, the pilot discovered the adhesive holding the foam cover of the throttle twist grip had deteriorated and become like grease (Figure 1). The pilot then slid the cover forwards on the collective<sup>1</sup> control to grip the steel column.

The pilot reported that they had not had any issues with the adhesive before, despite operating in temperatures over 40 °C, but they did not usually have the doors on. However, even though the temperature was about 35 °C on the day of the accident, the helicopter had been parked for 12 days with the doors on, and the temperature inside the cabin was much hotter. Additionally, there had been rain during the period the helicopter was parked at the airport, increasing the humidity inside the cabin. The pilot believed that the temperature (and possibly combined with high humidity) inside the helicopter must have exceeded the adhesive's limit. The pilot was unsure whether the adhesive, which had been applied during a rebuild of the helicopter about two years earlier, was the approved adhesive for the grip.

The pilot assessed that because the grip had slid forwards on the collective control, the bungee cord may not have been far enough over the steel column, and it then slid further forwards, allowing the collective to rise, and the helicopter then lifted off.

The R22 [Illustrated Parts Catalogue](#) specified Part Number B270-15 Adhesive to be used to install the grip. The specified adhesive was clear, and was manufactured by 3M, with part number 2262. According to the [Technical Data](#) for 3M Plastic Adhesive 2262, when the adhesive was tested for 'plus 7 days' at 140 °F (60 °C), it failed 'in adhesion to the indicated substrate (steel)'.

Given the helicopter was parked for over 7 days, with doors on and in hot and humid conditions, this testing suggests that if the approved adhesive was used on the collective grip, it was likely to fail.

A representative from Robinson Helicopter Company (RHC) advised that the bungee cord was not an RHC installation, nor part of the type design. The post-accident photo (Figure 1) shows that the collective friction knob was in the OFF position, which indicates that the pilot had not applied it. (When tightened to the 'locked' position, the collective friction knob is designed to prevent the collective from moving from the position it was locked in.) However, they emphasised that the safest way to prevent similar incidents is to never leave the flight controls unattended while the engine is running.

Pre-flight checks are designed to ensure the helicopter is capable of operating correctly. To ensure safety of flight, any discovery of an unservicability should be dealt with before flight.

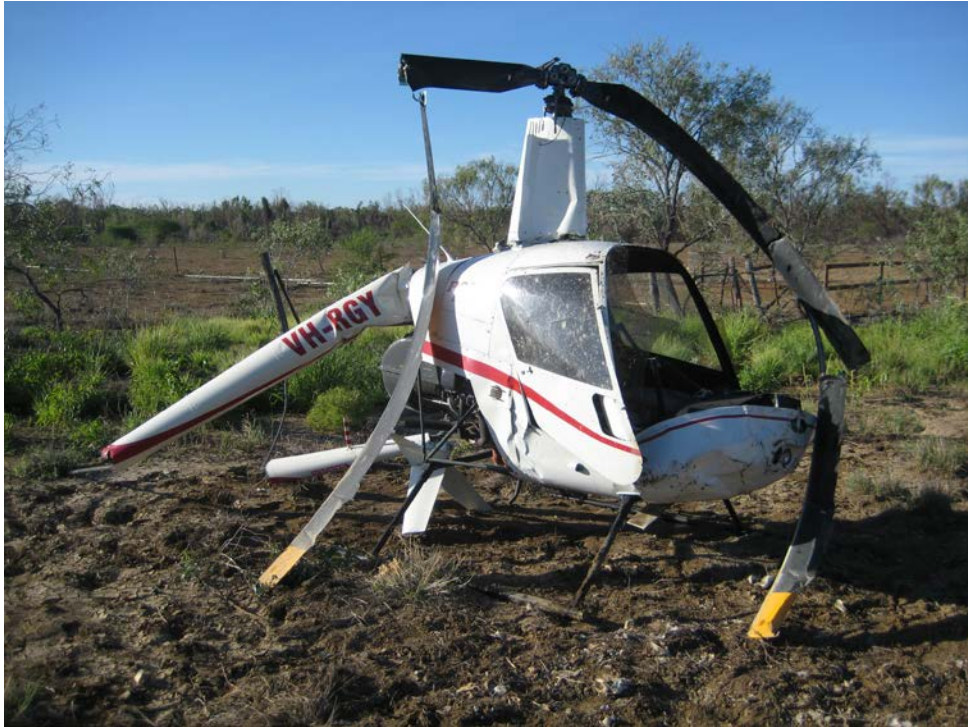
**Figure 2: Damage to VH-RGY (after removal from accident site)**

helicopter engine RPM increase, and turned and ran back towards the helicopter. The pilot and driver then observed the helicopter rotate away from the direction of the pilot, lift up, into and over the fence and land on its side on the other side of the fence, damaging the fence.

The helicopter sustained substantial damage (Figure 2). The pilot, who was outside of the helicopter was uninjured.
