Engine malfunction and collision with terrain involving Piper PA-23, VH-BIQ

near Mareeba, Queensland, 5 March 2016

ATSB Transport Safety Report
Aviation Occurrence Investigation
AO-2016-019
Final – 27 July 2016

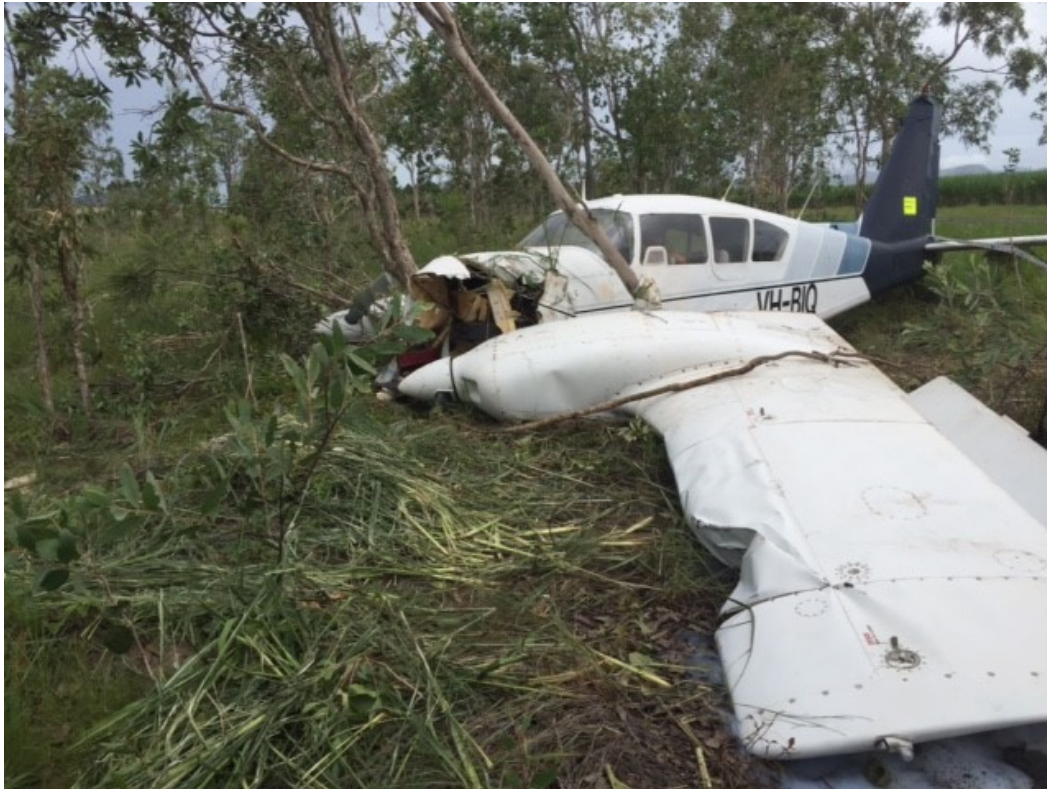
As the aircraft descended to about 200 ft above ground level, the pilot realised that the landing gear was extended. The pilot reduced the power to idle and conducted a forced landing. The aircraft collided with cane fields, crossed a road and collided with a tree, resulting in substantial damage (Figure 1). The pilot, who was the only occupant of the aircraft, initially exited the aircraft without injury. A small quantity of fuel in the cross-feed line ignited briefly, but the flame quickly extinguished. After assessing that there was then minimal risk of a fire, the pilot returned to the aircraft and in the process sustained a minor injury.

Figure 1: Accident site showing damage to VH-BIQ
