# Collision between a ballast regulator and tamper

near Greta, NSW | 14 July 2015

**ATSB Transport Safety Report**  
Rail Occurrence Investigation  
RO-2015-012  
Final – 24 March 2016

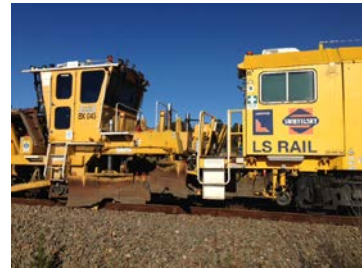
Track machines post-collision

The collision saw the ballast regulator ride above the tamper coupler and remain supported on the tamper deck. The ballast regulator also derailed the lead axle. The tamper operator sustained a minor injury and there was moderate damage to both vehicles.

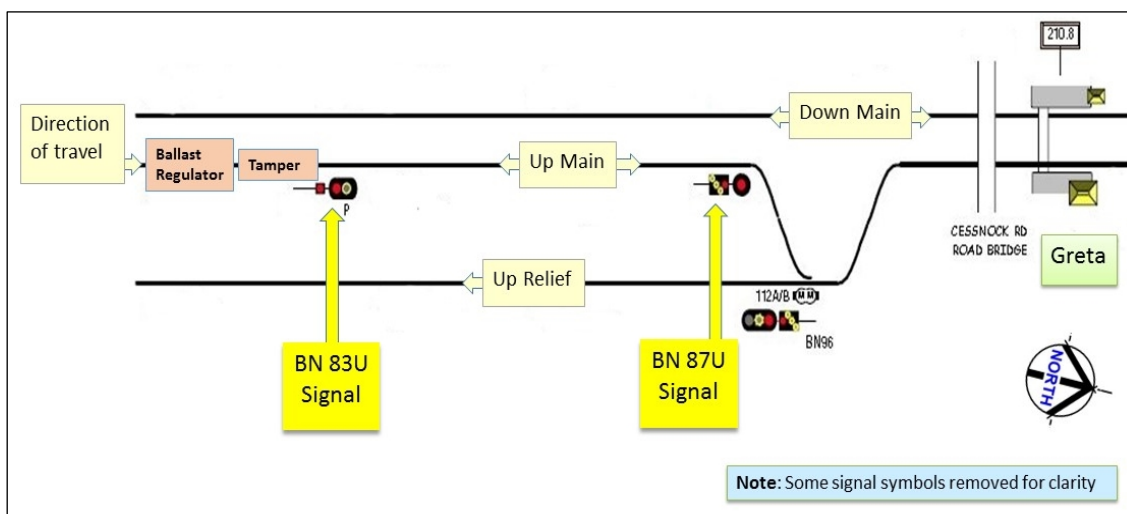
**Figure 2: Diagram showing track layout near Greta, NSW.**

The tamper and ballast regulator were authorised to travel to signal BN 87U before stabling on the Up Relief track at Greta. However, signal BN 83U (about 1450m before BN 87U) was showing a stop indication, requiring both vehicles to stop. Source: Graham Vincent, Track and Signal, annotations by ATSB

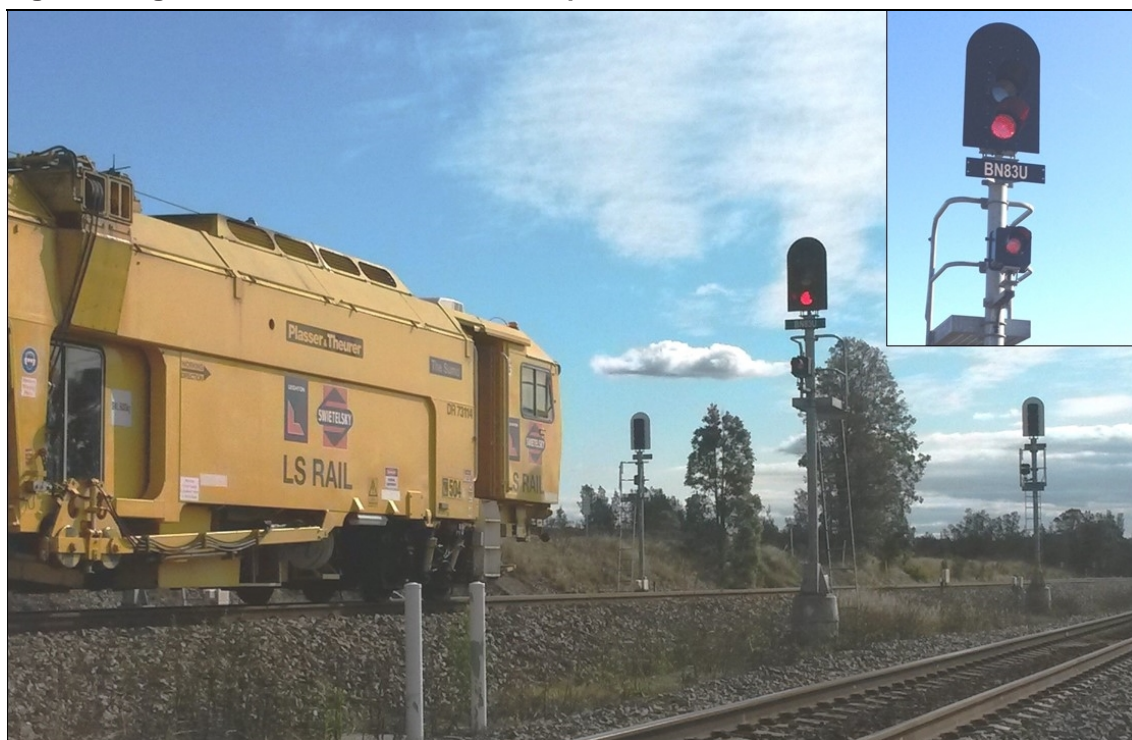
**Figure 3: Signal BN 83U and the Plasser tamper**

The collision occurred on a slight downhill grade, just before signal BN 83U (Figure 3). In the collision sequence, the front of the ballast regulator rode above the coupler on the tamper and came to rest partially on the rear deck of the tamper. The ballast regulator also derailed its lead axle.

Main image: Shows the location of the Plasser tamper following the collision, having previously stopped near signal BN 83U. Inset: Signal BN 83U and its corresponding signal identification sign. Source: Australian Rail Track Corporation and LS Rail.

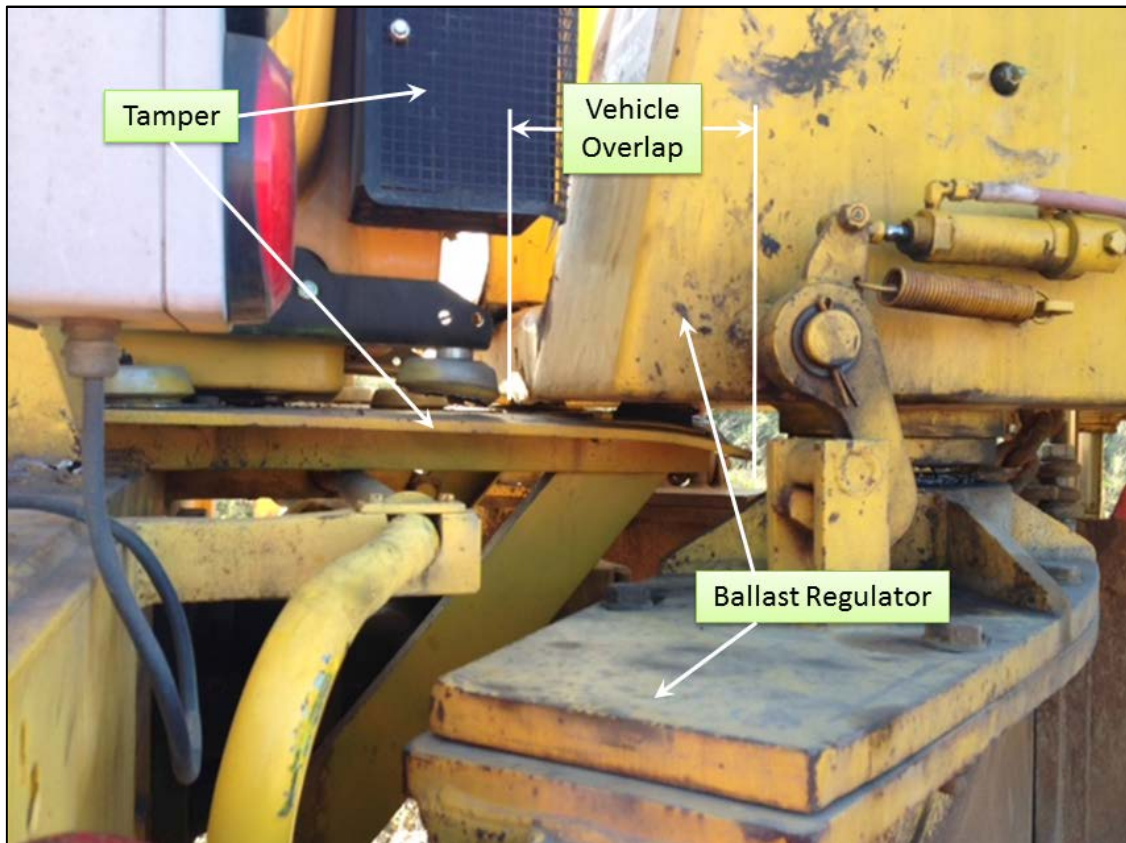
**Figure 4: Detail of ballast regulator resting on the rear deck of the tamper.**

A graph of the data also showed vertical accelerations of up to 2 g at the time of the collision – consistent with the ballast regulator riding above and then falling onto the rear platform of the tamper (Figure 4).

The ballast regulator remained overlapping and resting on the tamper's rear deck where ancillary equipment was damaged during the collision. The ballast regulator suffered a broken front towing 'A' frame and a deformed front chassis cross beam. Image Source: The Australian Rail Track Corporation.
