Collision on ground involving Cessna 172, VH-EWZ, and Cessna 172, VH-SYH

Moorabbin Airport, Victoria, 13 May 2016

ATSB Transport Safety Report
Aviation Occurrence Investigation
AO-2016-048
Final – 25 August 2016

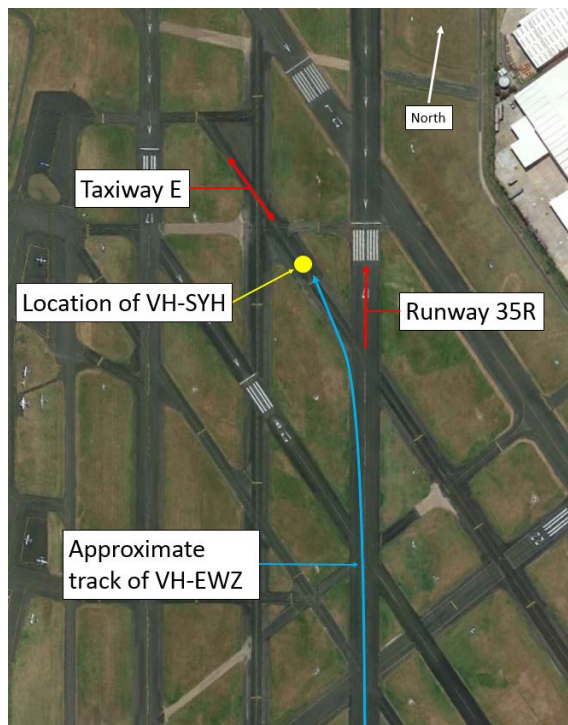
Figure 1: Moorabbin Airport showing location of collision

At the completion of their circuit training, the pilot of SYH landed and taxied clear of runway 35R, stopping on taxiway E facing north-west (Figure 1). Soon after SYH landed, at about 1059 Eastern Standard Time (EST), EWZ was on the final approach for another touch-and-go landing.¹

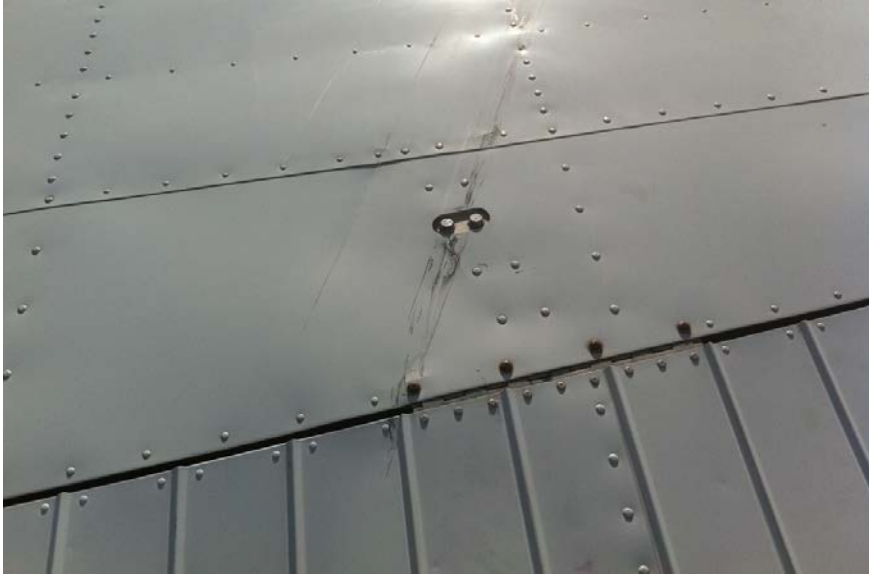
Figure 2: Damage to right wing of VH-SYH

The underside of the left wing of EWZ contacted the top of the right wing of SYH (Figure 2). EWZ came to a stop on the grass to the left of runway 35R. Both aircraft sustained minor damage and the pilots were uninjured (Figure 3).

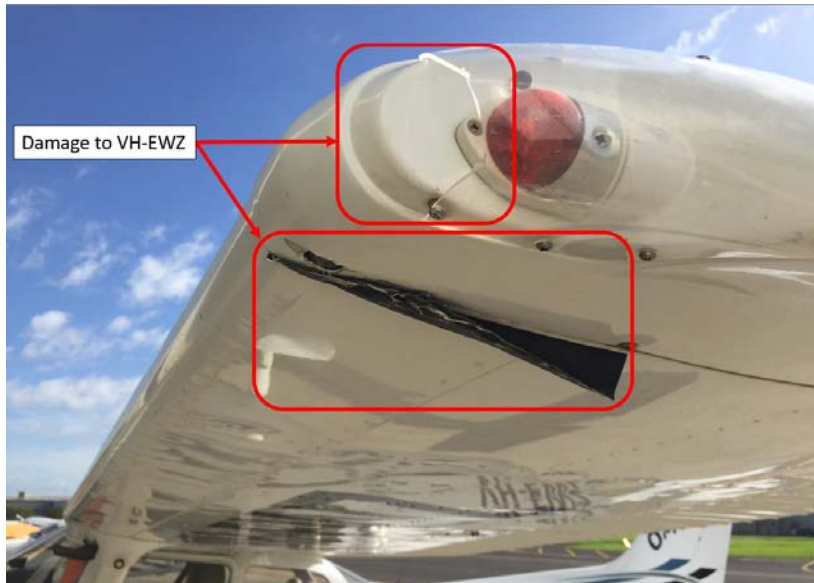
Figure 3: Damage to left wing of VH-EWZ

The pilot reported that during the landing, EWZ touched down heavily to the left of the runway centreline.² The pilot then applied full power to continue the take-off. As the power increased, the aircraft yawed to the left and ran off the runway. At that time, the pilot of EWZ sighted SYH on the taxiway, reduced the power to idle and applied full right rudder in an effort to avoid SYH.

Company instructors have reviewed the landing technique they were using and teaching. A video demonstration of approach and landing technique was recorded, both for staff training purposes and as a training tool.
