Near collision involving Piper PA-32, VH-NKA, and Cessna 210, VH-SQT

7 km WNW of Oenpelli Airport, Northern Territory, 25 May 2016

ATSB Transport Safety Report
Aviation Occurrence Investigation
AO-2016-054
Final – 8 September 2016

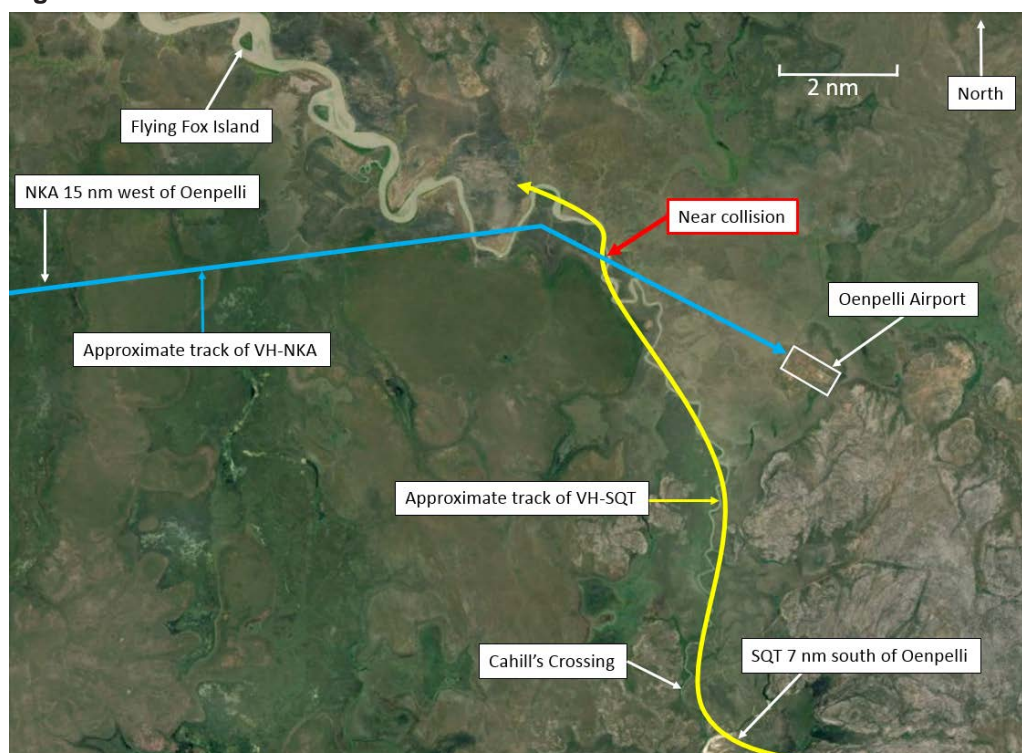
Figure 1: Overview of incident location

At 0926, a Cessna 210, VH-SQT (SQT), departed Jabiru Airport, NT, for a scenic flight over Kakadu National Park and the East Alligator River, NT. On board were the pilot and five passengers. SQT initially proceeded in an easterly direction before progressing north along the river (Figure 1).
