Australian Government
Australian Transport Safety Bureau

Aerial application safety

2015–2016 year in review

Research
AR-2016-022

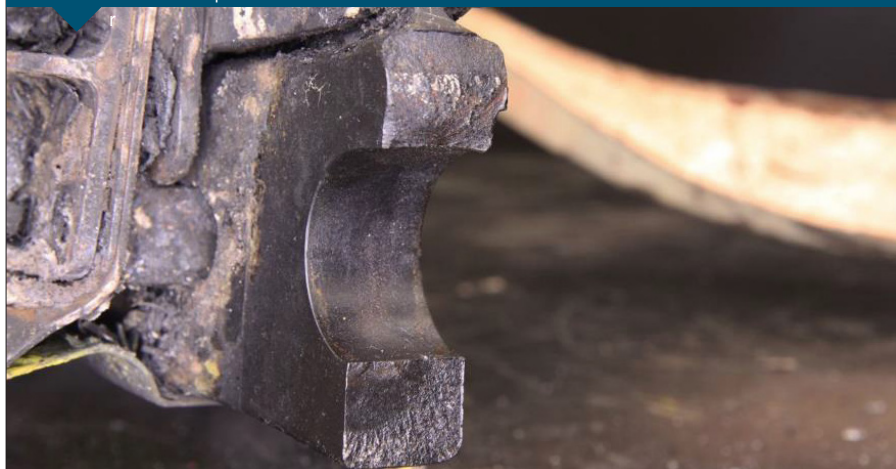
Figure 10: Outboard view of the fractured lower attachment fitting at the left wing main spar interconnection

The investigation found that the aircraft's left outboard wing lower attachment lug (Figure 10) fractured through an area of pre-existing fatigue cracking in the lug lower ligament. The fatigue crack originated at the small corrosion pits in the attachment

fitting. These pits formed stress concentrations that accelerated the initiation of fatigue cracks. The factors that were identified in the investigation included:

- Wing attachment fitting inspections: the corrosion pits in the left outboard wing lower attachment fitting were not completely removed during maintenance, which was contrary to the Civil Aviation Safety Authority (CASA) airworthiness directive. Furthermore, numerous micro-cracks, which were probably present in the bore of the left outboard wing lower attachment fitting at the last inspection for CASA airworthiness directive AD/PZL/5, were not detected by the non-destructive inspection.
- Aircraft operation: the aircraft had been operated at high speeds and subjected to a higher flight load spectrum than assumed by the manufacturer when it determined the aircraft's service life limitation. This likely increased the rate of fatigue damage, increasing the rate of formation and growth of the micro-cracks in the left outboard wing lower attachment fitting.

- Operators of some Australian M18 Dromaders, particularly those fitted with turbine engines and enlarged hoppers and those operating under Australian supplemental type certificate (STC) SVA521, have probably conducted flights at weights for which airframe life factoring was required but not applied. The result is that some of these aircraft could be close to or have exceeded their prescribed airframe life, increasing the risk of an in-flight failure of the aircraft's structure.

- Operation of the M18 aircraft with a more severe flight load spectrum results in greater fatigue damage than anticipated by the manufacturer when determining the service life of the M18. If not properly account for, the existing service life limit, and particular inspection intervals, may not provide the intended level of safety.

- Eddy current inspections used for this aircraft were not approved by CASA as an alternate means of compliance to an airworthiness directive. Aircraft would have been exposed to an inspection method that was potentially ineffective at detecting cracks in the wing attachment fittings.

- The engineering justification package supporting Australian supplemental type certificate SVA521 did not contain consideration of the effect an increase in the average operating speed could have on the rate of fatigue damage accumulation.

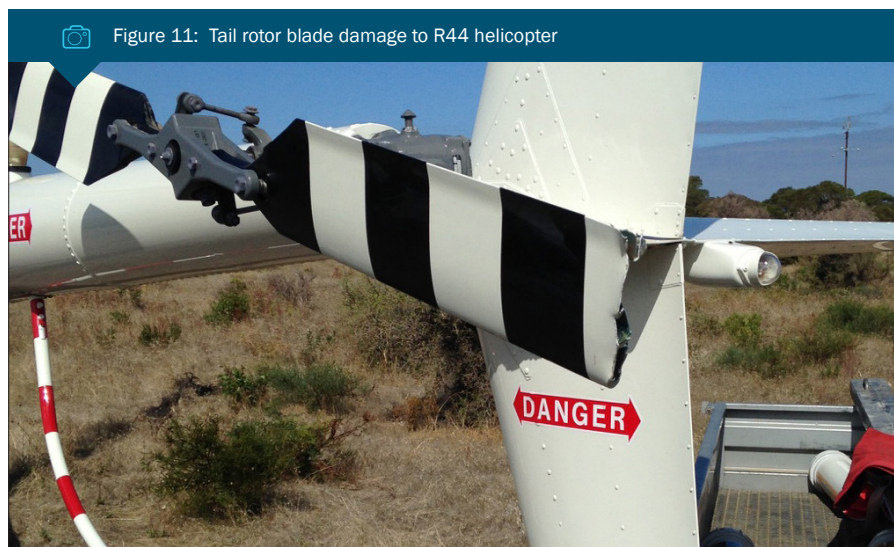
While surveying the field at low-level in search of the weeds, the helicopter struck a previously unidentified powerline. The helicopter's main rotor blade made initial contact with the powerline. Subsequently, the helicopter undertook an avoidance manoeuvre and the tail rotor blades also made contact with the wire, severing the blade tips. The helicopter was substantially damaged, but the occupants were uninjured (Figure 11).

The unidentified powerline was a single wire that was strung between the poles supporting the main and secondary powerlines. It also crossed, unsupported, through

the southern boundary of the operational area. It was not mentioned by the locals, nor marked on the data logger powerline overlay map. It was not easily visible from the air although additional support poles did lead the wire away from the secondary powerlines towards a distant building.

- The aircraft operator reviewed the risk assessment and aimed to standardise procedures. This included a focus on hazards and published information relating to high risk activities.
- The client updated their procurement processes in respect to hazard identification, operational briefings, and safety inductions.
- This investigation provides a reminder to flight crews of the need for consistency in aerial surveys for powerlines, the establishment of standardised procedures for their identification, and independent assessment of their presence.

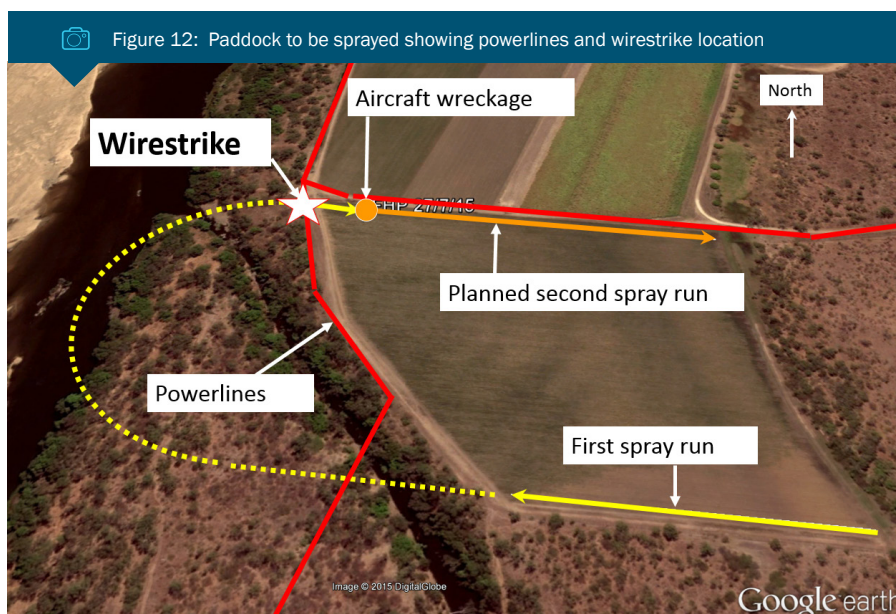
The pilot completed the first spray run towards the western powerline, overflow it, and then turned to line up for the second spray run. The pilot noted the powerline ahead, but then diverted their attention to the other powerline, running parallel to the direction of flight, and about 5 m off the left wingtip. The pilot also looked inside at the GPS to check the aircraft's line for the spray run.

The pilot commenced the descent into the paddock through the clearing in the trees and did not see the powerline at the time. As the aircraft descended, the pilot looked up and suddenly sighted the powerline. The pilot decided to push forward on the controls to increase descent. The aircraft then struck the powerline above the propeller on the wing struts.

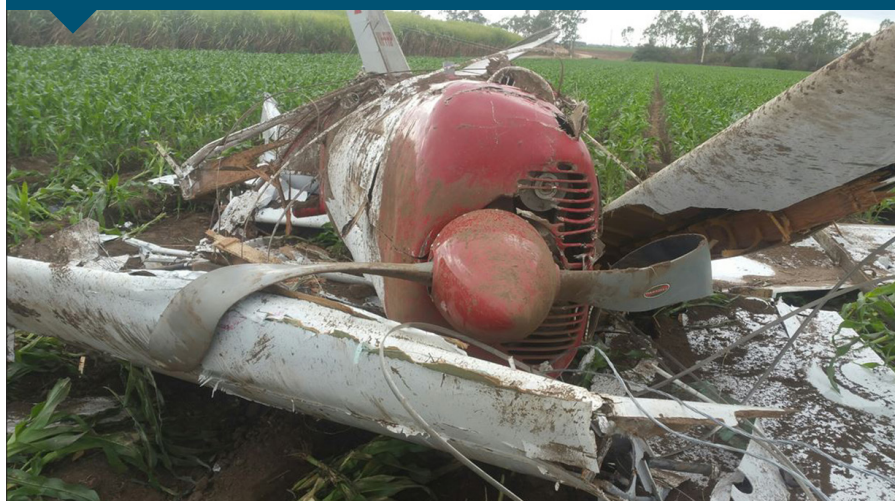
Figure 13: Eagle DW1 at accident site

After the aircraft struck the wires, it yawed violently to the left. The pilot used the right rudder to turn the aircraft away from the other powerlines, and the force of the aircraft pulled the transformer off the power pole on the left. The aircraft then yawed to the right. The force broke the power pole on the right and severed the powerline.

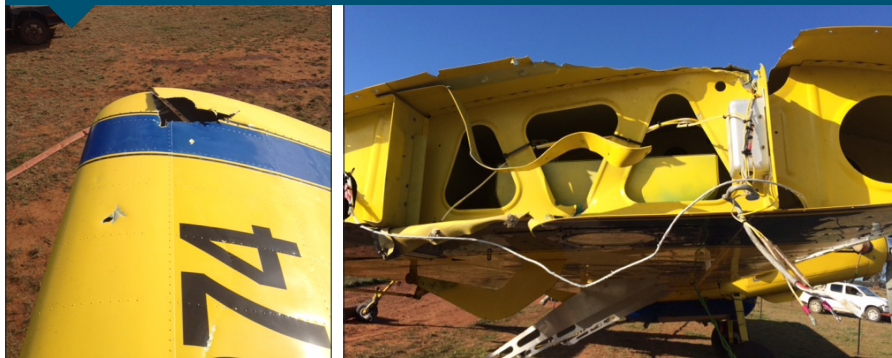
Figure 14: Wingtip damage to Air Tractor AT-802

- The pilot of an Air Tractor AT-802 was conducting aerial spraying operations in New South Wales. The pilot decided to spray the paddock in a back-to-back pattern within a series of mini- patterns. This was counter to their previous strategy of starting with the wire and then working away from it. During the operation, the aircraft struck a wire and the pilot conducted a precautionary landing. There was skin damage to the right-hand wing and wingtip and spray booms (Figure 14). The pilot reported they had not focused on their attention on the wire they struck because the wire was not in the planned spraying pattern at that stage. Furthermore, the pilot was also focused on the clean-up runs that would need to be sprayed (ATSB occurrence 201503510).

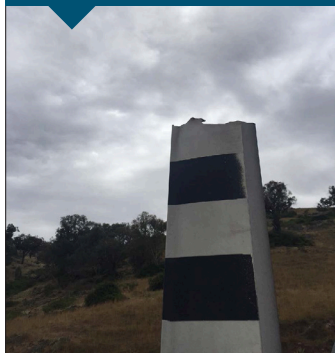
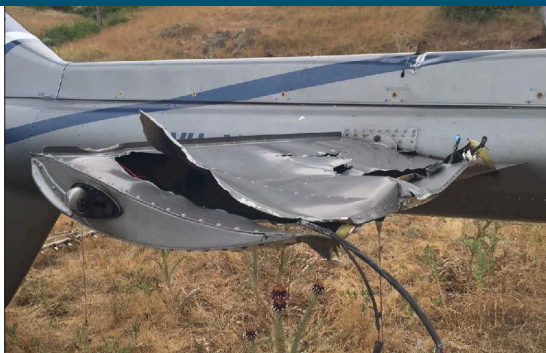
Figure 15: Damage to Bell 206B horizontal stabiliser and tail rotor

- Whilst spraying a paddock of blackberries in New South Wales, a Bell 206B helicopter struck a wire. The wire-cutter was effective at cutting through the wire, however, another wire hit the main rotor, tail rotor, and horizontal stabiliser, causing damage (Figure 15). The pilot then autorotated the helicopter to the ground (ATSB occurrence 201505993).

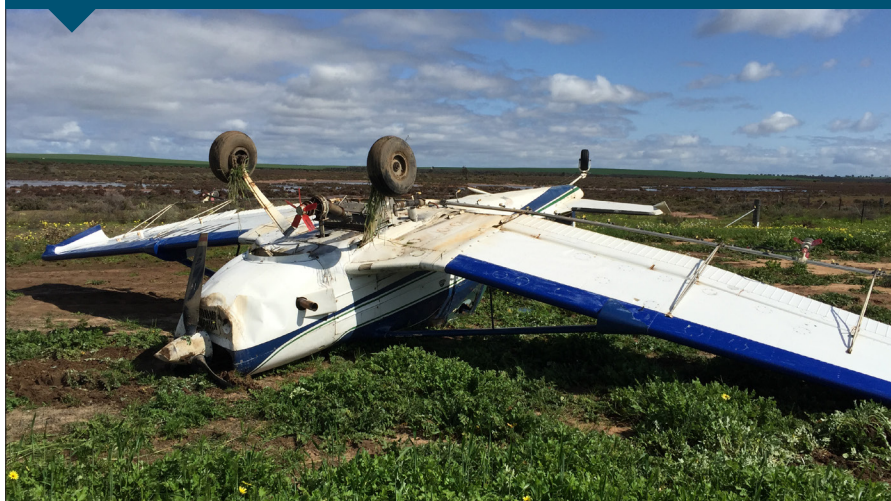
Figure 16: Cessna 188 inverted after landing

- During aerial spraying operations in Western Australia, a Cessna 188 Ag Husky experienced a total engine failure. The chemicals were dumped and the pilot conducted a forced landing in a paddock. During landing, the aircraft became inverted with substantial damage (Figure 16). The pilot had minor injuries. The engineering inspection revealed the number 2 crankshaft journal failed (ATSB occurrence 201503692).

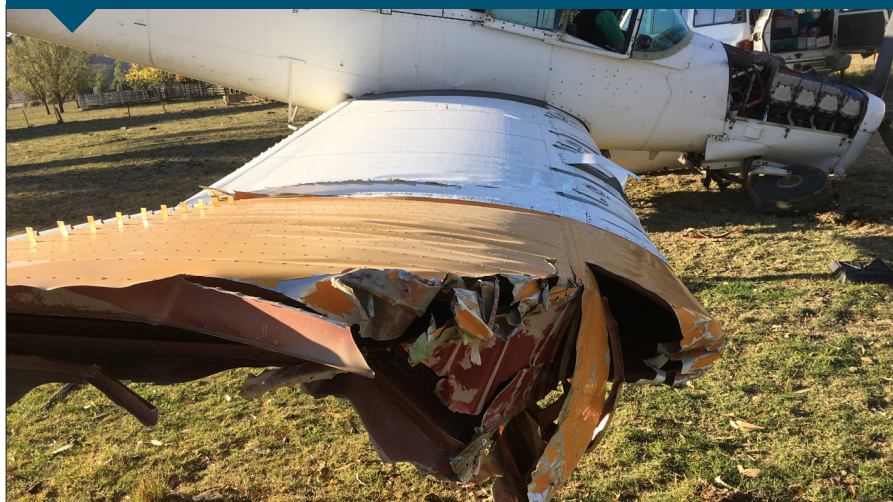
Figure 17: Wing damage on the Airparts FU-24

- During take-off while conducting aerial crop spraying operations in Victoria, a loud bang was heard from the engine of an Airparts FU-24 (PAC Fletcher). The connecting rod was then ejected from the engine. The engine then lost power and the pilot dumped the load. The pilot attempted to conduct a forced landing, but the right-hand wingtip impacted with a gumtree on the side of the road. The aircraft spun around, then came to rest. There was substantial damage to the aircraft including damage to the engine, outer panel on the right wing, propeller, and the nose leg had collapsed (Figure 17). An inspection revealed that the connecting rod on the number 8 cylinder failed and broke through the crankcase (ATSB occurrence 201600577).

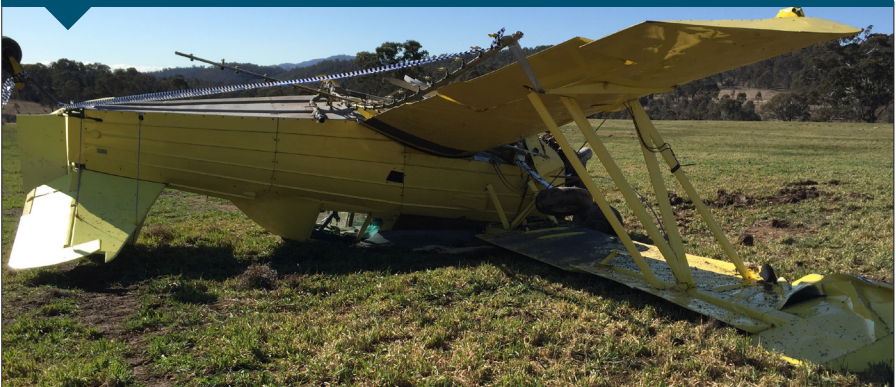
Figure 18: Damage to Grumman G164

The pilot commented afterwards it would have been favourable if the airstrip had been higher up and closer to the target zone. Therefore they would have had more time to dump the load, less distance to climb on each load, and a more accurate assessment of the wind conditions. Furthermore, dumping granular substances, such as superphosphate takes longer than liquid. Although the superphosphate had been dumped at the highest rate, about 300 kg of the initial 500 kg superphosphate load remained in the hopper. The pilot also commented that avoiding similar incidents was to

understand the atmospheric conditions in steep mountainous country. This is because variation in wind strength and direction due to terrain can have serious consequences on flight safety, particularly when operating at low airspeeds and close to the ground.

- Wind: the wind was about 2–5 kt crosswind on take-off. The pilot believed that the aircraft encountered a downdraft from the hill.
- Assessing and planning: the pilot observed the wind while he was having lunch, but decided to take-off again. They did not account for the wind at the top of the hill.

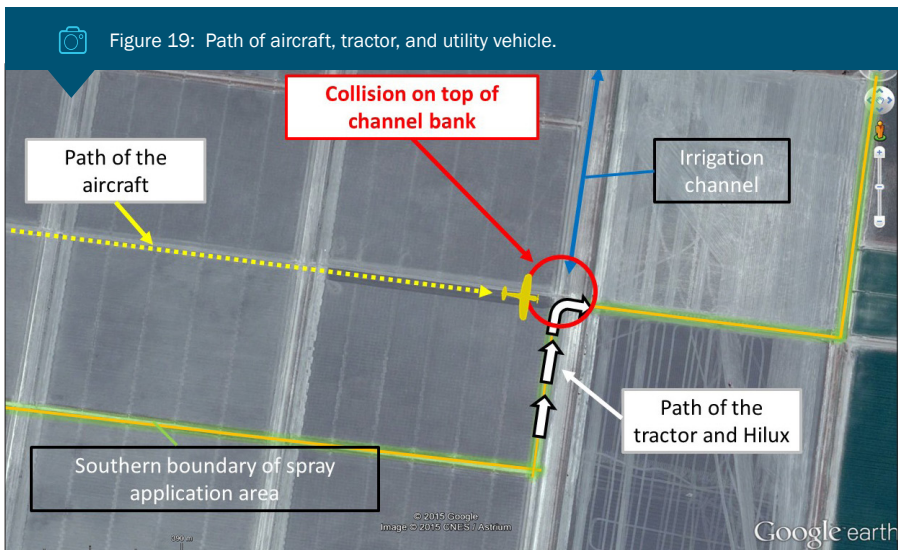
During this run, the pilot was conducting a spray run in an easterly direction, along a roadway that divided some of the paddocks inside the spray application area. The pilot intended to continue the run, across the irrigation channel, and along the southern boundary of the eastern most paddock in the spray area (Figure 19).

At this time, the pilot also reported seeing a white utility vehicle turn onto an irrigation channel crossing ahead of the aircraft. However, the vehicle appeared to be slowing to a stop, short of the intersection/irrigation channel crossing. The pilot assumed that the driver of the vehicle had seen the aircraft, and was stopping to allow the aircraft to continue its run over the channel crossing.

Confident that the vehicle was stopping, the pilot continued the spray run and as per normal routine. The pilot checked the spray pressure gauge, and momentarily looked to each side of the aircraft to confirm that no spray nozzles were blocked. As the pilot then turned their attention forward again, and commenced a short climb to clear the raised channel bank, they saw that the utility had not stopped. The utility had continued along the road, turned right, and was climbing up over the raised channel bank (Figure 19).

An inspection of the aircraft revealed parts of the left landing gear were damaged, particularly in the area where the leg of the landing gear attaches to the aircraft structure. The utility was substantially damaged in the collision, specifically the tray headboard and roof structure on the passenger side of the cabin area.

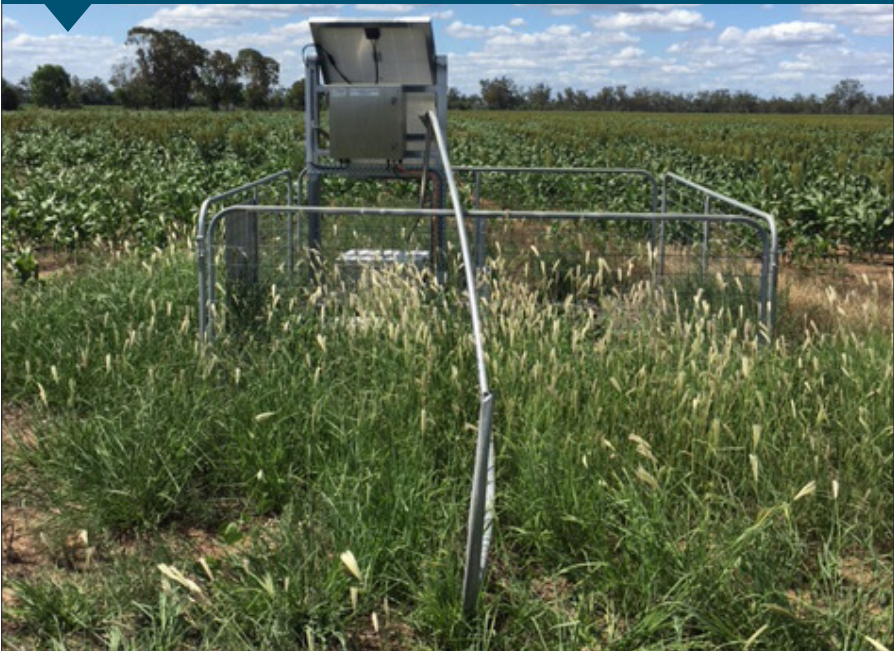
Figure 20: Bore with solar panels and antenna pole (after collision)

During the break after the first run, the pilot was provided with a map of the next area to the sprayed, which included a number of gas wells. Each gas well was on a gravel pad, with an antenna that posed a potential hazard to low-flying aircraft. The pilot was advised there were no other known hazards, such as powerlines, in the area.

Prior to commencing the operation, the pilot overflew the area twice to inspect the field at about 100 ft AGL and about 50 ft AGL. The pilot noted the wells on the gravel pads, and verified that there were no powerlines in the treatment area. The pilot also saw a solar panel a short distance from a well, located in the crop, and not on a separate pad. The pilot did not see an antenna at the site of the solar panel at the time.

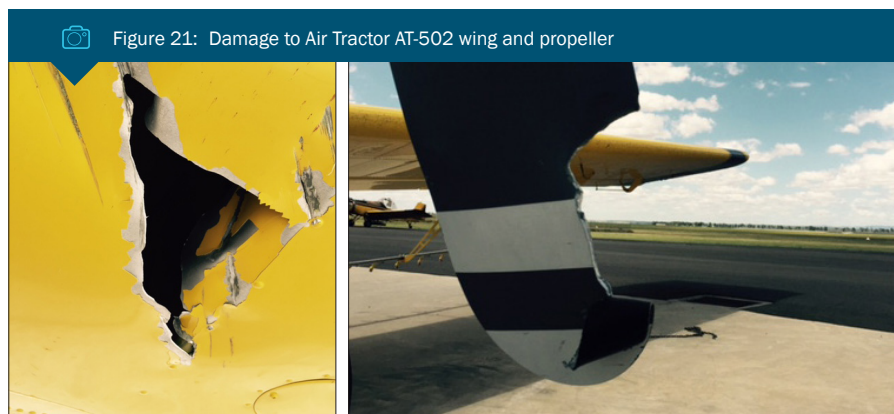
During the return flight, the aircraft still had a minor vibration. After landing, it was found the aircraft sustained damage to the left wing and propeller (Figure 21).
