# Wirestrike and collision with terrain involving Schweizer 269C, VH-NTZ

Deloraine, Tasmania, 20 July 2016

**ATSB Transport Safety Report**  
Aviation Occurrence Investigation  
AO-2016-081  
Final – 28 September 2016

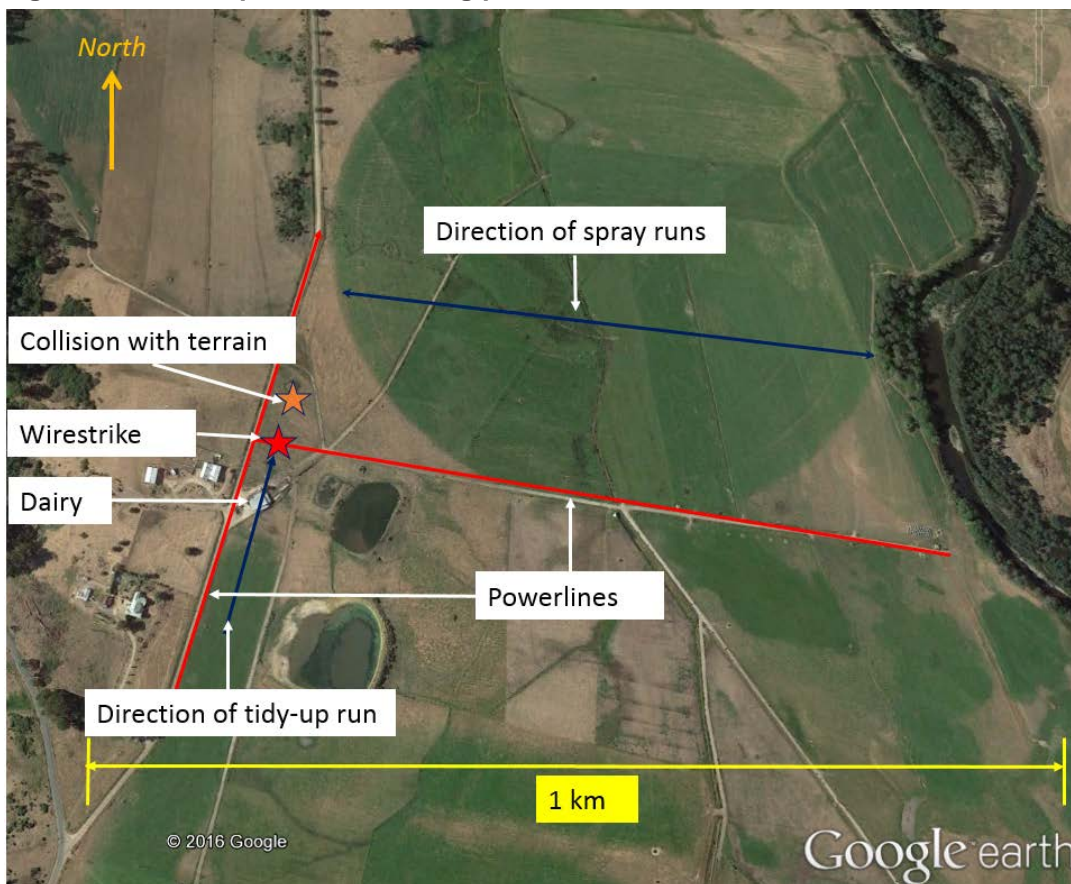
**Figure 1: Area of operations showing powerlines**

The pilot completed spraying one area, and prior to commencing spraying another, overflew it to assess the site. During that inspection, the pilot sighted two sets of powerlines, one running approximately north-south, and the other branching off to the east. Based on the location of the powerlines and the wind, which was a light northerly, the pilot elected to spray the paddock in an east-west direction (Figure 1). The helicopter was operating north of the powerline running east-west, and in each run, was overflying and remaining clear of the powerlines at the western end of the paddock.

At about 1230 Eastern Standard Time (EST), after completing two spray loads, the pilot tracked south over the powerline and turned to conduct a tidy-up run to the north along the road and powerlines running north-south.

After overflying a dairy building, the helicopter descended as the pilot intended to commence spraying. However, the helicopter struck the powerlines running east-west and subsequently collided with terrain.

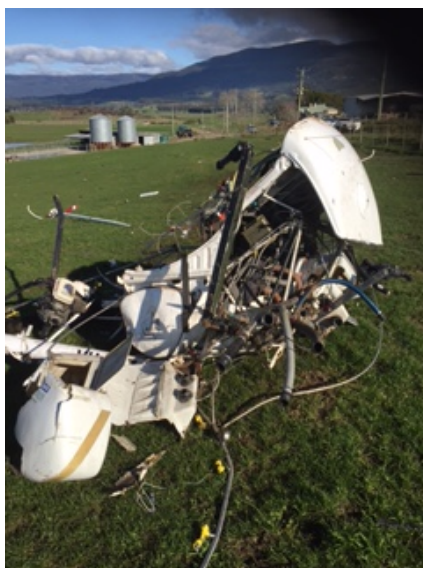
**Figure 2: Accident site**

The pilot, who was the sole occupant of the helicopter, sustained serious injuries and the helicopter was destroyed (Figure 2).

The pilot commented that in the tidy-up run they should have been thinking 'over the dairy and over the powerlines then descend', but had momentarily forgotten about the powerlines and descended after passing over the dairy. Usually they overflew the whole paddock again to check for hazards before commencing a tidy-up run, but had omitted to do it on this occasion.
