Aviation Short Investigations Bulletin

Issue 52

ATSB Transport Safety Report
Aviation Short Investigations
AB-2016-105
Final – 28 September 2016

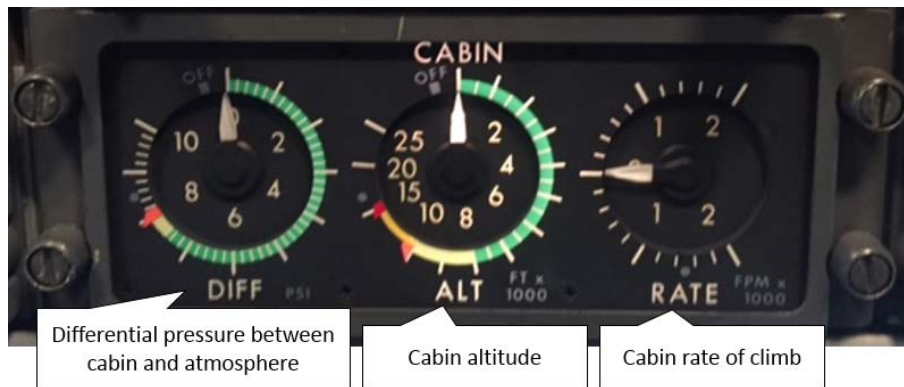
Figure 1: F28 cabin pressure gauges

The cabin crew believed the noise was coming from the forward lavatory, so one cabin crewmember inspected the lavatory, but could not identify where the noise was coming from. The PM checked the aircraft pressurisation indications located on the cockpit overhead panel and noticed that the cabin altitude³ indicated 6,000 ft as expected, but the cabin pressure rate of climb had increased from about 200–300 ft/min to about 500 ft/min⁴ (Figure 1). This indicated to the PM that they were losing cabin air faster than the pressurisation system could pressurise the aircraft.

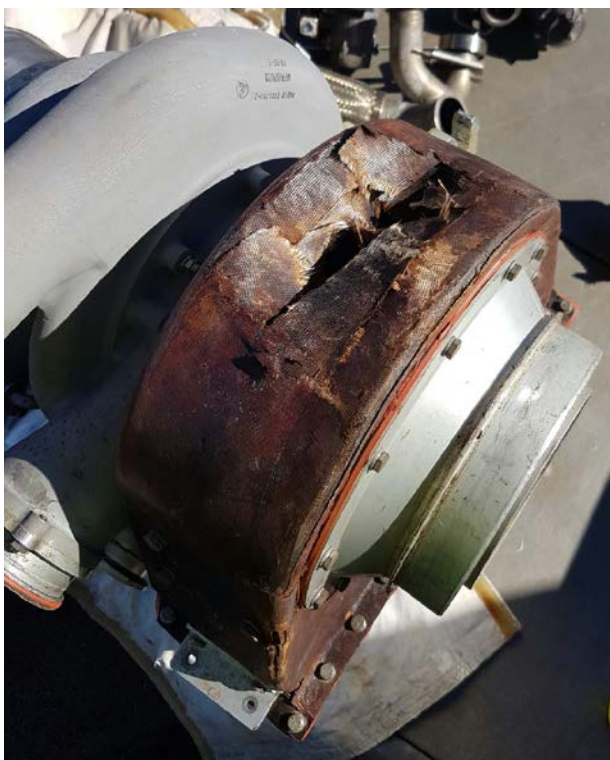
Figure 3: Ruptured plenum duct

- There was a ‘massive leak’ from the inlet and outlet of air-conditioning pack 1. Pack 1 was removed and a large hole found in the plenum duct¹³ (Figure 3). The plenum duct and primary and secondary heat exchanger were replaced on pack 1. Aircraft pressurisation was then tested and found to be serviceable (including operations with either pack 1 or pack 2 turned off).

Air-conditioning pack 1 is located on the left side of the aircraft underneath the floor of the flight deck, just aft of the left seat, which places it close to underneath the floor of the forward lavatory. The pack 1 plenum duct likely ruptured at about FL 305 to produce what the aircraft captain described as a loud 'whooshing' noise and what the cabin manager described as a 'suction' noise. According to [Flight Safety Foundation Human Factors and Aviation Medicine](#), the immediate

The subsequent maintenance investigation found duct leaks from both air-conditioning systems. However, only the leak from air-conditioning pack 1 triggered an alert to the pilots, and that fault was associated with an overheat condition. In accordance with the operator comments, the rapid increase in the cabin pressure altitude rate of climb, which occurred when the flight crew turned pack 1 off, indicates that pack 2 alone could not supply a sufficient quantity of air to the distribution ducting to maintain cabin altitude. The systems were only able to re-pressurise the aircraft following the descent to 10,000 ft (the demands on the pressurisation system were substantially reduced)¹⁴ and the successful reset of pack 1.

All parts removed from the number 1 air-conditioning pack will be forwarded to the manufacturer, or authorised repair organisation, for further technical investigation to determine the cause of the failure of the plenum duct.

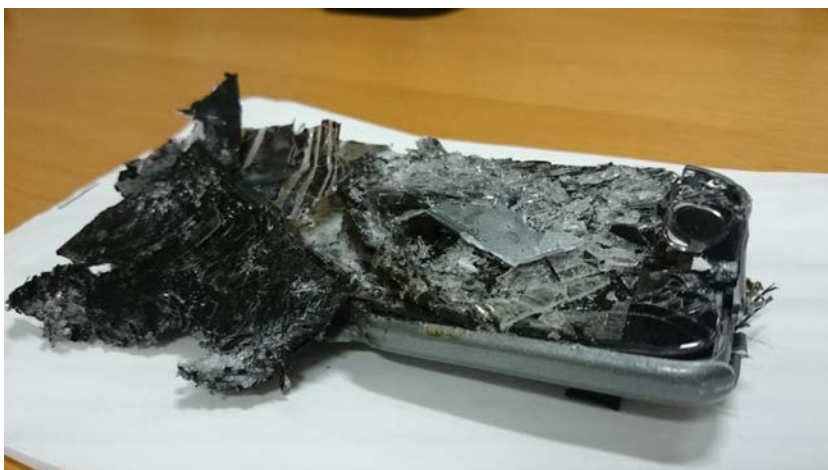
Figure 3: Crushed PED after removal from seat

After confirming the PED fire had been extinguished, the cabin crew attempted to remove the PED in order to place the device in water, in accordance with lithium type battery fire procedures. The PED could not be removed without further damage and risk of fire. Therefore, the cabin crew elected to leave the device in place and position a crewmember with a fire extinguisher near seat 3A for the remainder of the flight. About 10–15 minutes after the incident, this crewmember identified further heat coming from the crushed PED. They again discharged the fire extinguisher onto the PED, eliminating the heat.

Two passengers reported feeling unwell after the event, but it was unclear if this was as a result of the incident. The aircraft seat sustained minor damage.

- A review of reported events revealed 22 similar occurrences of trapped or crushed PEDs. Seven of these occurrences resulted in smoke and/or heat being produced. This incident was the first event to result in fire.
- The investigation determined that the likely area for the PED to intrude into the seat mechanism was adjacent to the seat belt anchor point. This area becomes more exposed as the seat reclines towards the flat position.
- Mesh netting within the seat structure is designed to capture objects that fall behind the seat. Damage to seat 3A consisted of an approximate 5 cm melt area to this mesh netting. There was no other damage noted to the seat structure.

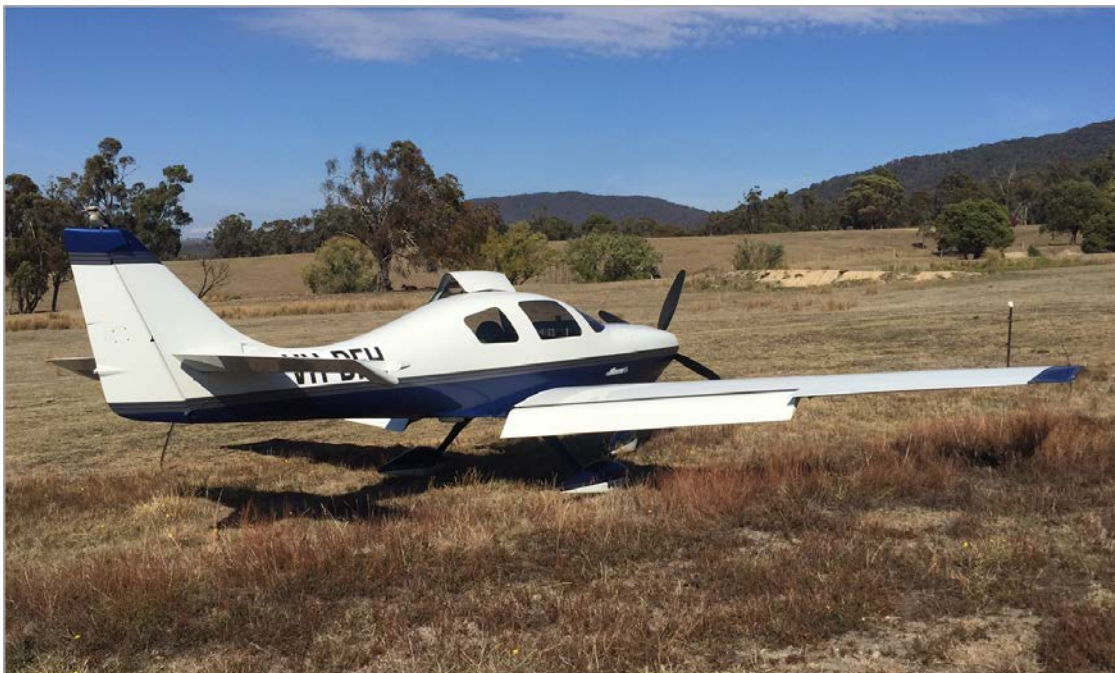
Figure 1: DFH at the accident site

The aircraft touched down about 25 m before the threshold on a grass area. The aircraft bounced slightly, touching down again on the grass area beside the airstrip. The left wing contacted an electric fence post and came to a stop a further 100 m after the initial touch down point (Figure 1). The pilot exited the aircraft after turning off all the electrical and engine controls. The pilot was not injured and the aircraft had minor damage.

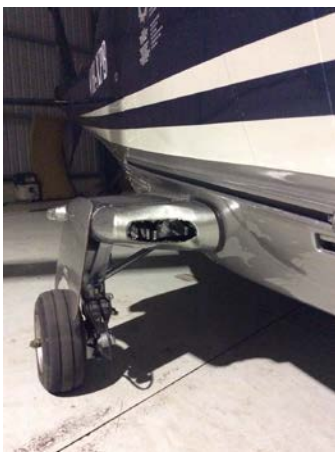
Figure 2: Damage to right landing light of VH-XPB

After landing, the passengers disembarked and the pilot refuelled the helicopter. The pilot then conducted a ferry flight to Camden Airport, NSW. After arriving in Camden, the helicopter was pushed into a well-lit hangar, at which stage damage to the helicopter was detected. It was apparent that the helicopter had struck a tree branch, causing damage to the right side landing lights, horizontal stabiliser, vertical fin and rotating beacon (Figure 2). It was unclear exactly when the helicopter had struck a tree.

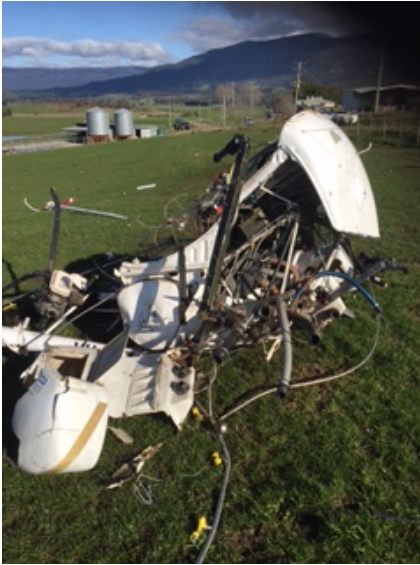
Figure 2: Accident site

The pilot, who was the sole occupant of the helicopter, sustained serious injuries and the helicopter was destroyed (Figure 2).

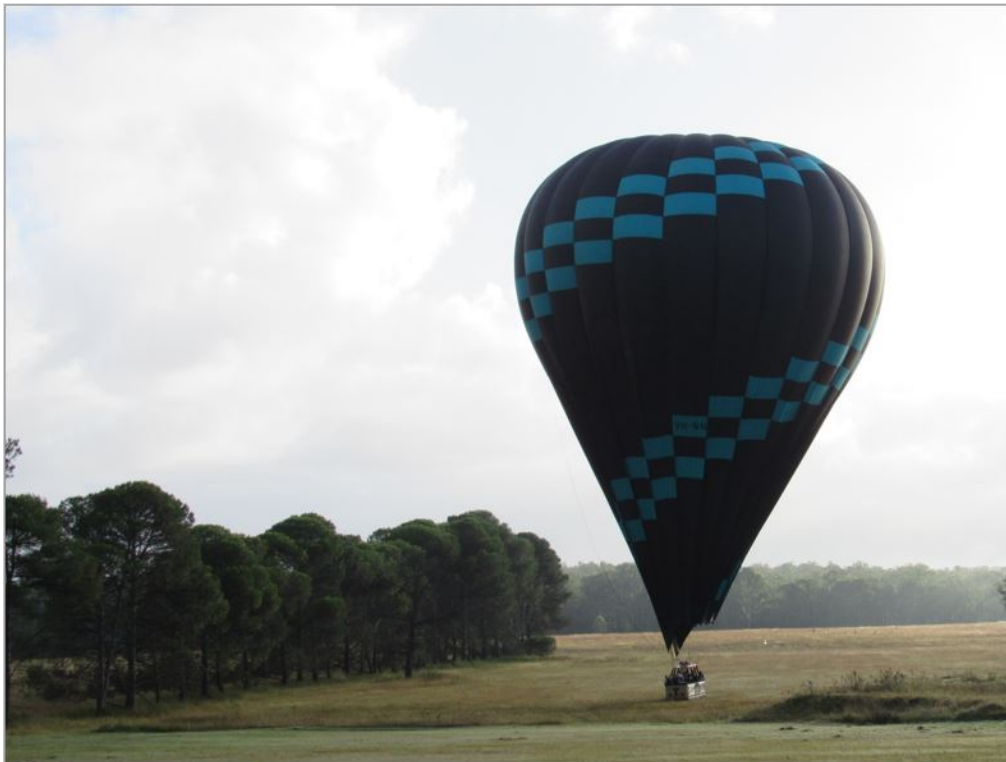
Figure 2: Kavanagh Balloons B-400, VH-WNV at Rothbury

During the emergency disembarkation, two of the passengers received minor burn injuries. The lower section of balloon envelope was substantially damaged.
