# Loss of power and collision with terrain involving Stoddard Hamilton Glasair SH-2FT, VH-HRG

near Wedderburn Airport | New South Wales on 19 July 2015

## ATSB Transport Safety Report

AO-2015-079

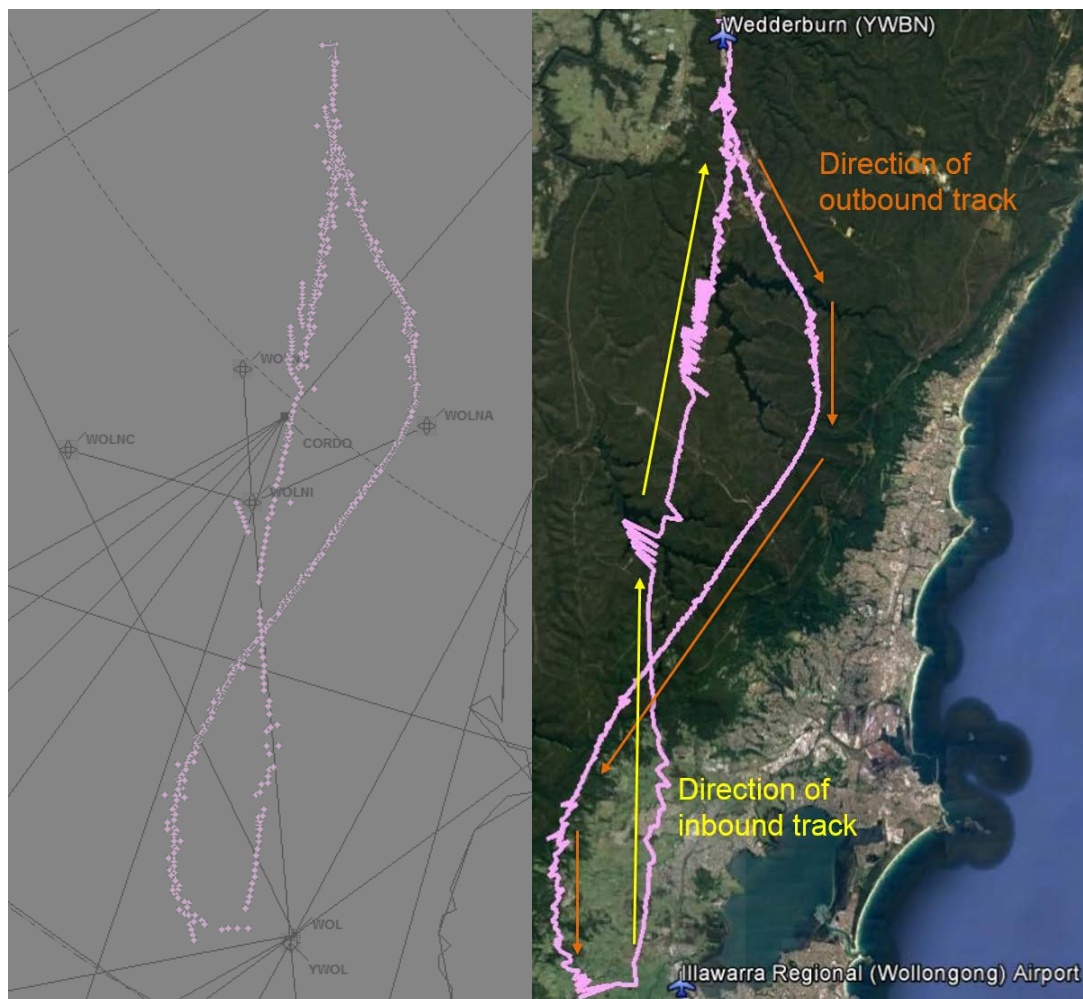
At 1628, an unverified aircraft was observed on Airservices Australia surveillance radar for the area, consistent with the position of VH-HRG. The aircraft tracked in a south-south-westerly direction toward Wollongong. At about 1639, when near Wollongong, the aircraft turned left and commenced tracking back to the north (Figure 1).

**Figure 1: Radar trace of the aircraft that appeared on Airservices Australia surveillance radar in the area of Wedderburn Airport at 1628 (at left, with the aircraft's radar returns shown in lilac) and the radar trace and returns (also in lilac) overlaid on Google earth (right)**

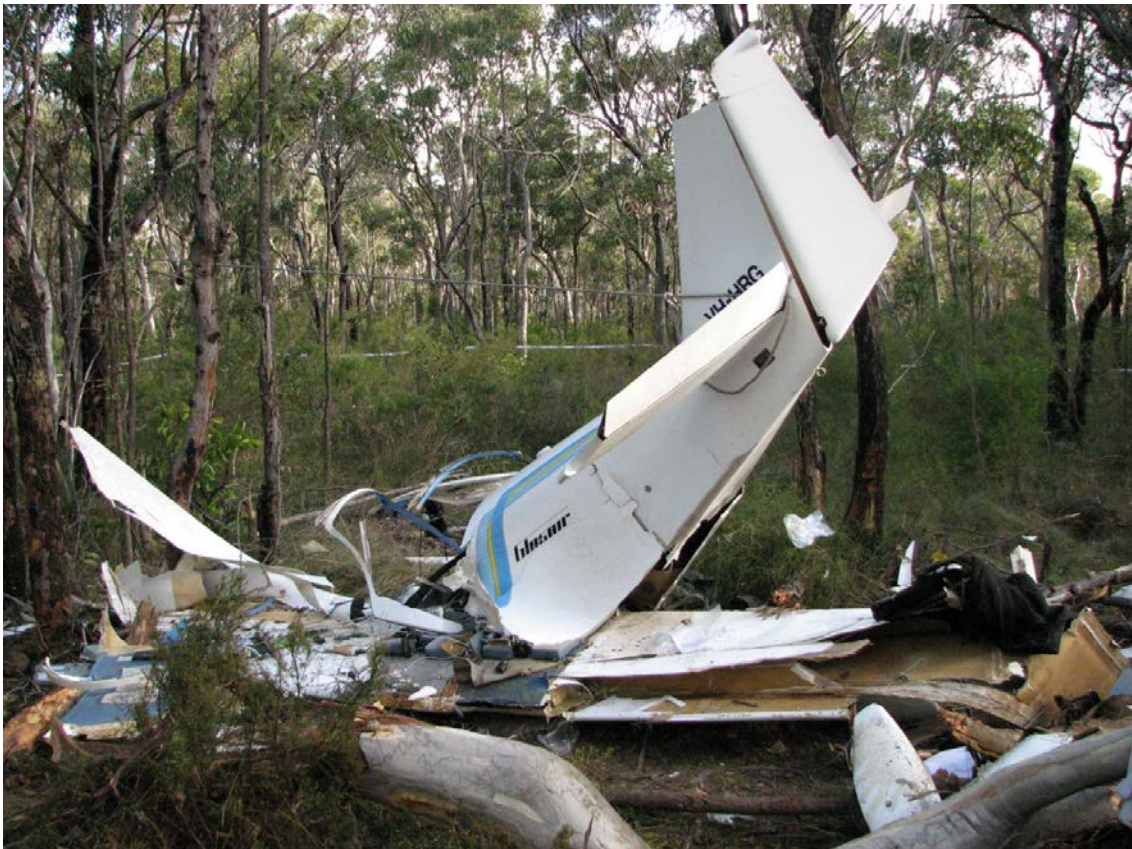
**Figure 2: Aircraft wreckage. Note that the tail empennage is secured in an elevated position by being tied off to a nearby tree**

Examination of the wreckage found that, following a steep descent, the aircraft collided with trees before coming to rest about 26 m further on into a wooded area and about 20 m from a road leading to the eastern gate of Wedderburn Airport. The initial point of impact was a tree about 7 m in height. A second tree, measuring about 30–35 cm in diameter, was impacted about 17 m further along the wreckage trail. The aircraft's angle of descent during the impact sequence with the trees was calculated to have been about 30°.

The impact sequence resulted in the engine oil sump being breached and destruction of the carburettor. The entire wing section, engine and fuselage forward section separated from the aircraft due to impact forces. The aircraft's wooden propeller blades were broken off at the root and had shattered.

The aircraft's landing gear collapsed and there was substantial damage to the fuel tanks and the header fuel tank was separated from the airframe. All header fuel tank plumbing was fractured. As a result of that damage, an unknown quantity of aviation gasoline leaked onto the ground under the wreckage and the amount of fuel on board prior to impact could not be determined. However, about 3 L remained in the header tank when examined.

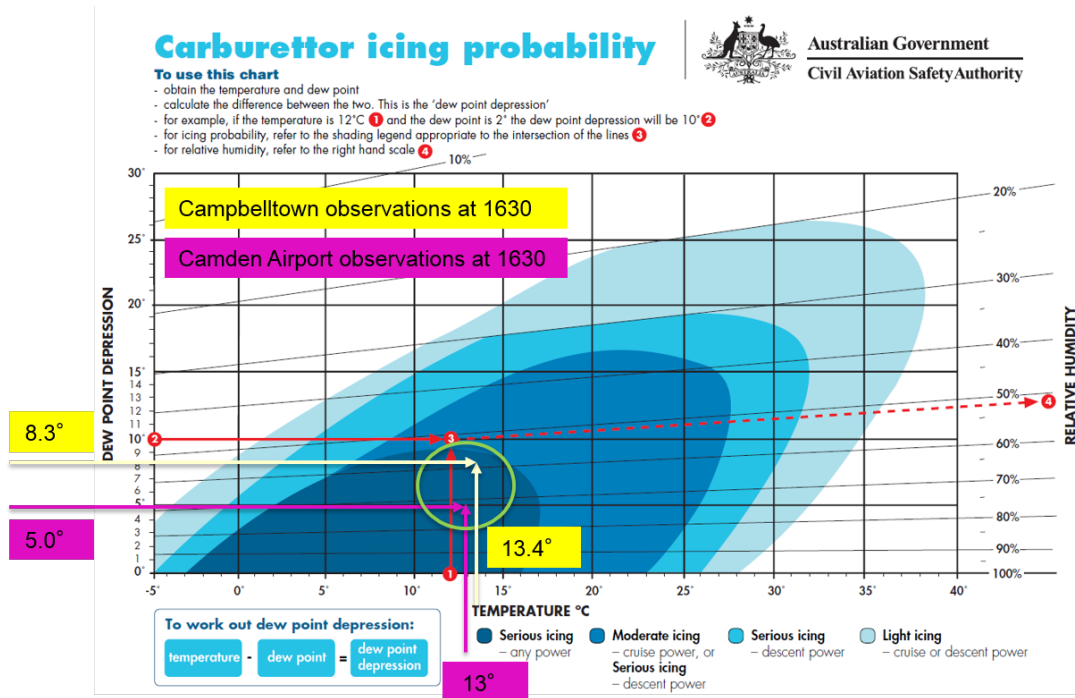
The 1630 METAR for Camden Airport indicated an air temperature of 13 °C and a dewpoint temperature of 5 °C. This resulted in a dewpoint depression of 8 °C.

According to the Civil Aviation Safety Authority (CASA) carburettor icing probability chart (see appendix A), the conditions recorded at Campbelltown (Mount Annan) and Camden Airport were conducive to 'serious' icing at all power settings.

Figure A1: Civil Aviation Safety Authority (CASA) carburettor icing-probability chart annotated with Campbelltown (in yellow) and Camden (in purple) temperature information at 1630

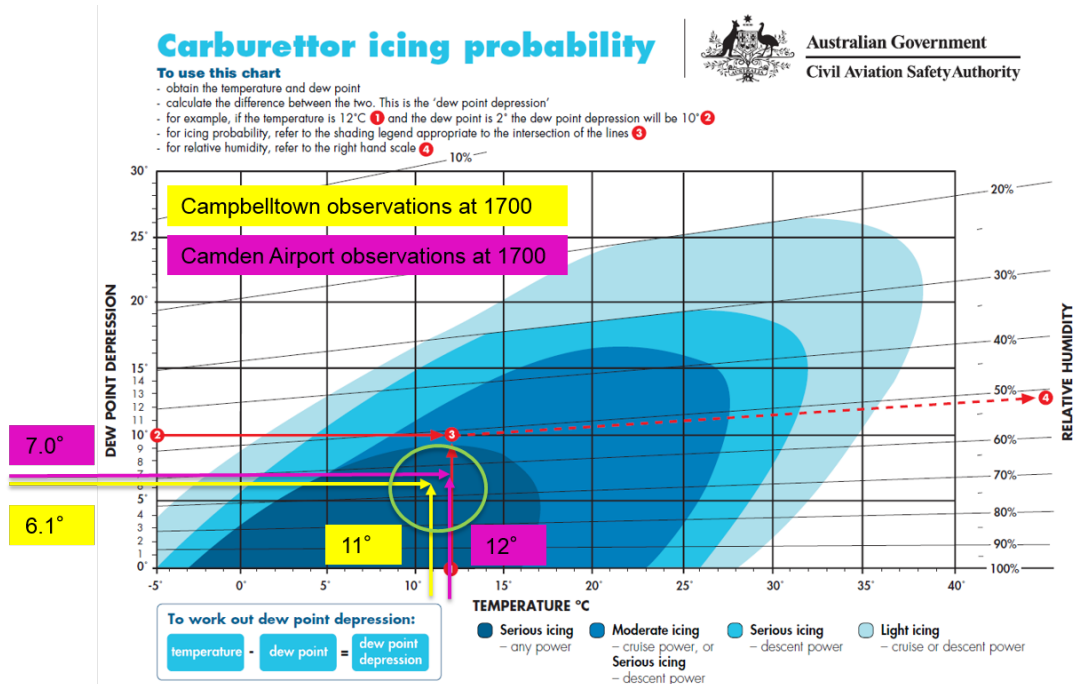
The 1700 METAR for Camden Airport indicated an air temperature of 12 °C and dewpoint temperature of 5 °C. This resulted in a dewpoint depression of 7 °C.

In this case, the meteorological conditions around the time of the accident were conducive to serious carburettor icing at all power settings (appendix A). In combination with the reported low power setting and lack of carburettor heat, there was an elevated risk of ice accreting in the throat of the carburettor. Ice in the throat of the carburettor would have reduced the flow of air to the engine and, without pilot action to correct the situation, the engine would have stopped.

Figure A2: CASA carburettor icing-probability chart annotated with Campbelltown (in yellow) and Camden (in purple) temperature information at 1700
