# Wirestrike involving Robinson R22, VH-HRL

63 km W of Blackall Airport, Queensland, 27 July 2016

**ATSB Transport Safety Report**  
Aviation Occurrence Investigation  
AO-2016-086  
Final – 14 October 2016

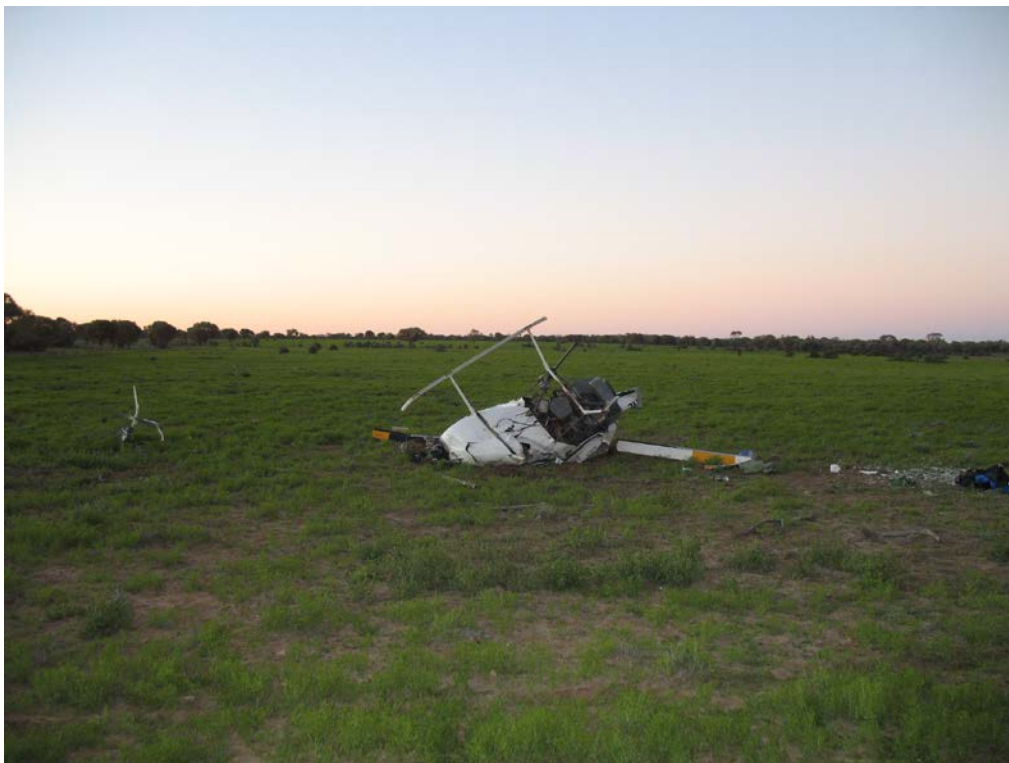
**Figure 1: Accident site showing damage to VH-HRL**

At about 1500, while inspecting the powerlines in the area, the line workers located the wreckage of HRL. The windshield and right skid of the helicopter had struck the single wire, which was strung east-west across a cleared area, 4.8 m above the ground. The first point of impact of the helicopter was about 31 m beyond the powerline and it then collided with the ground inverted about 18 m further away. During that impact, it appeared that the pilot's seatbelt sheared through and the pilot was ejected from the helicopter sustaining serious injuries. The wire had been stretched about 30 m, two power poles broke off and another two were pulled out of the ground. The helicopter was destroyed (Figure 1).

The helicopter struck the powerline in a clearing, mid-span between two power poles about 250 to 300 m apart. The helicopter was travelling across the direction of the powerline.

Based on the forward speed indicated by the distance of the wreckage from the wires, and the marks left in the ground by the helicopter main rotor blades, the helicopter engine was probably producing power at the time it struck the wire.
