Tail strikes during landing involving Bombardier DHC 8 402, VH-QOT and VH-QOS

Brisbane Airport, Qld on 5 November 2013 and Roma Airport, Qld on 11 December 2013

ATSB Transport Safety Report

AO-2013-201

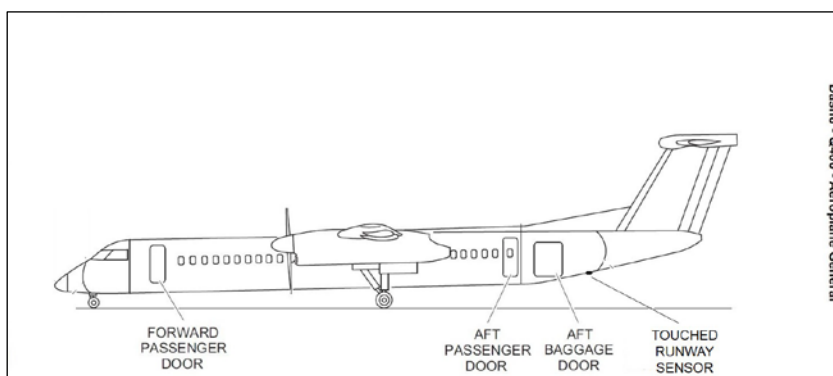
Figure 1: Touched runway detection system – sensor location

The Dash 8-400 is fitted with a touched runway detection system that includes a frangible switch/sensor located on the underside of the aft fuselage (Figure 1). In the event of a tail strike, a TOUCHED RUNWAY warning light, located on the overhead warning light panel in the cockpit, illuminates.

At touchdown, depending on main gear oleo compression and curvature of the runway surface, tail contact will occur at between 6.9° and 7.5° nose up.

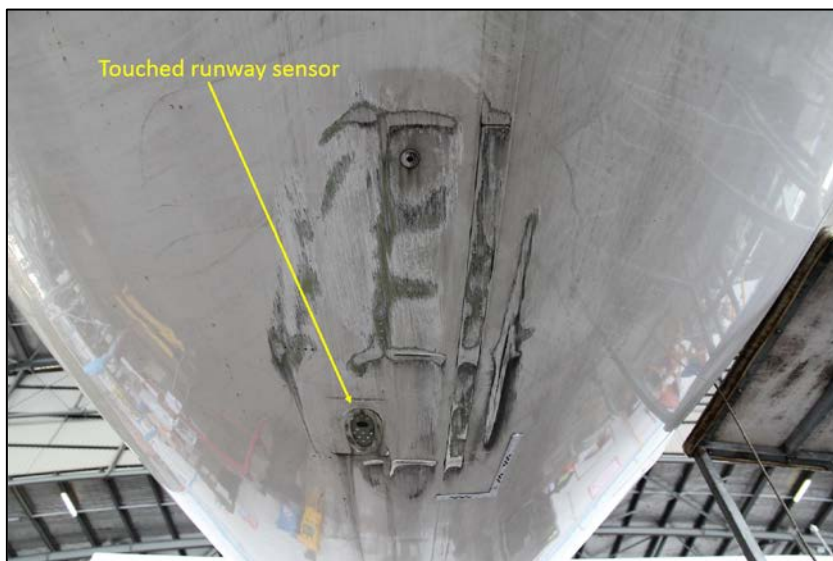
Figure 3: Damage to the tail section of VH-QOT (looking aft)

Both aircraft sustained impact and abrasion damage to the aft fuselage skin and buckling of internal structures in the area of the touched runway sensor (Figures 3 and 4).

During the flare, the sink rate was arrested by increasing the pitch attitude and power was reduced to flight idle as the aircraft descended through about 10 ft. The reduction of power to flight idle resulted in a loss performance and introduced a significant amount of propeller drag. Contrary to the recommended procedure, the rate of descent was reduced by further increasing the pitch attitude to 7.3°.

Following the initial flare and light touchdown, the pitch attitude was reduced to achieve level flight and the aircraft continued to float above the runway with idle power for about 4 seconds. The lack of engine power during this period resulted in a continued loss of performance that was instinctively countered by a further pitch attitude increase beyond the recommended 6° limit. This resulted in the tail contacting the runway.

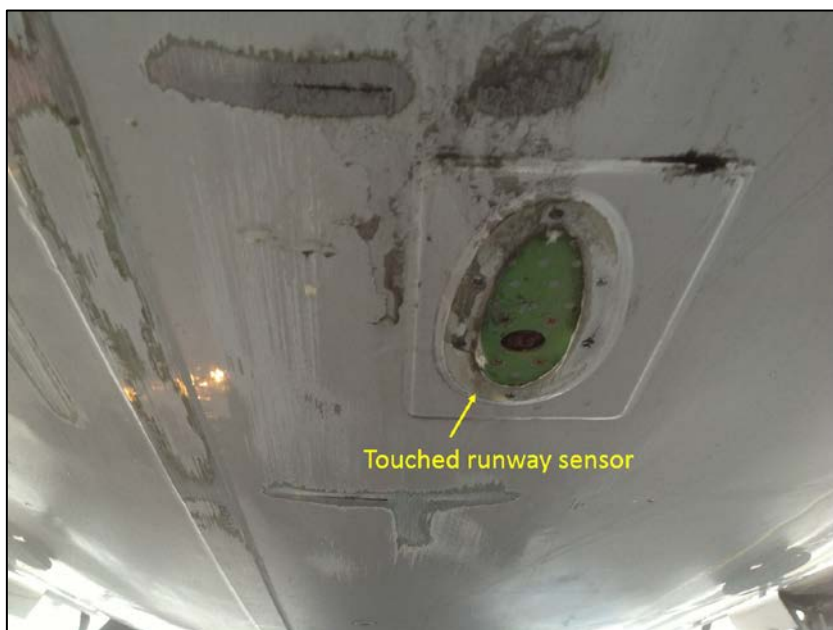
Figure 4: Damage to tail section of VH-QOS (looking aft)

In the case of VH-QOS, the aircraft arrived at the flare with an already-decreasing airspeed and insufficient engine power. These conditions were symptomatic of insufficient performance for the stage of flight. Reducing engine power to flight idle during the flare further reduced the aircraft's performance and introduced a significant amount of propeller drag.

The inadequate performance, significant propeller drag and additional drag associated with Flap 35 resulted in the airspeed reducing rapidly from 115 kt to 100 kt. While the corresponding loss of lift should have been countered by an increase in engine power, the FO intuitively pitched up further. At touchdown, the airspeed was 13 kt below the minimum airspeed and the pitch attitude was 8.4°.

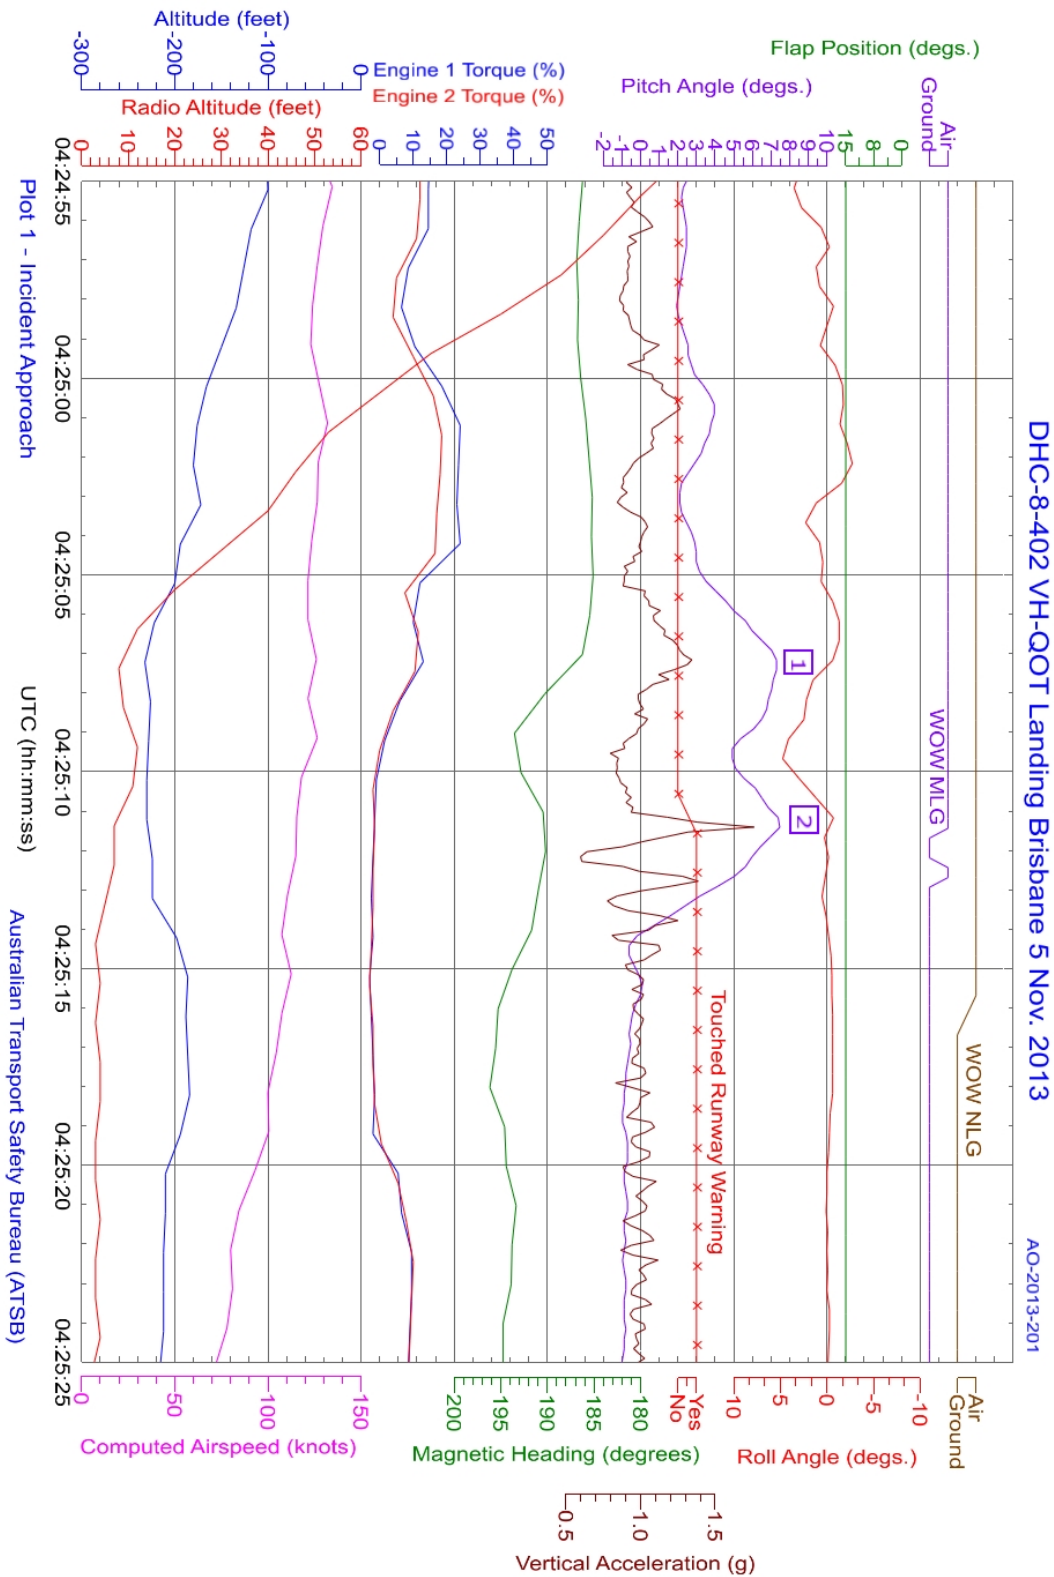
Appendix A – VH-QOT approach and landing data

During the flare, due to the prevailing crosswind, the FO conducted a 'de-crabbing manoeuvre' to align the aircraft with the runway. Flight idle was selected as the aircraft descended through about 10 ft and the pitch attitude during the flare reached a maximum of 7.3°. The recorded data did not register ground contact associated with that flare. However, as the flight crew recalled that initial touchdown was very light, there may have been insufficient weight applied to the main landing gear sensor to record the initial runway contact. The aircraft floated just above the runway for a period of about 4 seconds during which time the airspeed reduced to 116 kt with no change in power. V_{ref} was 119 kt.

The pitch attitude at the second touchdown, which included a bounce as the main gear temporarily unloaded, was 7.5°. A data plot is included at appendix A.

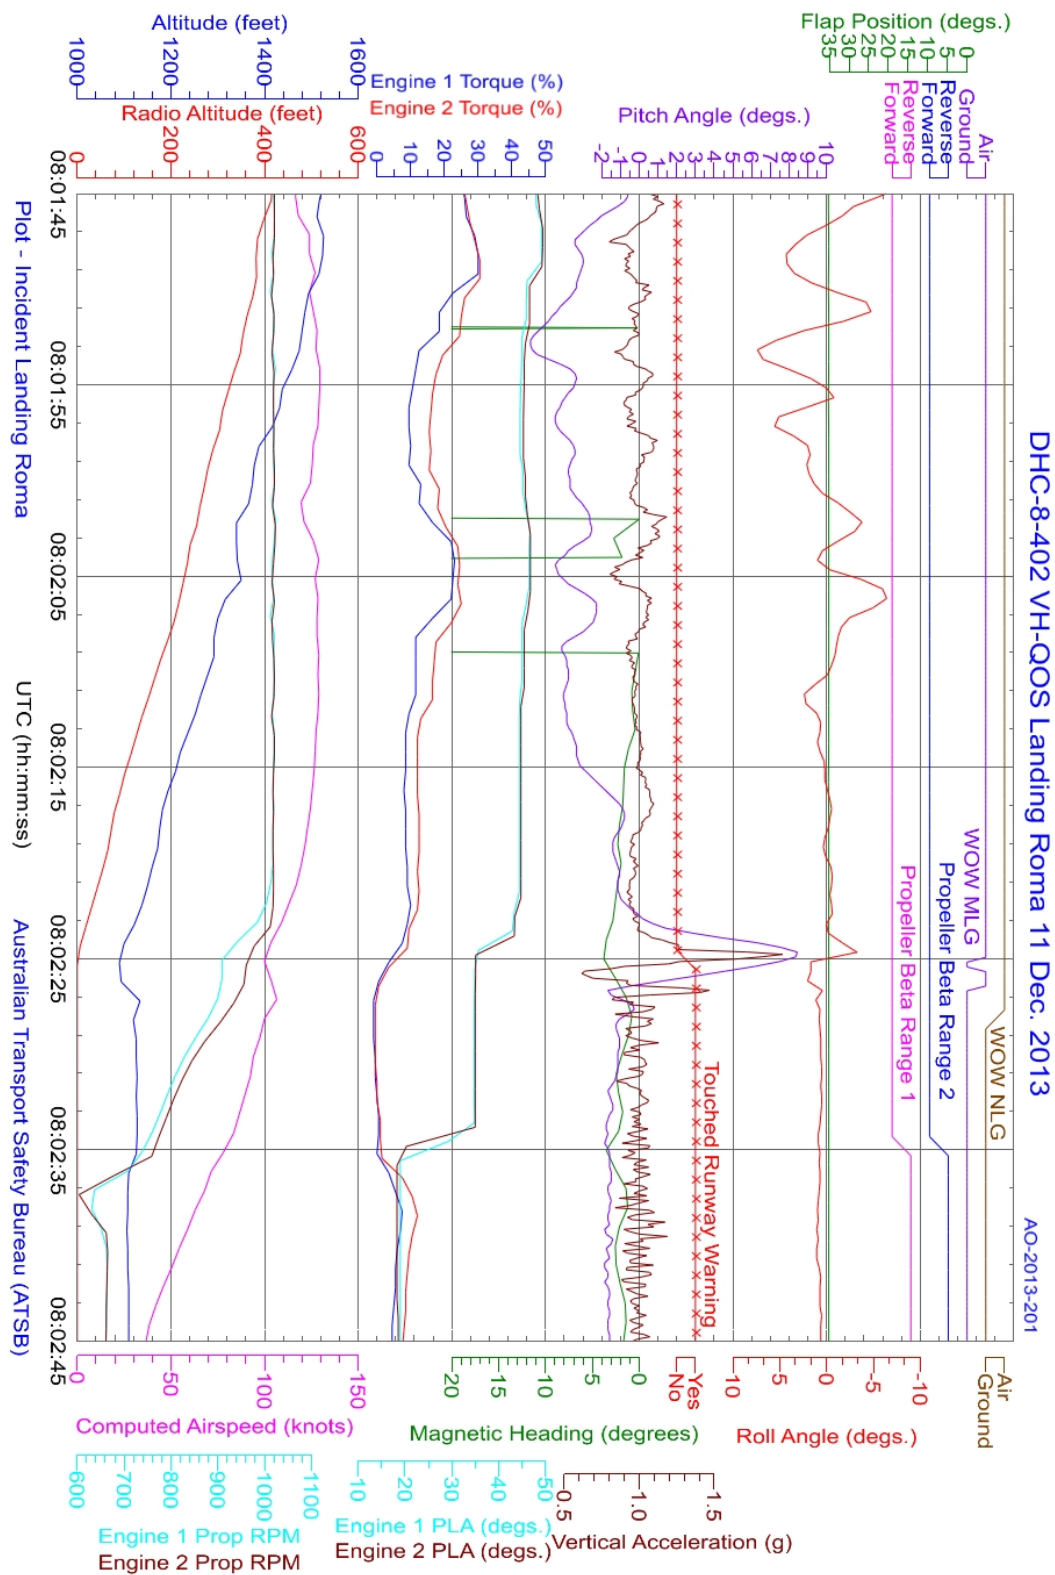
Appendix B – VH-QOS approach and landing data

Analysis of recorded data indicated that between 100 ft and 30 ft, the airspeed reduced from 127 kt to 115 kt. The target approach speed was 120 kt and V_{ref} was 113 kt. Engine torque during this period was about 14 per cent, significantly below the expected torque for a Flap 35 landing of about 24 per cent.

The flare to land was commenced at about 30 ft and at about 10 ft, engine power was reduced to flight idle. Touchdown, which included a bounce as the main gear temporarily unloaded, occurred at an airspeed of 100 kt, 13 kt below the V_{ref} of 113 kt. The pitch attitude was 8.4° at that time. A data plot is included at appendix B.
