# Near collision due to runway incursion involving Van's RV-7, VH-VTZ, and Glaser-Dirks DG-400 motor-glider, VH-XJZ

Gympie ALA, Queensland, 27 August 2016

**ATSB Transport Safety Report**  
Aviation Occurrence Investigation  
AO-2016-111  
Final – 22 November 2016

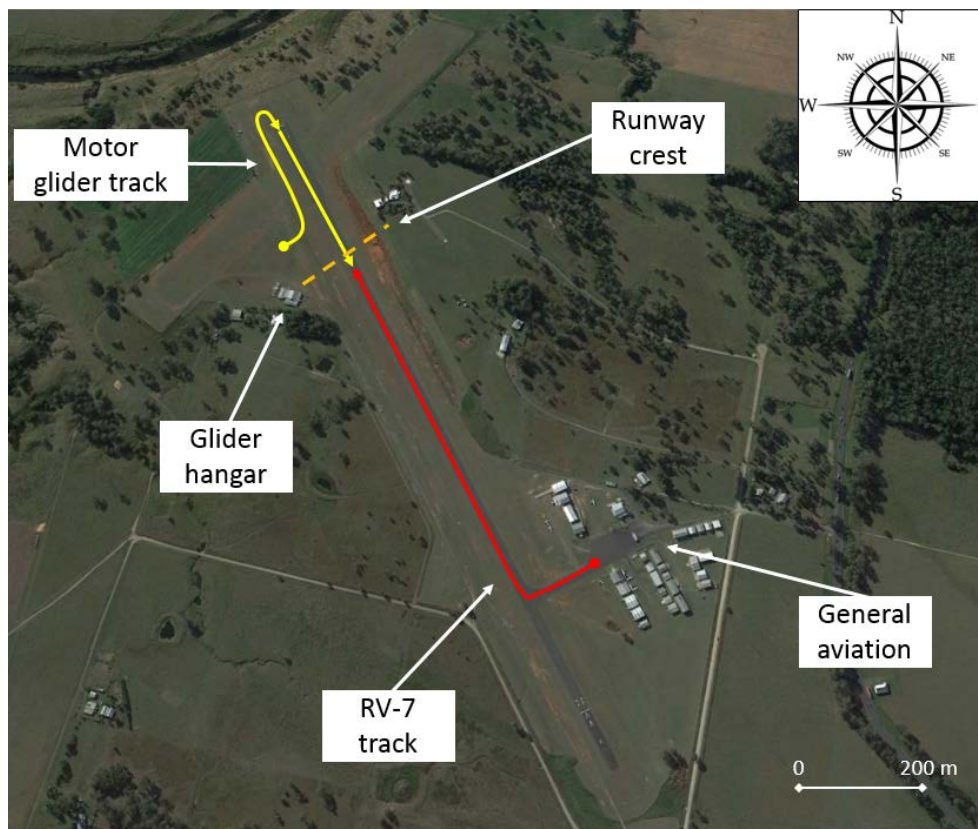
**Figure 1: Gympie ALA and ground tracks of the aircraft**

The pilot taxied the motor-glider from the Gympie ALA glider hangars and back-tracked on the grass alongside runway 14 (Figure 1). Before entering the runway strip, the pilot made a radio broadcast on the common traffic advisory frequency (CTAF) 126.7, that they were entering and back-tracking runway 14. On arrival at the runway threshold, the pilot made another broadcast that they were lining-up on runway 14. The pilot taxied the motor-glider onto the threshold of runway 14 and conducted their engine run-up checks. After about 10–15 seconds, they made a broadcast that they were rolling on runway 14 and released the brakes for take-off.

At about the same time as the motor-glider was backtracking runway 14, the pilot of the RV-7 made a broadcast on the CTAF that they were taxiing from the general aviation hangars. At the runway holding-point, the pilot then made a broadcast that they were entering and back-tracking runway 14 (Figure 1). Neither pilot heard the broadcasts from the other pilot.

From the runway 14 threshold, runway 14 slopes upward to a crest, which is in line with the glider hangars (Figure 1). Runway 14 then slopes downhill to the threshold of runway 32. The motor-glider pilot commented that in an aircraft low to the ground, such as a glider, stationed at the threshold of runway 14, the pilot would not be able to see an aircraft such as the RV-7, back-tracking runway 14, until the other aircraft was abeam the glider hangars (Figure 1). The RV-7 pilot commented that when back-tracking runway 14 in their aircraft they cannot see another low profile aircraft, such as a glider, until they are about 300 m from the threshold of runway 14.

The pilot of the RV-7 indicated they would introduce a radio check broadcast, when circumstances permit, during their start checks to verify their transmission volume and readability.

The Gympie Aerodrome Operator indicated they intend to add a note to the Gympie entry in the Enroute Supplement Australia, under 'Additional Information', to advise pilots that poor radio propagation between aircraft operating on the ground at opposite ends of the main runway may be experienced.
