# Engine failure and collision with terrain involving Ryan Aeronautical Company STA-SPL, VH-SQD

14 km NNW of Tyabb ALA, Victoria, 15 November 2016

**ATSB Transport Safety Report**  
Aviation Occurrence Investigation  
AO-2016-153  
Final – 17 January 2017

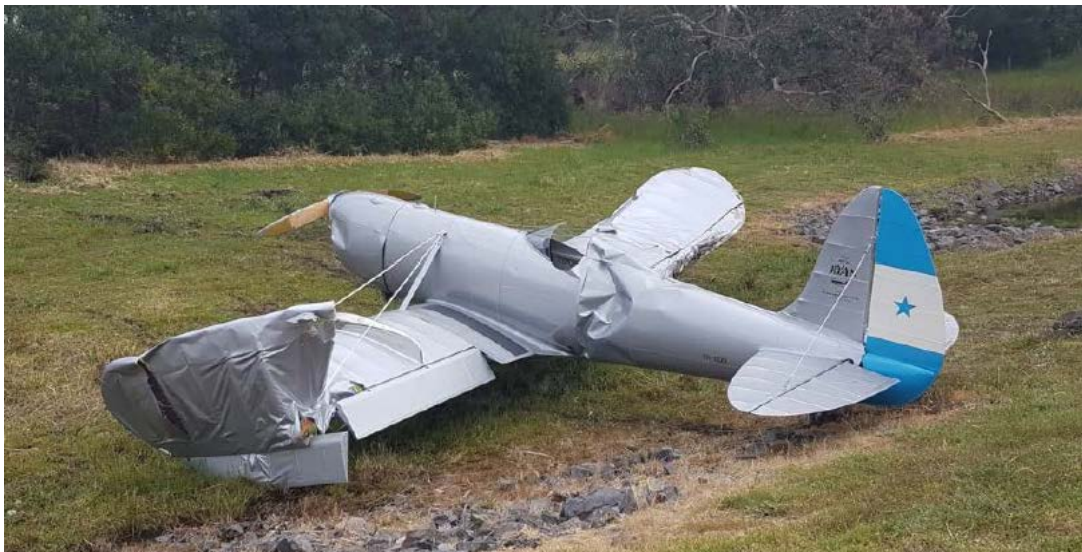
**Figure 1: Accident site showing damage to VH-SQD**

About 10 minutes after take-off, when at about 1,000 ft above mean sea level, the aircraft's engine suddenly stopped, then briefly restarted and then stopped again. The pilot conducted a forced landing into a field. The aircraft landed heavily and with a tailwind, and the pilot assessed that the aircraft may not slow down sufficiently before a fence up ahead. The pilot therefore used the available airspeed to take-off again and fly the aircraft about 15 ft over the fence. The pilot aimed the aircraft's wing at a tree to reduce the remaining speed and ensure it stopped prior to a major freeway. The aircraft collided with the tree, then the ground and was substantially damaged (Figure 1). The pilot sustained a minor injury.

A post-accident inspection found no evidence indicating the cause of the engine failure.

The engine probably stopped due to carburettor icing, and the aircraft was not (and was not required to be) fitted with carburettor heat.

The aircraft was below 1,000 ft above ground level when the engine failed and the pilot had limited options for landing sites. The pilot landed the aircraft with a tailwind component, and directed the aircraft towards a tree to reduce the ground roll and prevent the aircraft continuing onto a freeway.

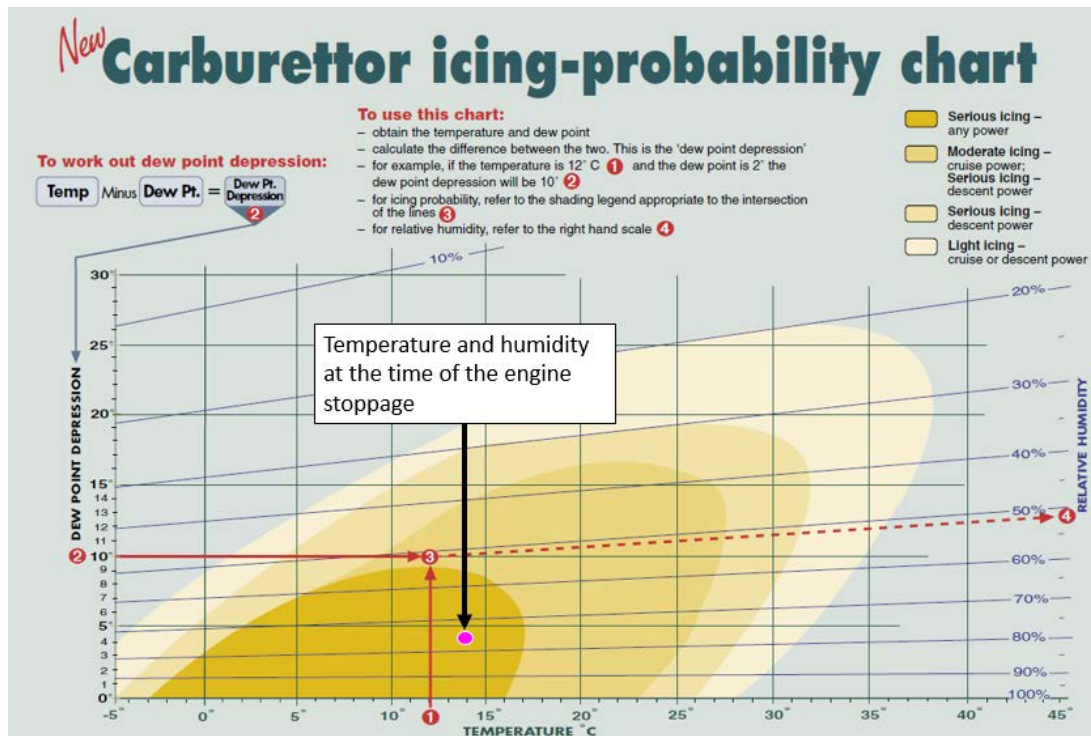
Figure 2: Carburettor icing probability chart

The temperature at the time of the accident was 14 °C, the relative humidity 76 per cent, and the dew point depression 4 °C. According to the carburettor icing probability chart (Figure 2), there was a serious risk of carburettor icing at any power setting.
