Engine failure and forced landing involving Cessna 208, VH-TYV

Darwin Airport, Northern Territory, 11 November 2016

ATSB Transport Safety Report
Occurrence Investigation
AO-2016-149
Final – 9 February 2017

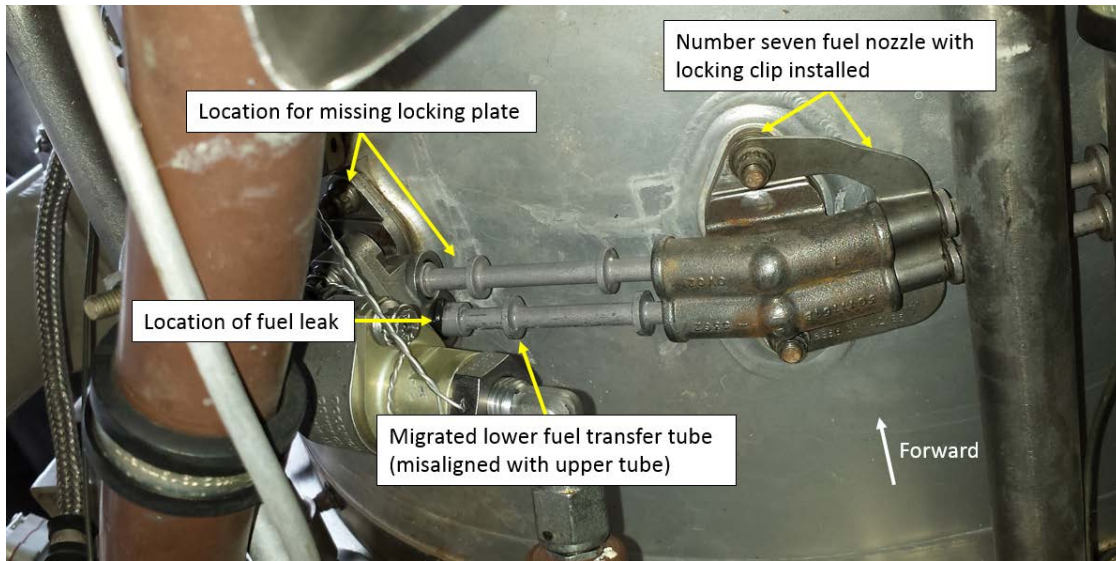
Figure 2: TYV fuel transfer tubes

A post-incident examination of the engine found the number eight fuel nozzle locking plate missing (Figure 2). This allowed the fuel transfer tube to migrate out of the number eight fuel nozzle adaptor. There was no damage to the locking plate mounts.

The fuel nozzles had been replaced 86 flight hours prior to the incident, while the aircraft underwent maintenance in the United States, prior to importation into Australia. All other required hardware was found to be correctly installed, including the number eight fuel transfer tube locking plate fasteners.

The lack of damage to the locking plate mounts, along with the locking plate being entirely missing, and the fasteners being found installed indicates the locking plate probably did not fail. The locking plate was probably not reinstalled when the fuel transfer tubes and nozzles were installed after replacement. The missing locking plate allowed the fuel transfer tube to slowly migrate out of the nozzle adaptor over the subsequent 86 flight hours.

- The number eight fuel transfer tube locking plate was likely not installed when the fuel transfer tubes and nozzles were installed after replacement.
- The missing locking plate allowed the fuel transfer tube to migrate out of the fuel nozzle adaptor and fuel to escape. This starved the engine of fuel and led to the engine power loss in flight.

This incident serves to underline the importance of ensuring all maintenance is completed entirely and correctly. The locking plate was not installed during scheduled maintenance, however, the fuel leak did not develop for a further 86 flight hours. This demonstrates how the effects of incomplete maintenance can take a long period of time to manifest. The ATSB research report: [An overview of human factors in aviation maintenance](#) provides information on human factors errors made in the maintenance environment.

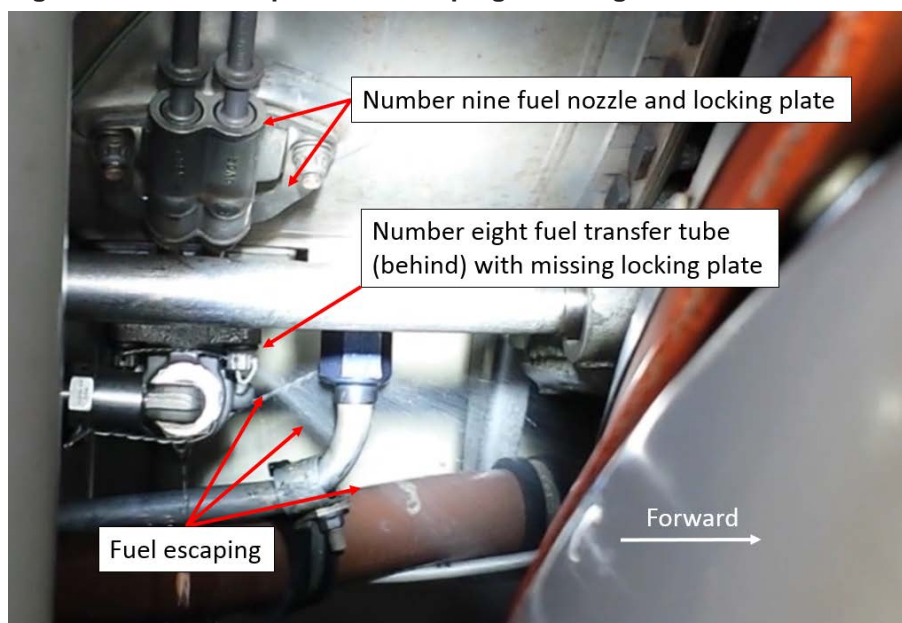
On the incident flight, the fuel transfer tube migrated far enough that fuel under pressure was able to escape from the nozzle adaptor (Figure 3).

Figure 3: Fuel under pressure escaping from migrated fuel transfer tube
