Ground strike involving Robinson R44, VH-HHZ

74 km NE of Sleisbeck, Northern Territory, 18 November 2016

ATSB Transport Safety Report
Aviation Occurrence Investigation
AO-2016-158
Final – 9 February 2017

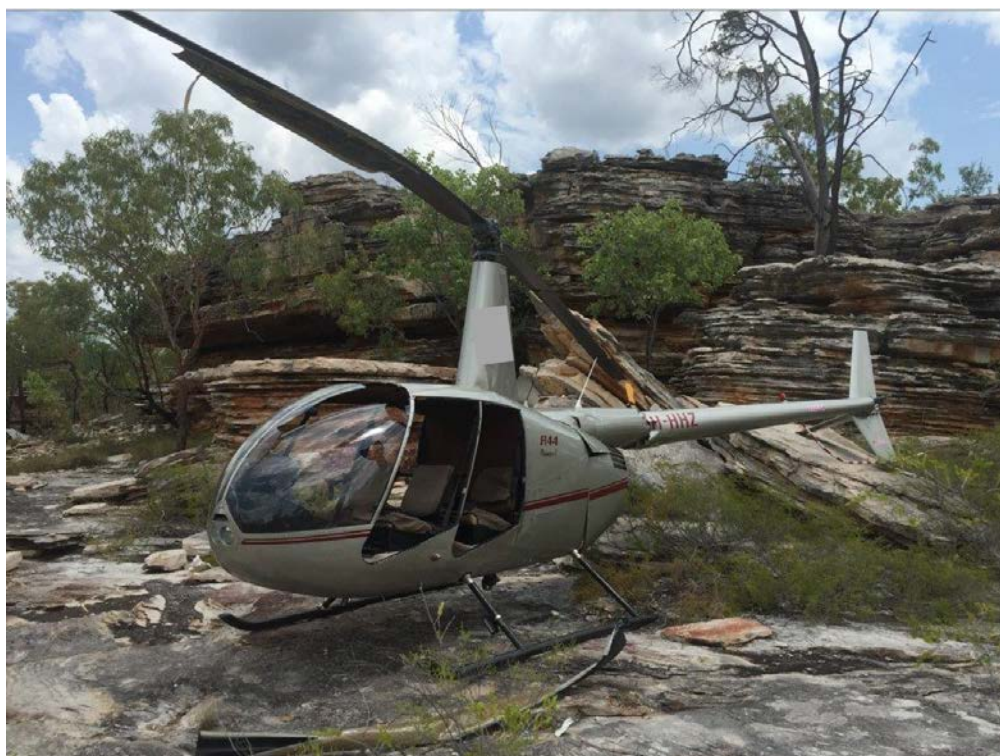
At about 1600 Central Standard Time (CST), the pilot conducted an approach to a landing site they had already landed at twice that day. The landing site was a flat rocky surface, but one side had a slight downwards slope. The pilot confirmed the wind direction from smoke nearby and approached the landing site into wind. As the pilot lowered the collective¹ and the helicopter's skids touched down, the helicopter started to slide to the right. The pilot attempted to correct the sideways movement, but the main rotor blade struck a rock, and the helicopter started vibrating. The pilot rolled off the throttle and applied right pedal, but the helicopter rotated to the left and the horizontal stabiliser struck a rock. The helicopter sustained substantial damage (Figure 1). The pilot and two passengers were not injured.

Figure 1: Accident site showing damage to VH-HHZ

- The helicopter landed on a portion of rock, which had a slight downwards slope. The actions taken by the pilot, when the helicopter started to slide, did not prevent the main rotor blades and the horizontal stabiliser from striking a rock.

The company issued a notice to flight crew emphasising the importance of conducting a thorough aerial assessment before committing to landing at any remote location including confined areas.
