Australian Government
Australian Transport Safety Bureau

Aviation Short Investigations Bulletin

Issue 57

ATSB Transport Safety Report
Aviation Short Investigations
AB-2017-007
Final – 9 February 2017

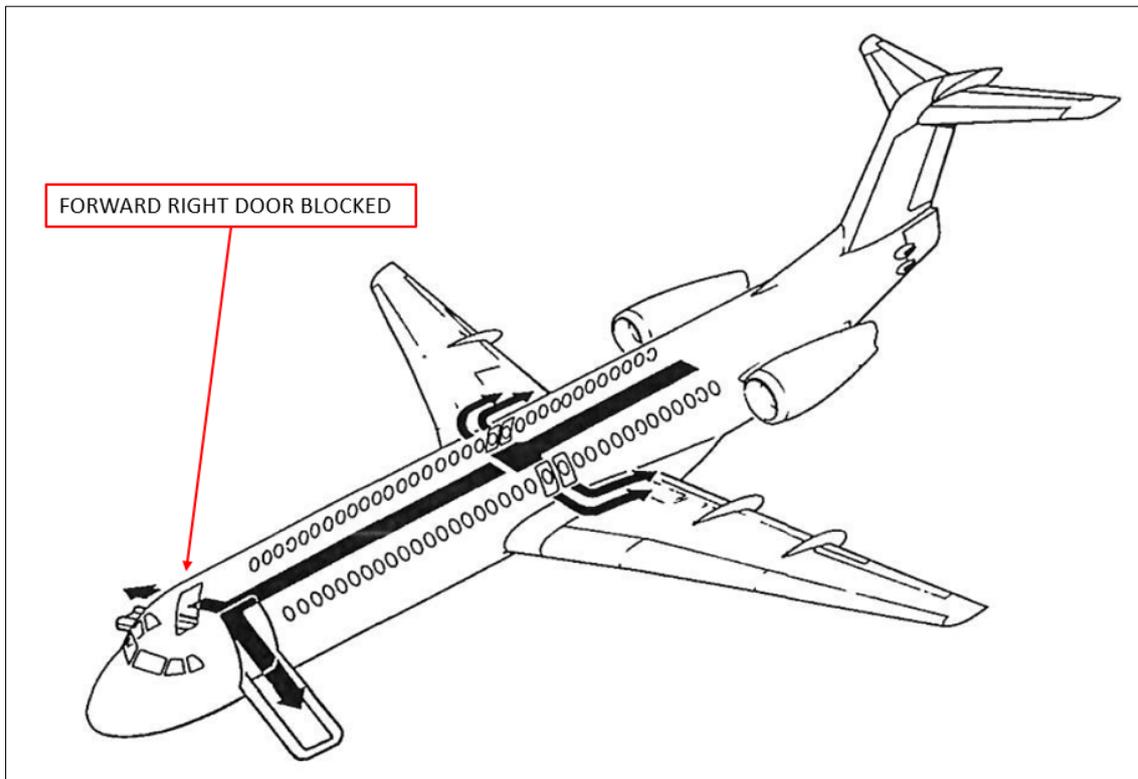
Figure 2: Aircraft emergency evacuation routes

The flight crew started the emergency evacuation checklist and the captain called for the evacuation over the public address system. The cabin crew opened the two front doors and the four over-wing emergency exits were removed by the passengers (Figure 2). The forward left door (L1) slide did not automatically inflate when the slide deployed, so the CCM manually inflated the slide. When the CCM checked on the forward right door (R1) slide they observed that it was not deployed and the cabin crewmember was blocking the exit. The passengers evacuated through the forward left door and the over-wing exits.

During the emergency evacuation, the R1 door slide did not deploy. The maintenance inspection found the R1 door was disarmed and no fault was found with the door operating mechanism. Therefore, it is likely that during the emergency evacuation procedure the cabin crewmember at the R1 door reverted to previous experience and disarmed the door prior to opening it, which prevented the slide from automatically deploying.

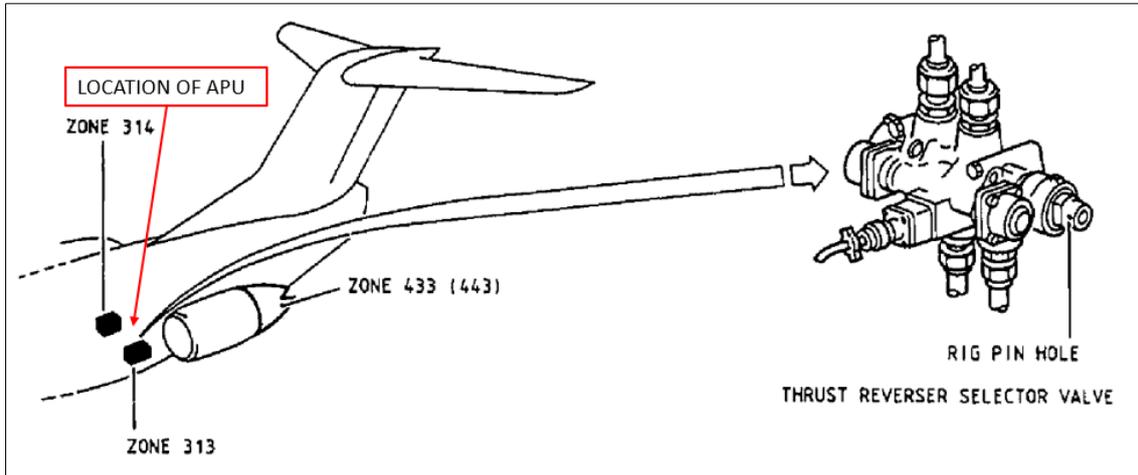
Figure 3: Location of APU and thrust reverser selector valves

The maintenance organisation found the number 1 engine thrust reverser selector valve (see *Thrust reverser selector valves*), located in the left outboard APU (see *Auxiliary power unit*) compartment (zone 313), leaked hydraulic fluid from a damaged O-ring (Figure 3). Further inspection found the APU and air-conditioning system were contaminated with hydraulic fluid.

A gap between the APU intake door actuator rod cut-outs was identified as the path for contaminated air to enter the APU inlet. When the APU inlet door is open inflight, air is scooped into the inlet creating an area of high pressure. However, when the aircraft is on the ground with the APU running, the APU inlet becomes an area of lower pressure as the APU is now ‘sucking’ air into the inlet.

- A damaged O-ring in the left engine thrust reverser selector valve resulted in a hydraulic leak.
- Hydraulic fluid, or vapour, entered the APU air intake through a gap between the APU intake door actuator rod cut-outs.

Following the replacement of parts contaminated with hydraulic fluid and cleaning of the APU area and air-conditioning system, the operator and their maintenance organisation conducted air quality checks on the aircraft before return to service.

The operator's flight operations department issued flying operations advisory bulletin (FOAB) 031/16: *Fumes ingestion by the APU*. The bulletin advises flight crew of the potential for ingesting fumes through the APU intake in the event that the APU is operating with a hydraulic leak in the tail section of the aircraft.

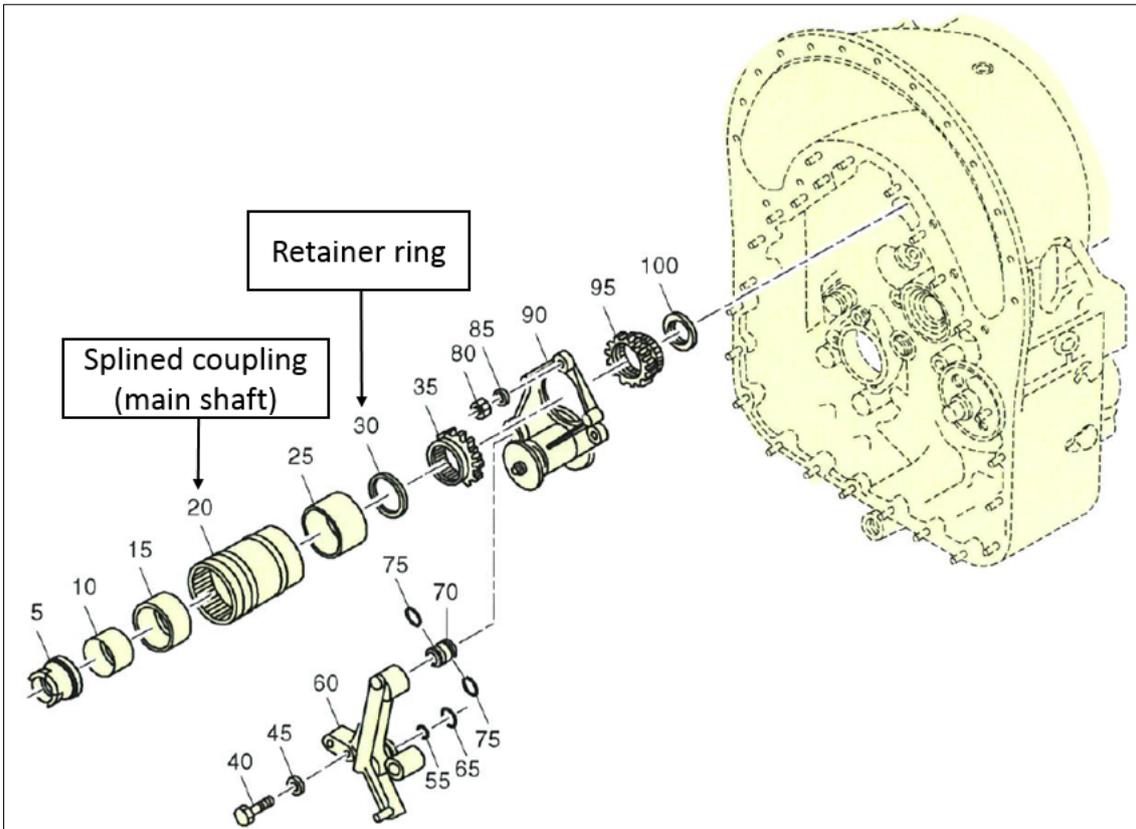
Figure 2: Engine accessory gear assembly

The engine installed in the aircraft was the Honeywell (previously Garrett) TPE331-12UHR-701G. The operator's engine maintenance organisation found a retainer ring within the engine accessory gear assembly had failed, which allowed the main shaft (which drives the propeller) to de-couple from the engine driven reduction gearbox (Figure 1).

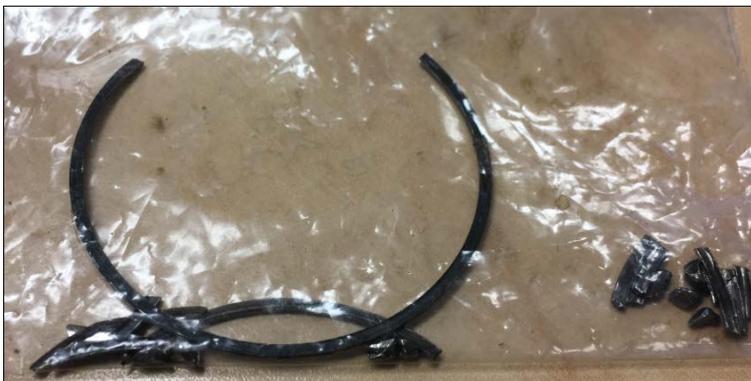
Figure 2: Retainer ring

In October 2015, Honeywell added temporary revision 72-241 to the maintenance manual procedure: *removal and installation of accessory gear assembly*, to direct the replacement of the retainer ring at each exposure. Figure 2 depicts the failed retainer ring.

- The retainer ring failed within the prescribed maintenance interval.
- There was no prior warning of an impending failure of the retainer ring.

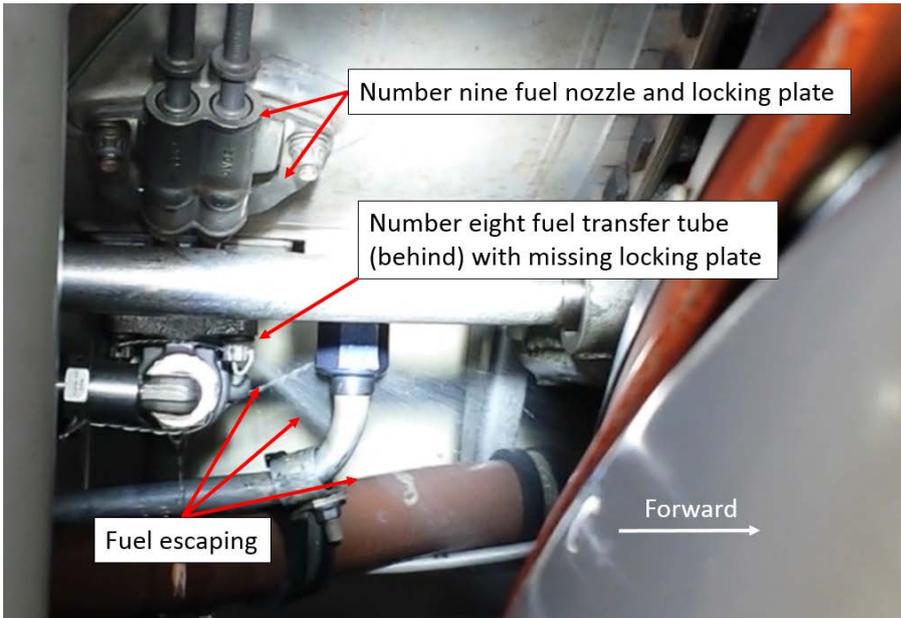
Figure 3: Fuel under pressure escaping from migrated fuel transfer tube

On the incident flight, the fuel transfer tube migrated far enough that fuel under pressure was able to escape from the nozzle adaptor (Figure 3).

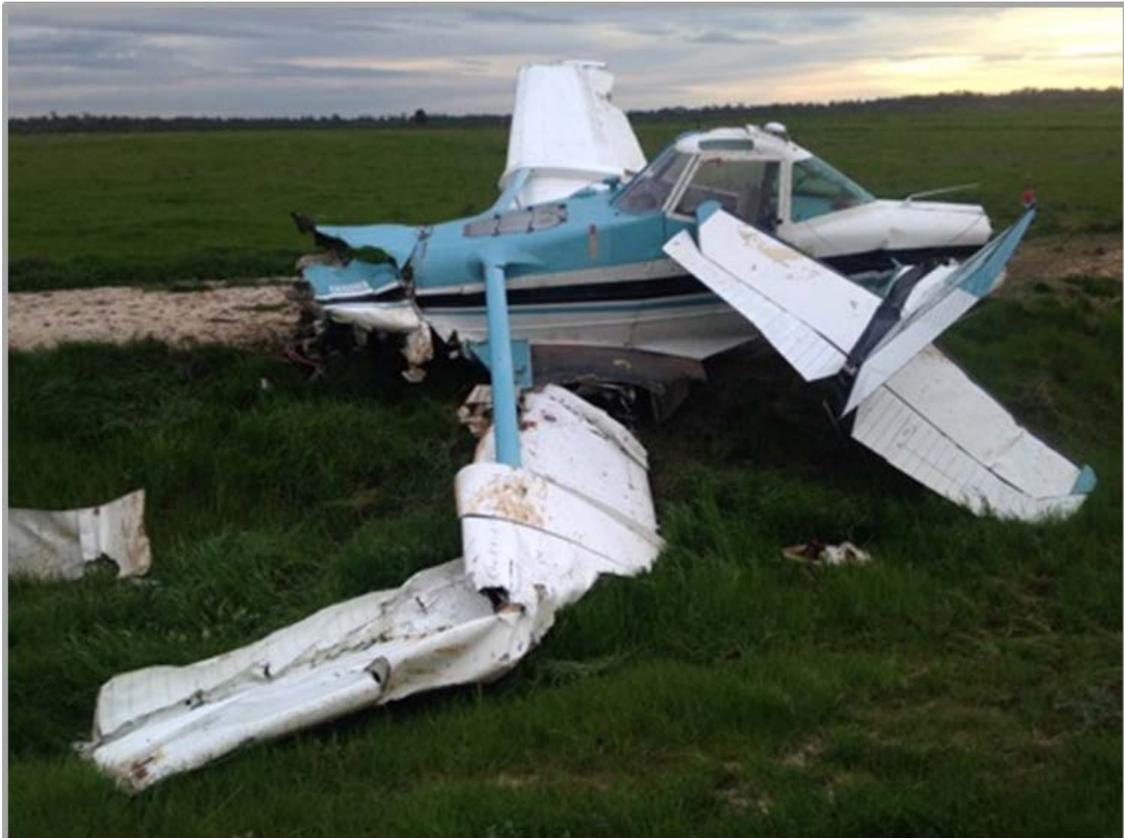
Figure 2: BCT at the accident site

nose of the aircraft and when it became evident that the aircraft was not going to make the strip, the pilot elected to land straight ahead. As the aircraft flew over a channel, the tail wheel clipped that channel, and the aircraft collided with the ground on the flat area between two channels. The landing gear and propeller detached as the aircraft continued forward and came to rest on the top of the opposite channel. As there was a lot of fuel leaking from the fuel tanks, the pilot quickly turned off the engine magnetos and the electrical master switch and exited the aircraft through the cockpit door. The pilot was uninjured and the aircraft was substantially damaged (Figure 2).

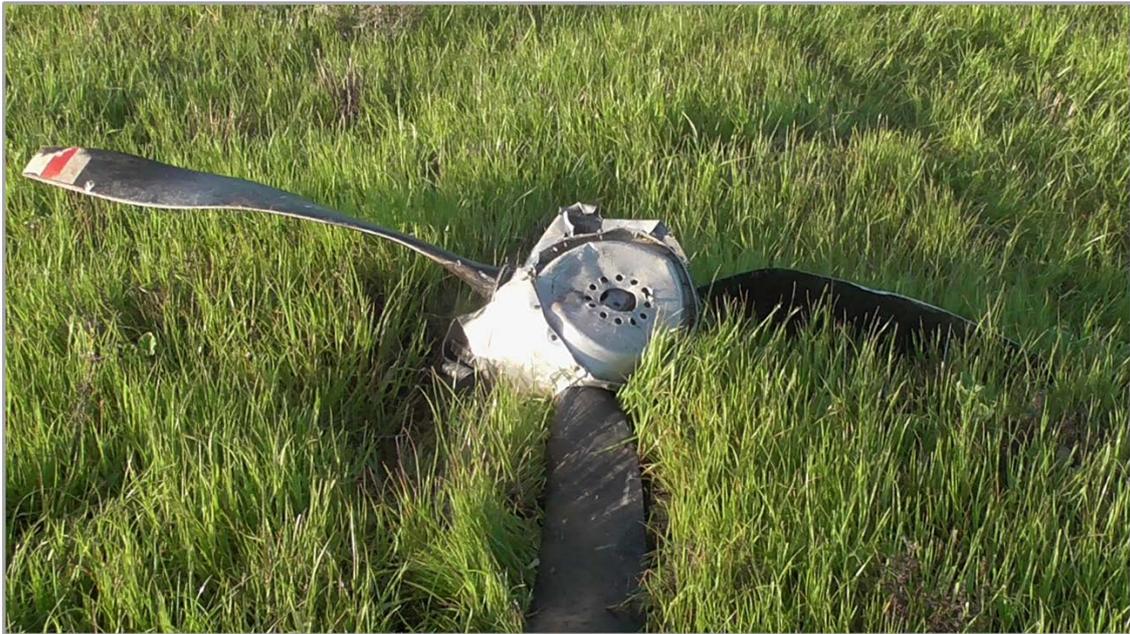
Figure 3: BCT damaged propeller²

A licensed aircraft maintenance engineer inspected the engine and no reason was identified for an engine power loss. The engine magnetos and engine carburettor were tested separately and found to be operating normally. As such, the operator believed the engine was still producing full power at the time of the accident. The engine and propeller were extensively damaged by the accident sequence (Figure 3).

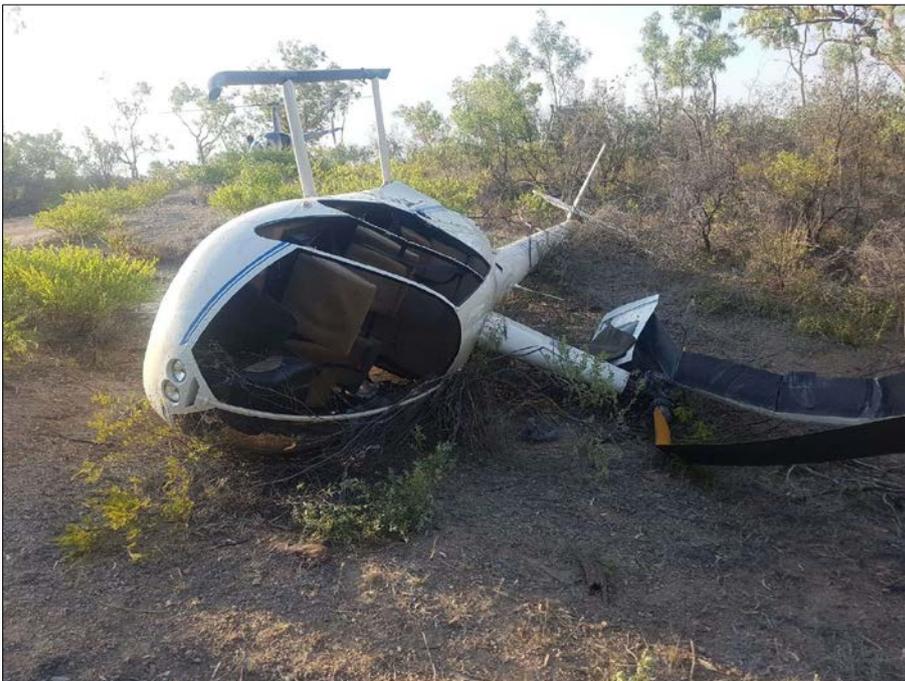
Figure 5: VH-YMJ accident site

As the helicopter approached the ground, the pilot raised the collective lever¹ to cushion the landing. The right skid of the helicopter landed first, on the side of the road and the left skid landed off the side of the road below the right skid, which resulted in the helicopter rolling onto the left side before coming to rest (Figure 1). One passenger received minor injuries and the helicopter was substantially damaged.

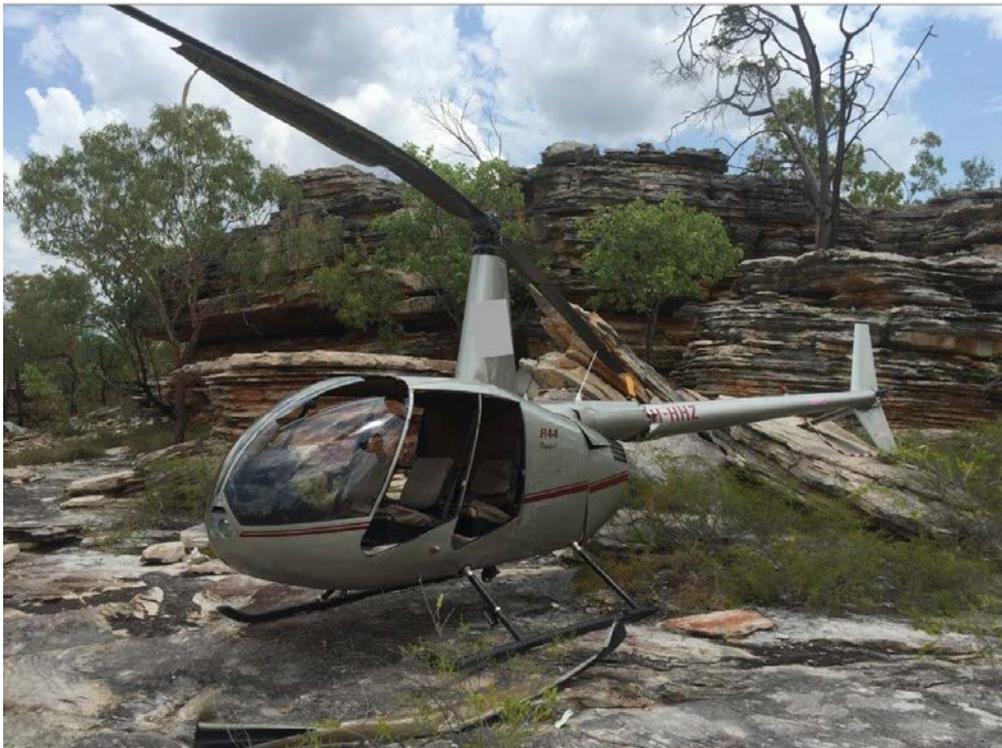
Figure 6: Accident site showing damage to VH-HHZ

At about 1600 Central Standard Time (CST), the pilot conducted an approach to a landing site they had already landed at twice that day. The landing site was a flat rocky surface, but one side had a slight downwards slope. The pilot confirmed the wind direction from smoke nearby and approached the landing site into wind. As the pilot lowered the collective¹ and the helicopter's skids touched down, the helicopter started to slide to the right. The pilot attempted to correct the sideways movement, but the main rotor blade struck a rock, and the helicopter started vibrating. The pilot rolled off the throttle and applied right pedal, but the helicopter rotated to the left and the horizontal stabiliser struck a rock. The helicopter sustained substantial damage (Figure 1). The pilot and two passengers were not injured.
