Forced landing involving Robinson R44, VH-SJK

16 km south of Sydney Airport, New South Wales, 17 December 2016

ATSB Transport Safety Report
Aviation Occurrence Investigation
AO-2016-172
Final – 27 April 2017

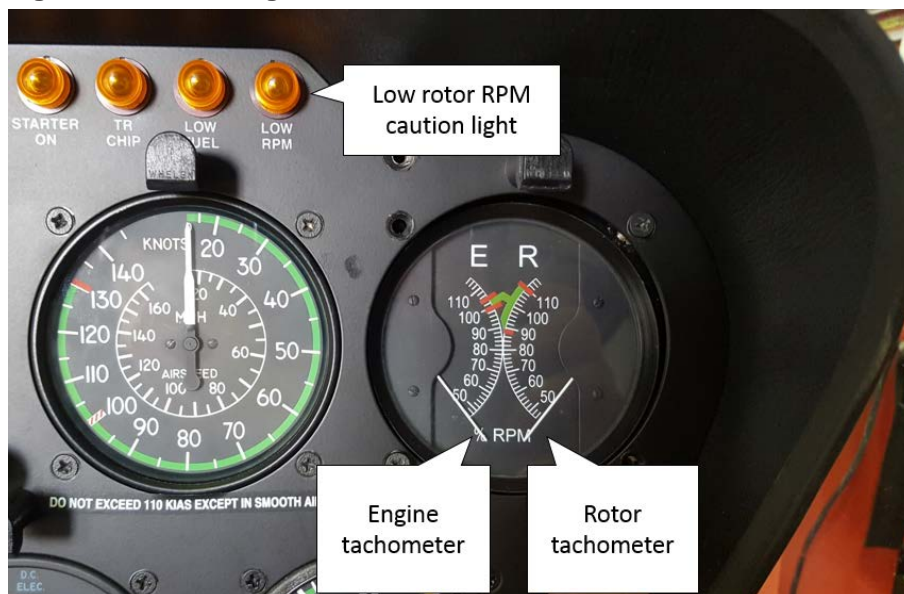
Figure 1: VH-SJK engine and rotor tachometers

The pilot checked the engine and rotor tachometer and noted that the engine RPM was in the normal flight range, but the rotor RPM had degraded to about 85 per cent (Figure 1).¹ They immediately turned right towards land (coastal cliffs) while considering the possibility that it was an instrument fault. However, during the turn and again when over land, the rotor RPM tachometer indicated a decay in RPM whenever the pilot raised the collective.² The rotor RPM response to the pilot's collective movements indicated to the pilot that there was a genuine problem with the helicopter's drive system (see *Rotor drive system*).

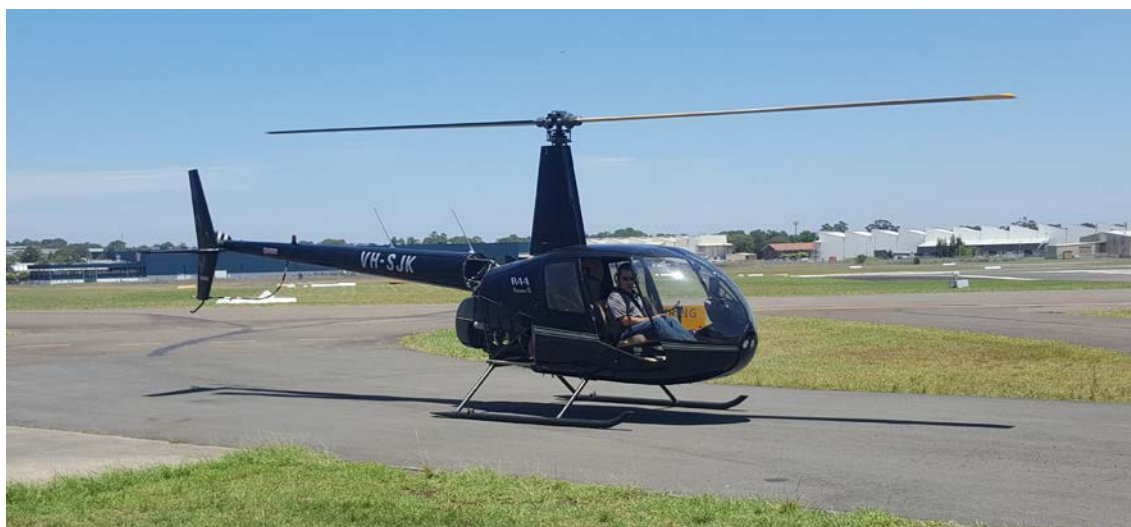
Figure 2: VH-SJK ground running post-recovery

A post-recovery maintenance inspection was conducted, which included a visual inspection and ground run of the helicopter (Figure 2). No fault was found with the engine, drive system or flight controls, but the visual inspection did find chaffing damage to a rotor tachometer wire, which was in intermittent contact with earth. Damage to the helicopter prevented a maintenance test flight.

An initial ground run was performed below maximum gross weight, which reached a power setting of 22 inches manifold pressure without fault. A subsequent ground run was performed after loading the helicopter to 200 kg greater than the maximum gross weight. On the second ground run a power setting of 27 inches manifold pressure, which exceeded the red line for maximum power, was reached before the helicopter became light on the skids. There was no indication of RPM decay from the engine or rotor. The chaffed rotor tachometer wire was deliberately shorted to earth during the ground runs, but did not produce any fault indications from the tachometer.

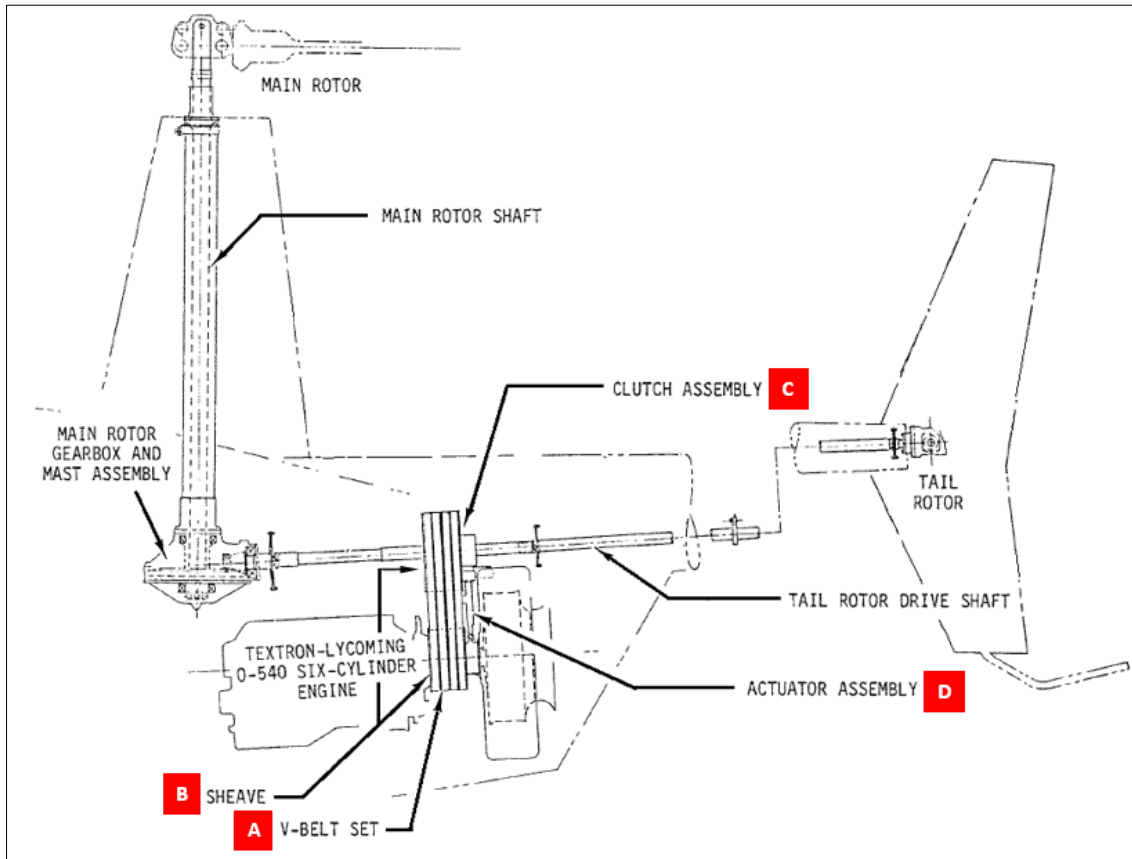
Figure 3: R44 rotor drive system

The rotors are driven by a V-belt sheave drive system, bolted directly to the crankshaft of the engine (Figure 3). Four, double V-belts (A) transmit power from a lower sheave to an upper sheave (B), which has a clutch in its hub (C). The clutch transmits power forward to the main rotor and aft to the tail rotor. A clutch actuator (D), positioned between the lower and upper sheave, extends to tension the V-belts and prevent slippage.
