# In-flight pitch disconnect involving ATR 72 aircraft VH-FVR

47 km WSW of Sydney Airport, New South Wales on 20 February 2014

AO-2014-032

Second Interim Report – 5 May 2017

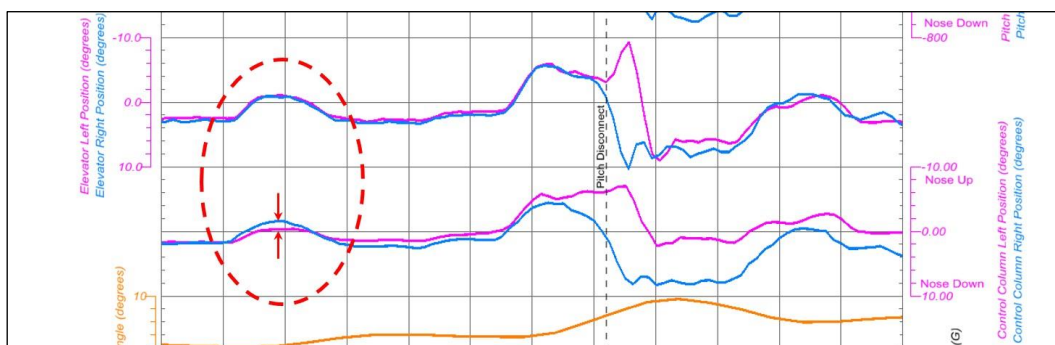
In addition to the effect on the control column-elevator relationship, the control system flexibility also results in differences between the left and right control columns. This can be observed in the differences in the left and right control column positions before the pitch disconnect in the recorded data from the flight (Figure 1).

**Figure 1: Excerpt from the flight data recorder information around the time of the pitch disconnect. The circled area highlights a difference in the left and right control column positions (red arrows) during an input from the first officer on the right control column. Note, there is no corresponding difference between the position of the left and right elevators. For the complete image, refer to the previous interim report.**

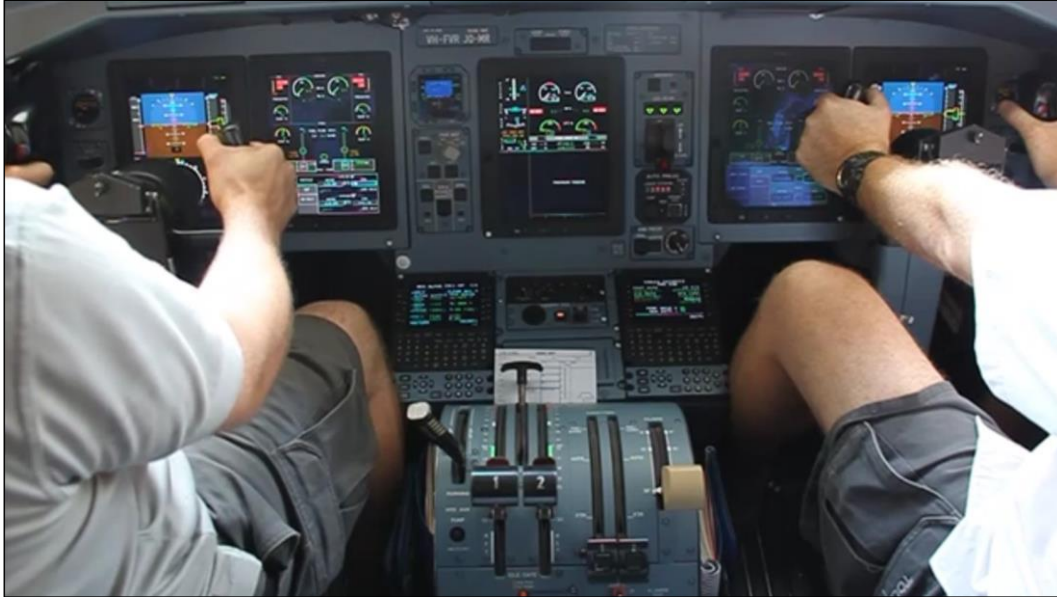
This flexibility was also noted during the on-ground testing of the pitch disconnect system after the occurrence, where there was a noticeable difference between the left and right control column positions just before the pitch uncoupling mechanism activated (Figure 2).

**Figure 2: Still image from video of on-ground pitch disconnect testing carried out on VH-FVR following the occurrence. The right control column was held fully forward while the left control was pulled back. The image is just before the pitch uncoupling mechanism activated. Note the difference between the left and right control column positions. The left control column is about halfway through its full travel, while the right control column is at the forward limit.**

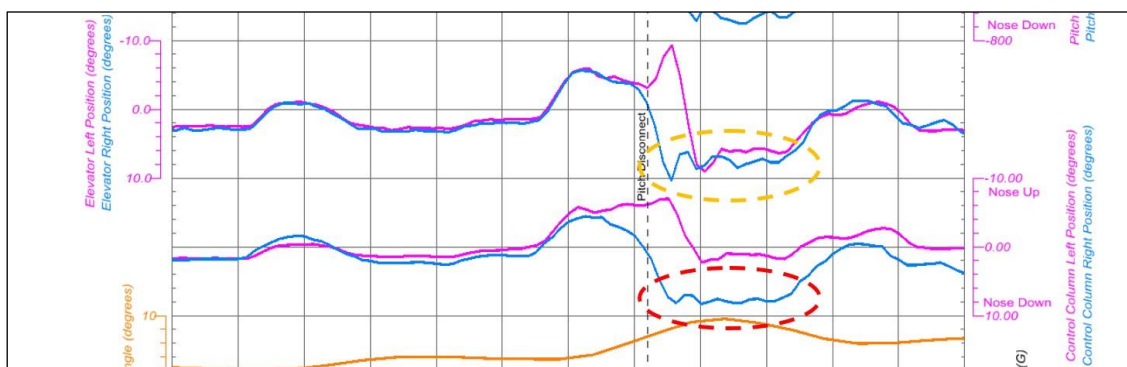
A similar transient oscillatory characteristic, was identified in the FDR data during the pitch disconnect occurrence on VH-FVR (Figure 3).

**Figure 3: Excerpt from the FDR data from VH-FVR during the pitch disconnect event. The underdamped oscillatory characteristic response of the elevator movement following pitch disconnect is circled in yellow.**
