Breakaway of *Spirit of Tasmania II*

Station Pier, Port Melbourne, Victoria | 13 January 2016

ATSB Transport Safety Report
Marine Occurrence Investigation
324-MO-2016-001
Final – 11 May 2017

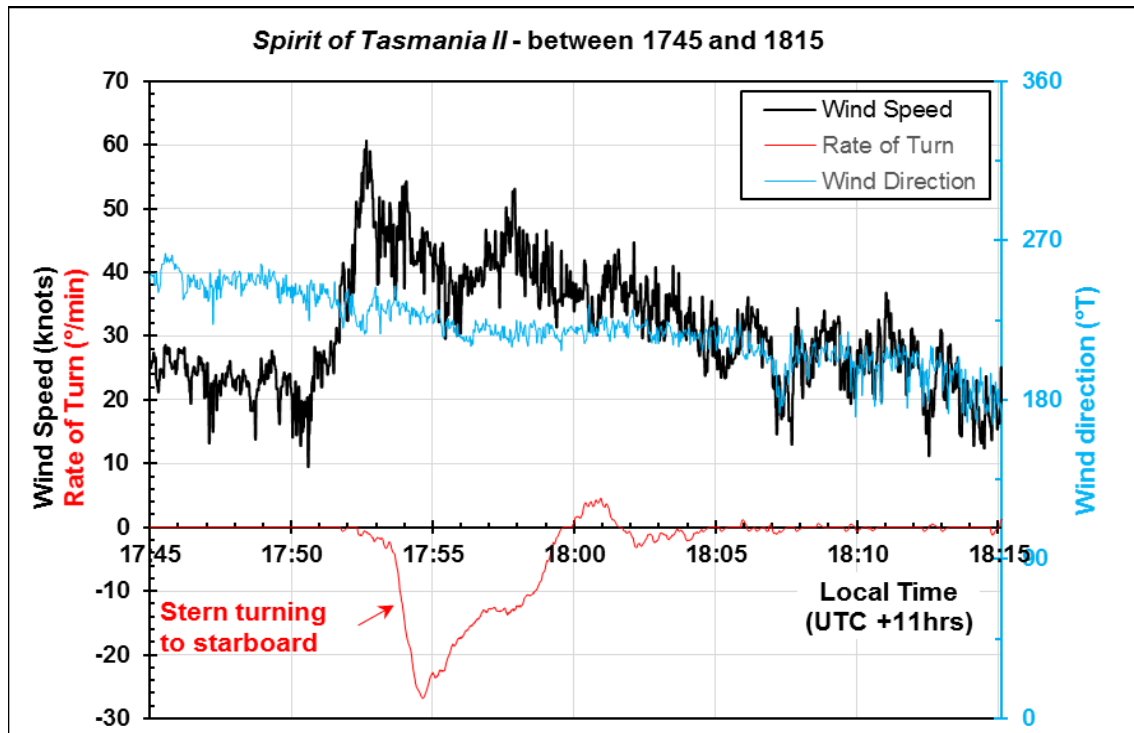
Figure 3: Wind speed and direction, and the ship's rate of turn

By 1755, the ship was at an angle of approximately 45 degrees to the wharf and turning away from it (negative rate of turn in Figure 3) at 27°/min.

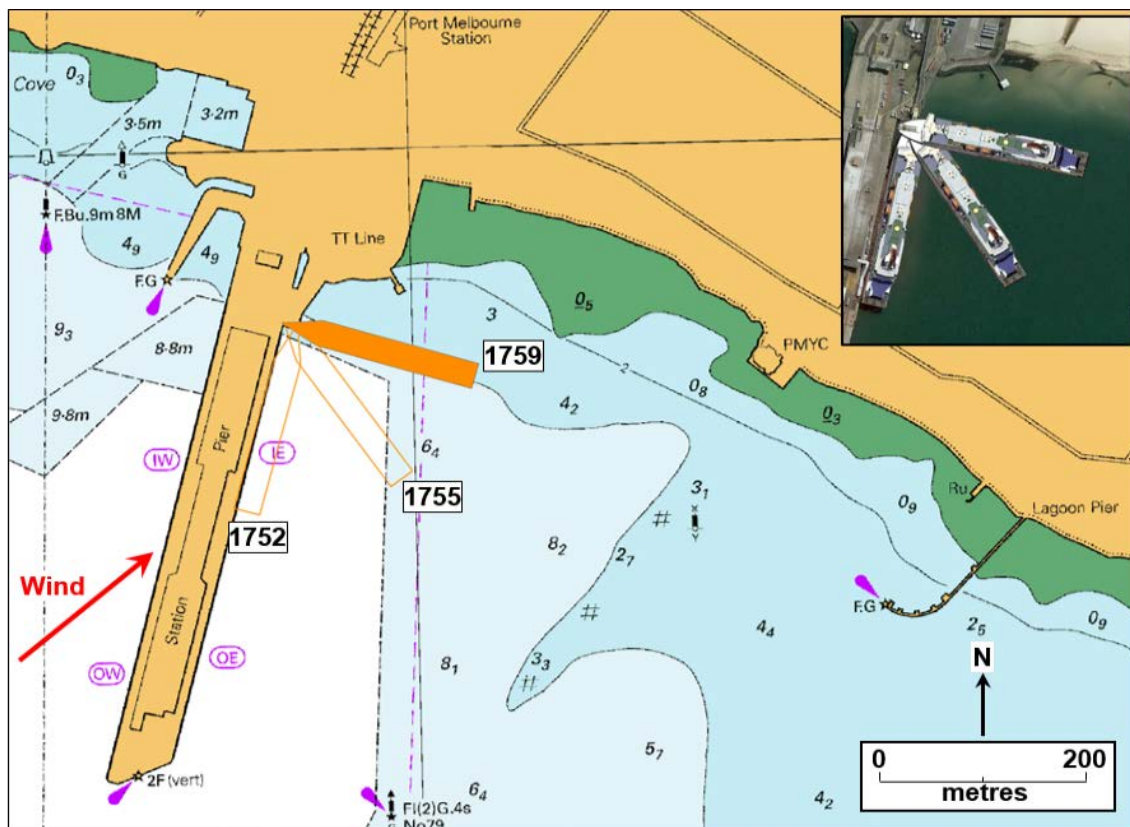
Figure 4: Section of navigational chart Aus 154 showing the ship's breakaway

With the strong winds pushing the stern away from the wharf, the ship's aft mooring lines failed in rapid succession. The ship pivoted about its bow and swung away towards the shore (Figure 4).

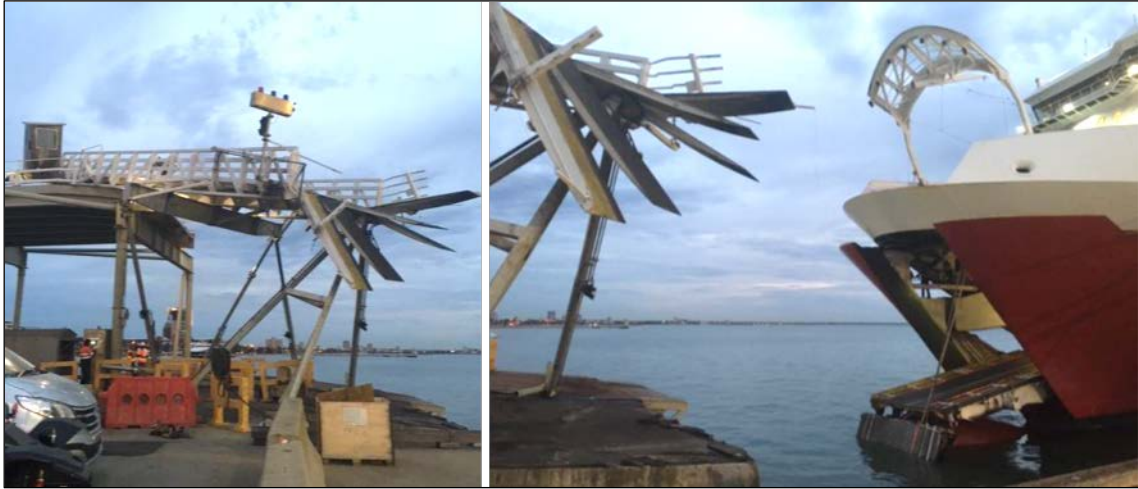
Figure 5: *Spirit of Tasmania II*'s damaged upper bow ramp (skybridge)

When *Spirit of Tasmania II* had turned off the wharf, its starboard bow door had come to rest against the wharf structure. Weight had then come onto it and pushed it against the lower bow ramp, resulting in damage to a number of its door operating components. The hydraulic system used to operate the doors was not damaged. As the lower bow ramp moved off and under the wharf, its end fingers were damaged as they made contact with the wharf piles. The upper vehicle ramp suffered extensive damage (Figure 5) requiring it to be removed from the wharf and taken away for repairs.

Inspections and repairs as required by the Australian Maritime Safety Authority, the ship's flag State authority, and its classification society were then undertaken. On 17 January, 4 days after the incident, *Spirit of Tasmania II* returned to service.

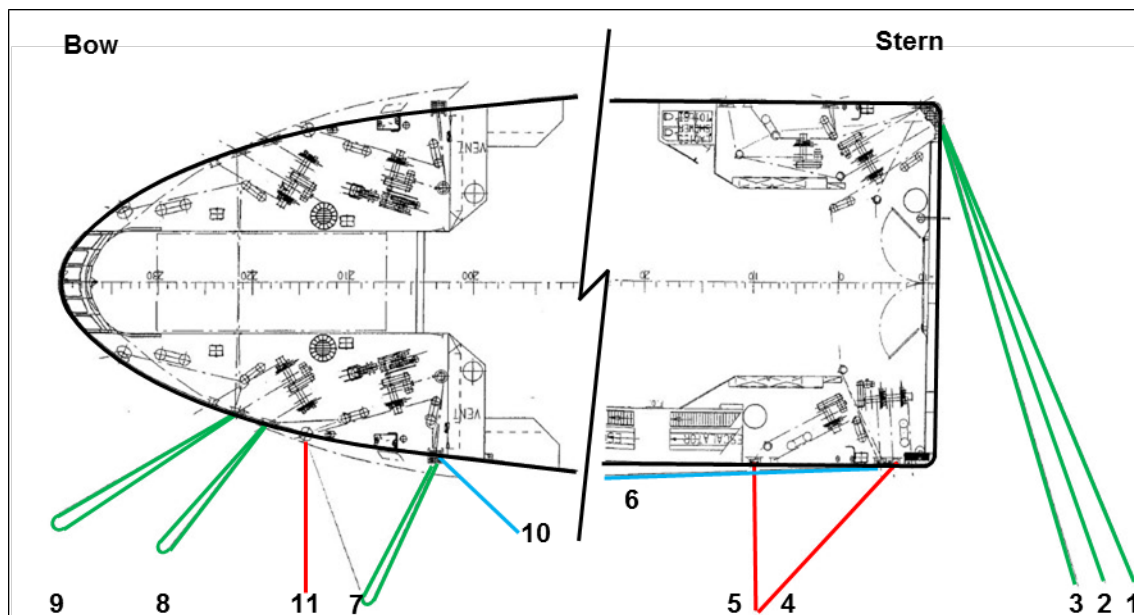
Figure 6: *Spirit of Tasmania II*'s standard mooring line pattern for Station Pier

Spirit of Tasmania II's standard mooring line pattern⁷ had been developed for the Station Pier berth (Figure 6). This consisted of three head lines on bights⁸ (numbered 7, 8 and 9 in Figure 6), a spring line (10) and a breast line (11) forward, and three stern lines (1, 2 and 3), two breast lines (4 and 5) and a spring (6) line aft. All mooring lines were 64 mm diameter, mixed synthetic fibre rope,⁹ each with a breaking load of 82 t.

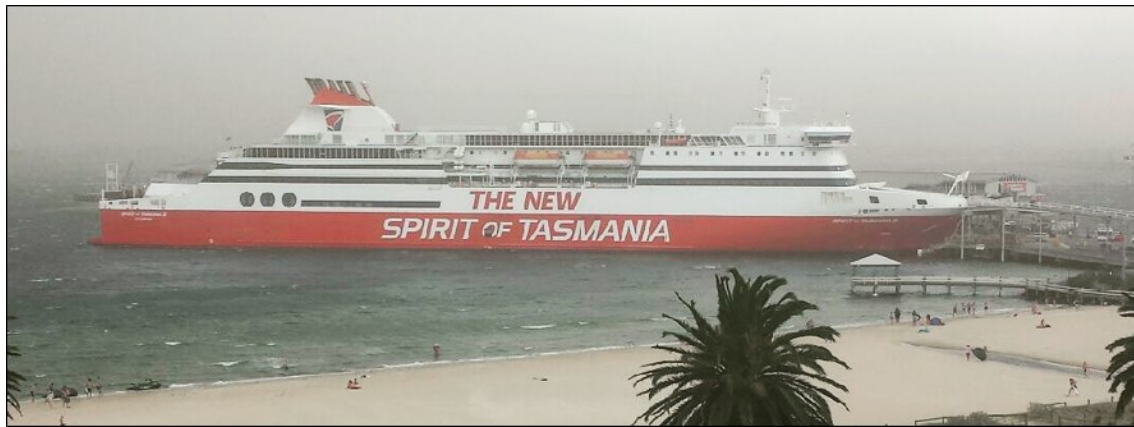
Figure 8: *Spirit of Tasmania II* adjacent to Port Melbourne Beach

By 1759, the ship lay at right angles to the wharf and parallel to Port Melbourne Beach (Figure 8). While waiting for tugs to assist, the ship's propulsion was used to maintain its position and prevent grounding. By 1905, the ship was back alongside Station Pier with the two tugs assisting. No one was injured and damage was limited to the ship's bow ramp and doors.

As the wind speed was peaking, the ship's stern moved more than 4 m off the wharf stretching the aft moorings lines. Soon after 1753, the shortest of the stern lines parted. As the ship moved further off the wharf, the load increased on the other stern lines and they quickly parted. The two breast lines were unable to pay out quickly enough and parted. As the ship pivoted about its bow, the forward mooring lines overloaded and parted leaving just two lines intact (Table 1).

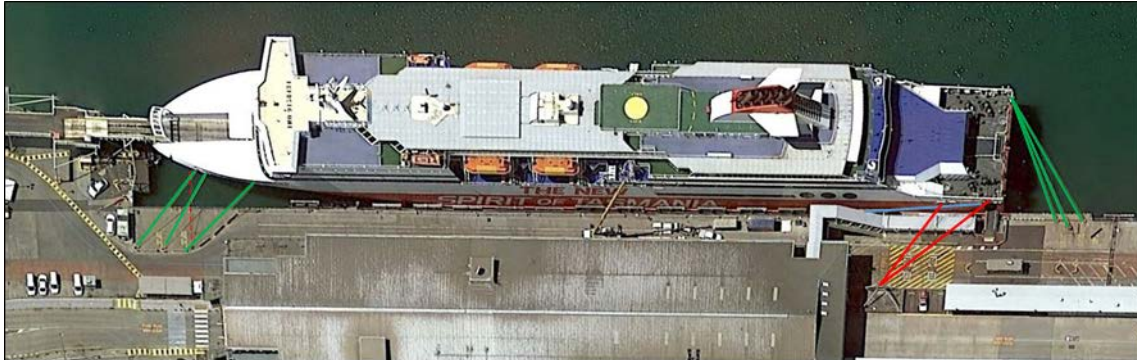
Figure 10: *Spirit of Tasmania II*'s mooring lines as run on 13 January (lines highlighted)

The ship's planned maintenance system required mooring lines to be inspected every month. The maintenance records indicated that all aft lines were in good or new condition when inspected on 2 January, a few days before the breakaway. The records indicated that regular maintenance had been carried out on the mooring winches. The design winch brake holding capacity was 69 t. No defects were recorded at the previous 3 monthly mooring equipment inspection, completed in

At the time of the breakaway, all stern lines were held on the winch brake. The winches holding both aft breast lines were set to self-tension. The self-tension setting was reported to have been between 80 and 100 per cent of the winches' rated pull²³ of 15 t.

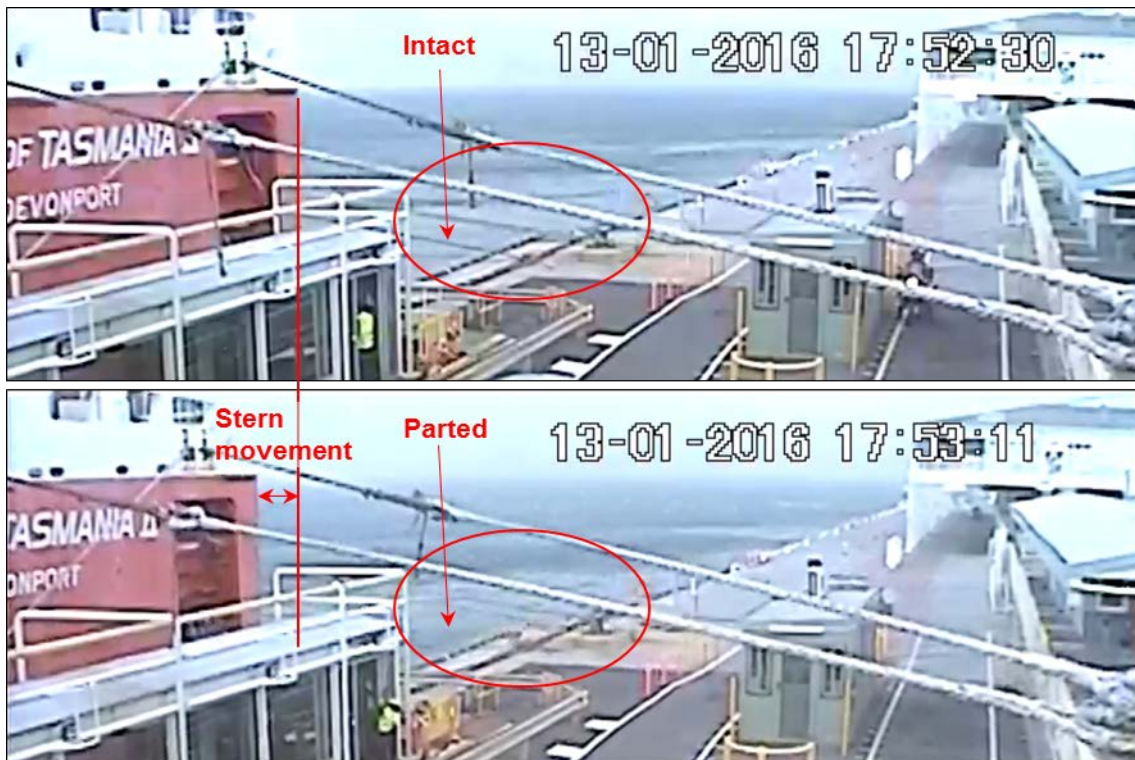
Figure 11: CCTV images showing the ship moving off the wharf and the first line parting

The CCTV footage from 1752 shows *Spirit of Tasmania II*'s stern moving off the wharf and its aft mooring lines stretching due to the wind loading (Figure 11). By 1753, as the wind was peaking at about 60 knots, the ship's stern was over 4 m off the wharf with the lines considerably stretched as the winch brakes held. Moments later, the shortest stern line parted when it could not stretch any further. As the load transferred to other stern lines, they parted in quick succession.

As the ship's stern was breaking away, the winches holding the breast lines paid out. However, as the ship's movement gathered speed, those lines parted. Two of the three forward head lines also parted during the breakaway.

- unequal tension in mooring lines (before the sudden increase in wind speed)
- not all lines were held on winch brakes (some winches on self-tension)
- unknown mooring line defects
- sudden dynamic forces (six-fold increase in wind loading)
- dynamic loading (ship's momentum as it rapidly moved off the wharf).
