Engine failure involving Airbus A330, VN-A371

Melbourne Airport, Victoria | 6 May 2014

ATSB Transport Safety Report
Aviation Occurrence Investigation
AO-2014-081
Final – 1 June 2017

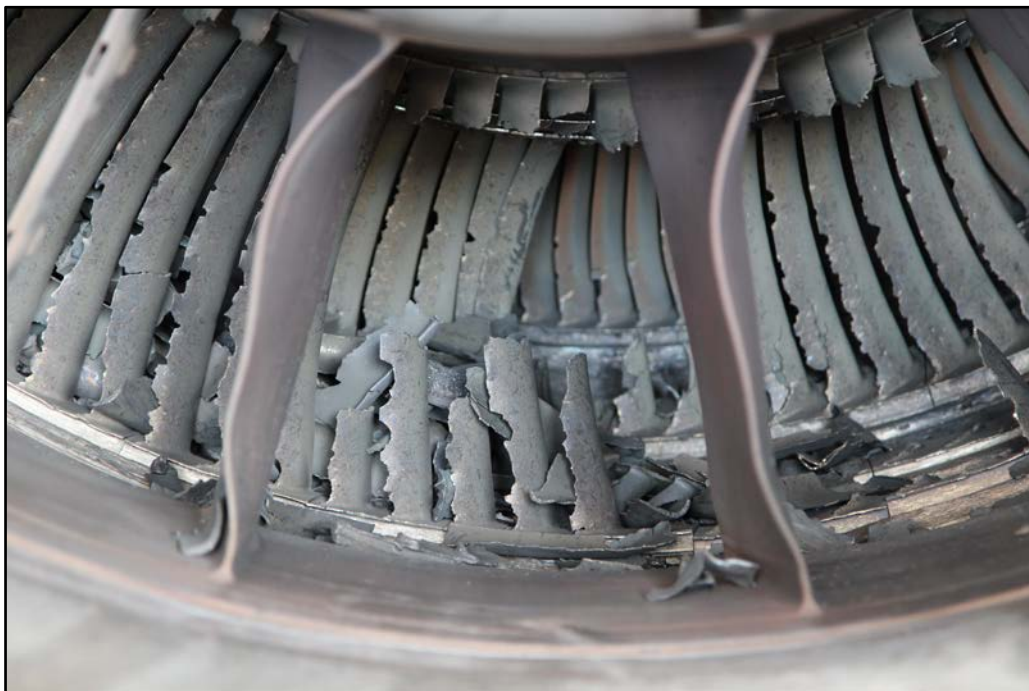
A subsequent technical examination determined that the right engine had sustained an uncontained failure of the low-pressure turbine (Figure 2).

Figure 2: Right engine low-pressure turbine damage, looking forward from the exhaust duct

The engine cowls contained liberated LPT fragments that exited the engine radially via a 38 cm perforation in the LPT front case. There was no other damage associated with the LPT case rupture.

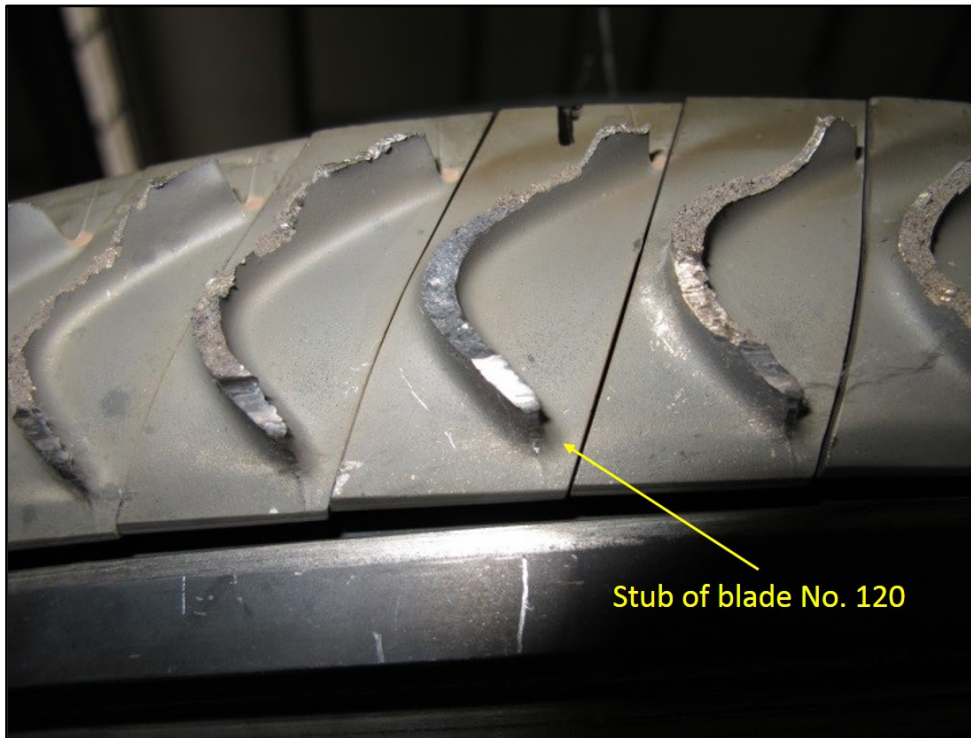
The right engine, serial number P733510, was removed from the aircraft and shipped to a maintenance facility in Singapore for disassembly and examination under the supervision of the United States National Transportation Safety Board (NTSB). The examination determined that the engine lost power due to a failure in stage four of the LPT. Turbine blade stub number 120 (of 130) exhibited a fracture surface that was visually different to the remainder of the fractured blades (Figure 4).

The ATSB conducted a preliminary examination of the set of fractured stage four LPT blade stubs. All of the blades were fractured close to the blade platform and exhibited similar leading edge damage. This was consistent with rotational contact or 'clashing' between the blades' leading edges and a stationary component.

Figure 4: A number of the fractured stage four low-pressure turbine blade stubs, with the stub of blade 120 highlighted

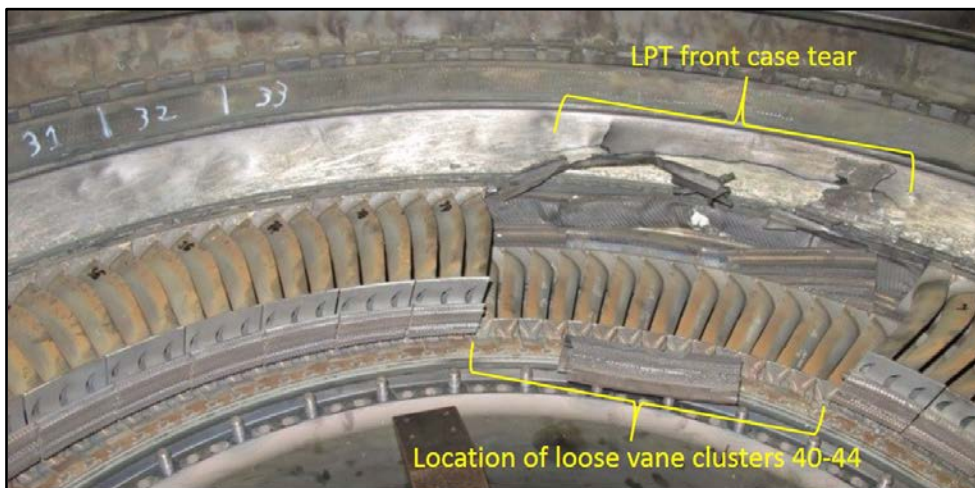
Additionally, stage four LPT vane clusters numbered 40-44 were loose and askew near their originally-installed positions. This area coincided with the tear at the 11–12 o'clock position in the LPT front case (Figure 5).

Figure 5: Case tear and the location of the loose vane clusters (vane clusters 40–44 are not present in the image)

The ATSB and Pratt and Whitney were not able to conclusively determine why the vane clusters contacted the fourth stage LPT blades. The case tear resulting from the failure of blade 120 was in the same location as the vane clusters that were identified as being loose and disengaged. It is possible that distortion and damage to the structure retaining the stage four vane clusters resulted in their contact with the rotating blades of the stage four LPT rotor. However, it is also possible that the vane clusters were displaced by an unidentified mechanism resulting in contact with the stage four blades and the initiation of HCF fatigue cracking in blade 120. In this scenario, further aft movement followed, resulting in the metal smearing observed on the fracture surface of blade 120.

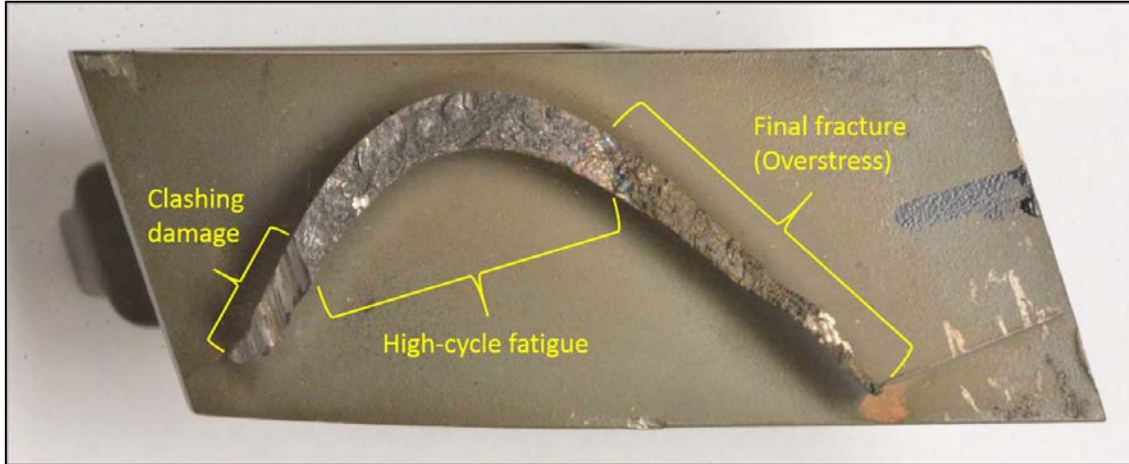
The fracture surface of the stub of turbine blade 120 contained a significant region of high-cycle fatigue cracking, probably originating from the leading edge (Figure 6). The fatigue crack origin had been machined away by the clashing damage and, as a result, the presence of any pre-existing material anomaly or damage in the blade could not be determined.

In addition to confirming the high-cycle fatigue cracking in turbine blade 120, detailed examination by Pratt and Whitney identified evidence of fatigue crack progression adjacent to the leading edge damage in 19 other blades. However, blade 120 exhibited 0.7 inches (18 mm) of fatigue progression, which was significantly greater than the 0.01 to 0.089 inches (0.25–2.3 mm) on the other 19 blades. The fatigue region of blade 120 was also more heavily oxidised, due to exposure to the gas stream, than the next most fatigued blade (blade 18). Blade 120 was therefore considered likely to have been the first to fracture (Figure 6).

Figure 6: Blade 120 fracture surface, showing the region of high-cycle fatigue, the clashing damage and the final overstress fracture

Turbine blade 120 failed as a result of HCF crack initiation and progression from the blade's leading edge, to the point where the remaining material failed in overstress. The crack origin could not be examined for material anomaly or damage due to clashing damage from a number of stage four vane clusters. However, metal smearing over the HCF crack surface indicated that the cracking preceded the clashing damage. Despite being unable to determine the factors contributing to the cracking of blade 120, the extent of the cracking indicated that it was most likely the first blade to be released in the failure sequence.

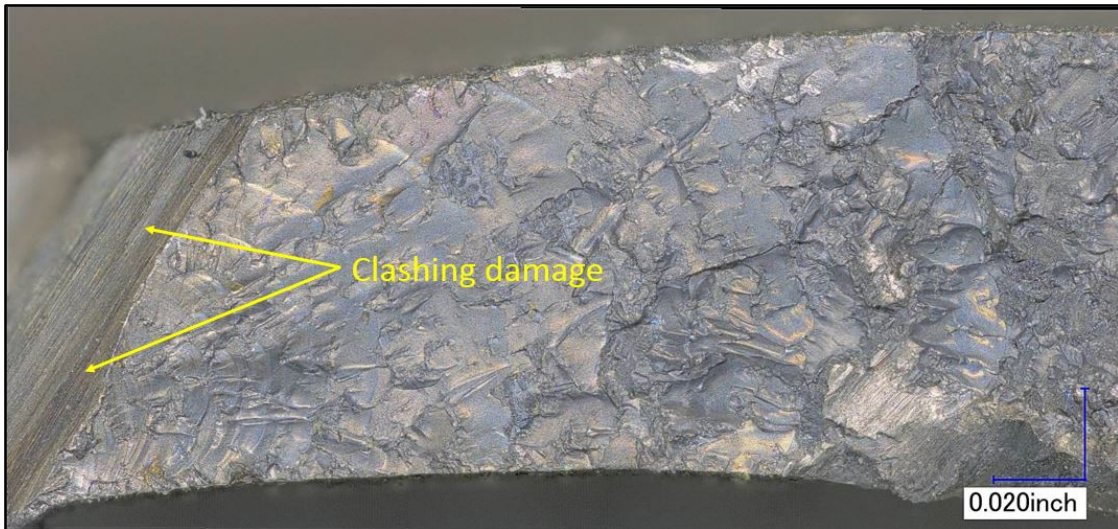
The origin of the fatigue cracks in each blade had been machined away by clashing damage (Figure 7). Blade material was also smeared over portions of the fatigue region of blade 120, adjacent to the clashing damage. This indicated that the fatigue cracking preceded the clashing damage (Figure 8). By contrast, no smearing was observed over the fracture surface of blade 18 (Figure 9).

Figure 7: Blade 120 fatigue region, with leading edge clashing damage indicated on the left

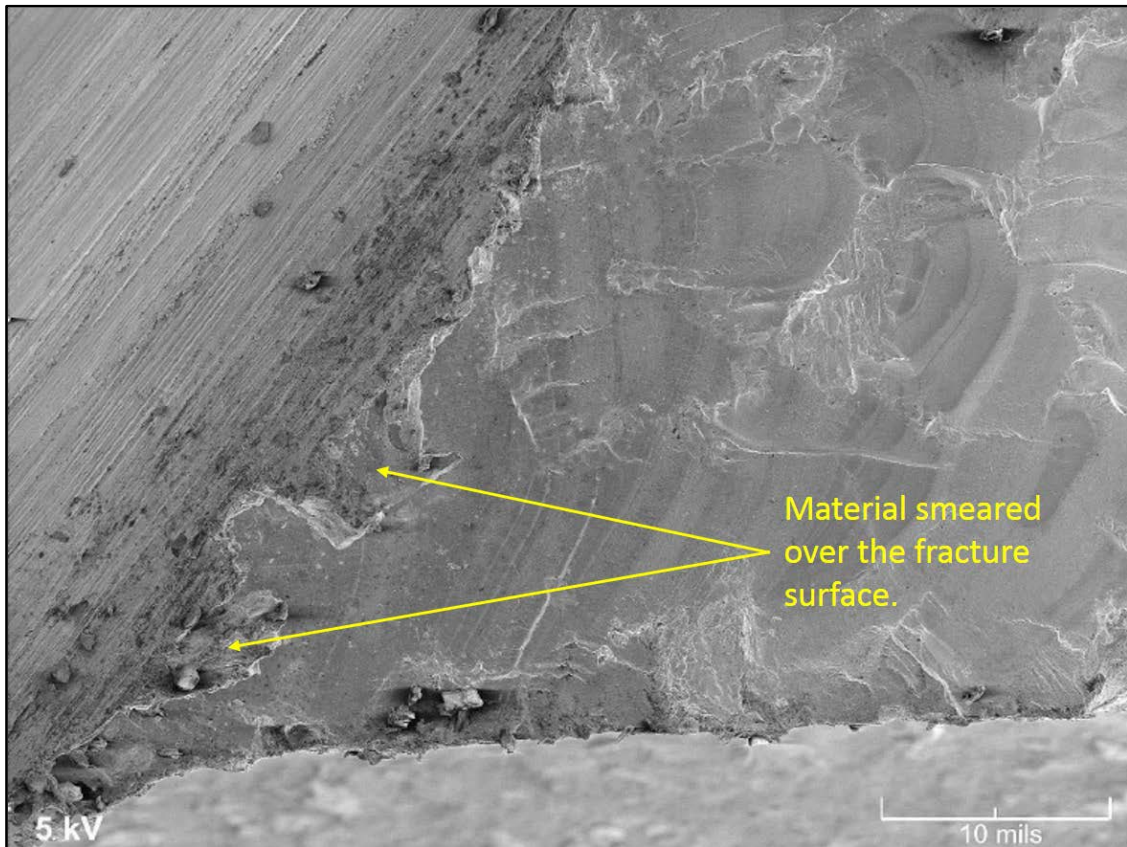
Figure 8: Blade 120 fracture surface, showing metal smearing

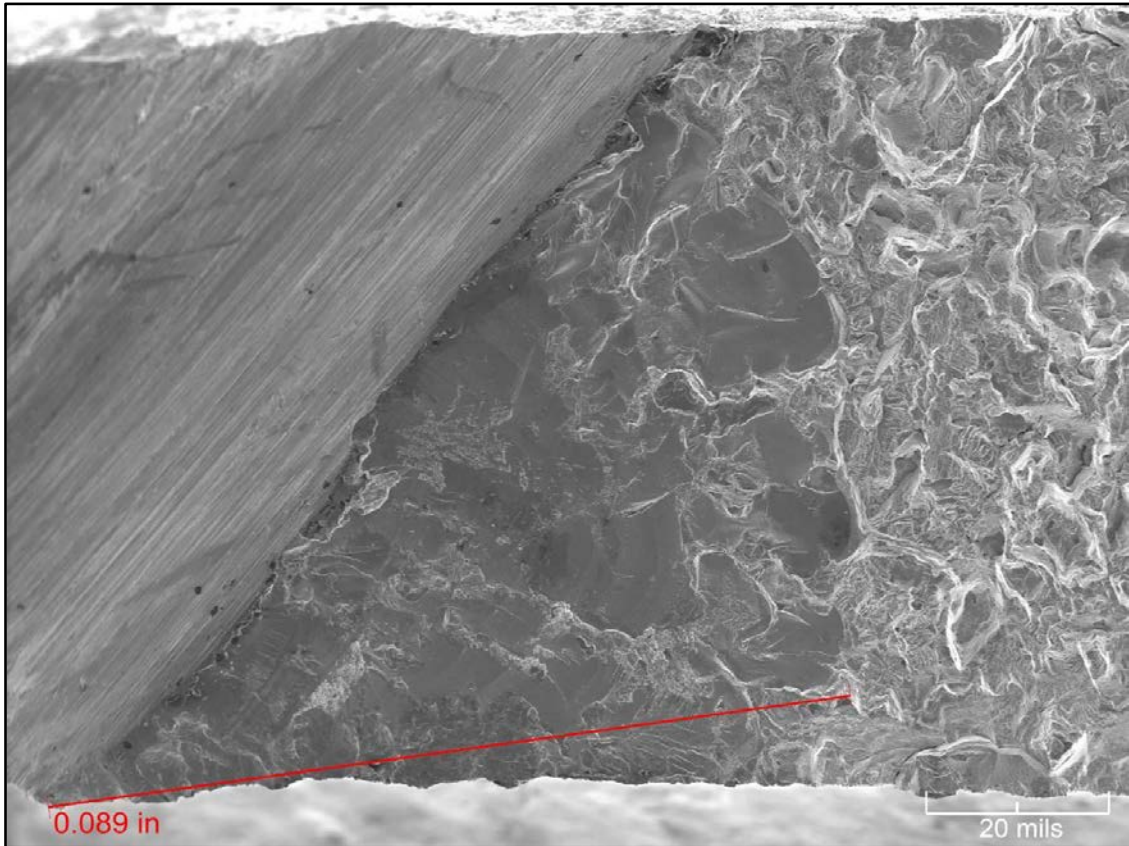
Figure 9: Blade No. 18, showing a fatigue progression of 0.089 inches (as compared to 0.7 inches in blade No. 120 before failure)

In addition to blade 120, HCF cracking was found in 19 other stage four LPT blades. These blades exhibited minor cracking when compared to blade 120 but also exhibited similar clashing damage as sustained by blade 120. Less oxidation on blade 18, compared to blade 120, indicated that the blade 18 fracture surface was exposed to the gas stream for less time than blade 120. Further, the HCF fracture surface on blade 18 was less advanced at the same distance from the blade's leading edge compared to blade 120. This supports the cracking in blade 18 occurring later in the engine failure sequence than the cracking in blade 120, probably after the clashing commenced. It was therefore considered that the most likely initiator of the minor fatigue cracking in the 19 other blades resulted from their contact with the fourth stage vanes.

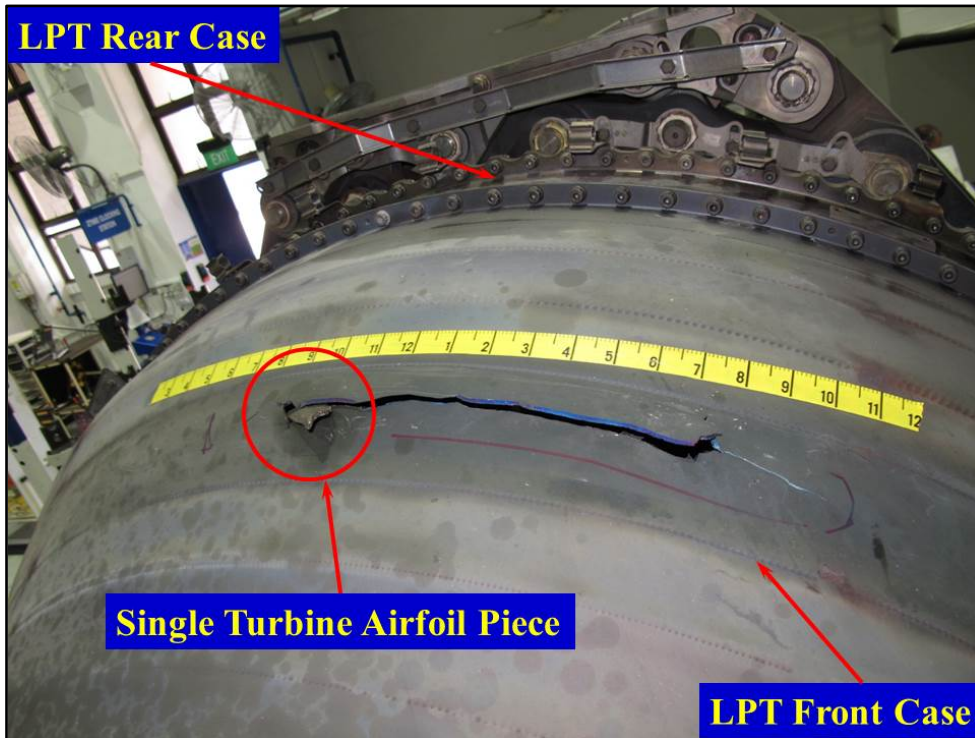
The LPT front case exhibited a 38 cm circumferential tear, with associated outward deformation, from the 11 to the 12 o'clock position in the stage four rotor's plane of rotation. A single, unidentified airfoil was wedged in the breach (Figure 10). In addition, a 2.5 cm circumferential puncture was observed at the 6 o'clock position of the front case in the stage four rotor plane of rotation (Figure 11).

Sections of the LPT front case adjacent to the 38 cm and 2.5 cm perforations were tested for hardness, wall thickness and grain size. The results of these tests found that the:

- hardness measurements were consistent with applicable standards
- wall thickness and grain size measurements for both sections conformed to Pratt and Whitney specifications.

Figure 10: Low-pressure turbine front case tear at the 11–12 o'clock position. Note that the scale is in inches and the view is looking aft

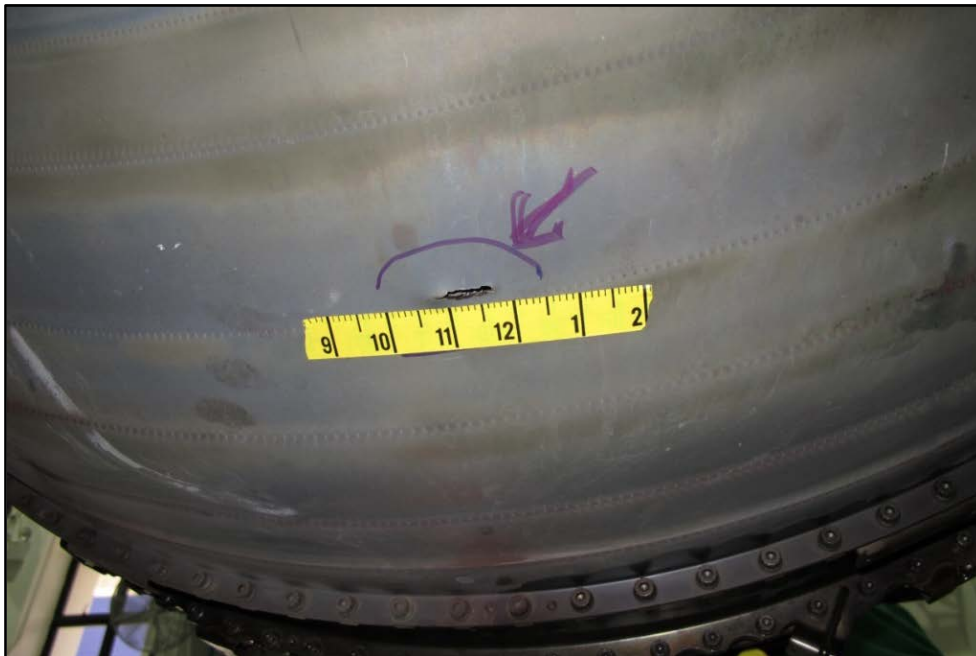
Figure 11: Low-pressure turbine front case tear at the 6 o'clock position. Note that the scale is in inches and the view is looking aft

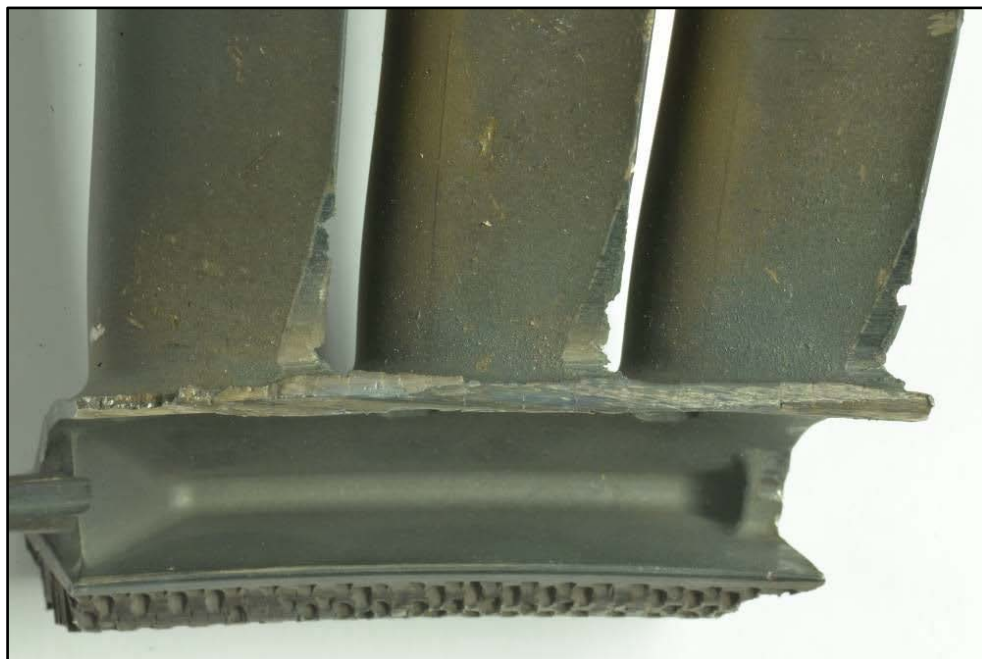
Nine consecutive stage four LPT vane clusters from positions 36–44 exhibited clashing damage on the aft end of their inside diameter shrouds. Of these clusters, three also exhibited trailing edge clashing damage on the vane aerofoils (Figure 12). The clashing damage resulted from contact with the rotating stage four LPT blades.

Figure 12: Stage four low-pressure turbine vane cluster showing clashing damage to the inside diameter of the shroud and aerofoils
