# Fuel starvation involving Cessna 210, VH-HZE

11 km N of Mildura Airport, Victoria, 6 February 2017

**ATSB Transport Safety Report**  
Aviation Occurrence Investigation  
AO-2017-020  
Final – 27 July 2017

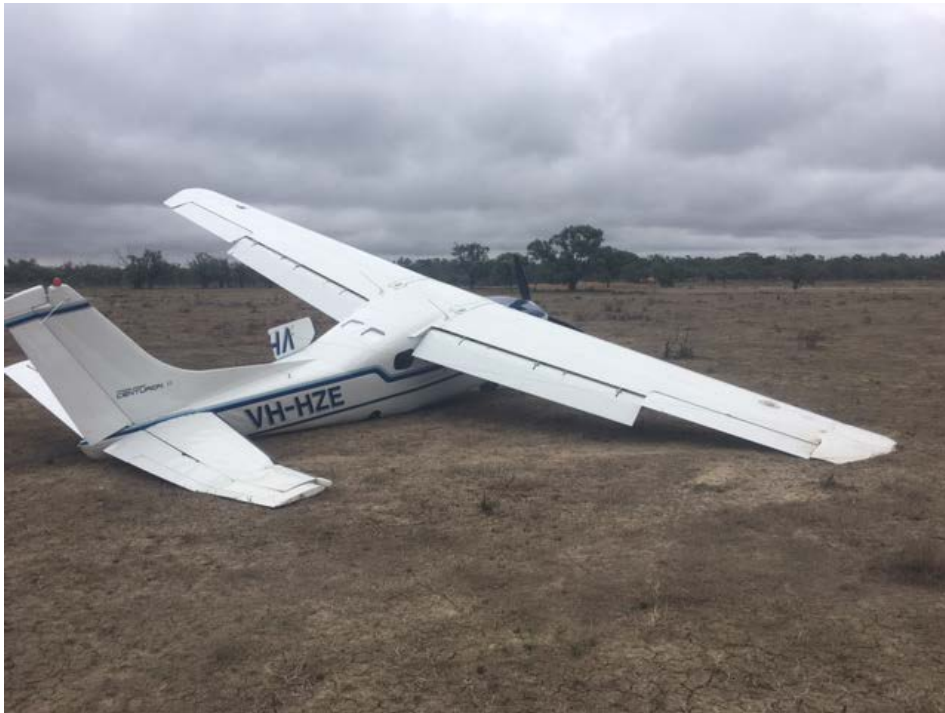
**Figure 1: Damage to HZE**

The pilot landed the aircraft in the paddock and collided with a fence during the ground roll. Once the aircraft had stopped, the pilot selected the master switch to off and exited the aircraft uninjured. The aircraft was substantially damaged (Figure 1).

- The engine failed due to fuel starvation when the limited amount of fuel remaining in only one of the two tanks became unusable during manoeuvring.
- Prior to departure, the aircraft's fuel tanks were probably not full. However, the pilot selected full fuel tanks on the fuel flow computer and therefore the fuel flow computer provided the pilot with a higher reading of fuel on board than what was actually on board.
