Runway excursion involving Gippsland Aeronautics GA-8, VH-AZH

50 km NW of Hollins Bay ALA (Avoid Island), Queensland, 23 March 2017

ATSB Transport Safety Report
Aviation Occurrence Investigation
AO-2017-035
Final – 27 July 2017

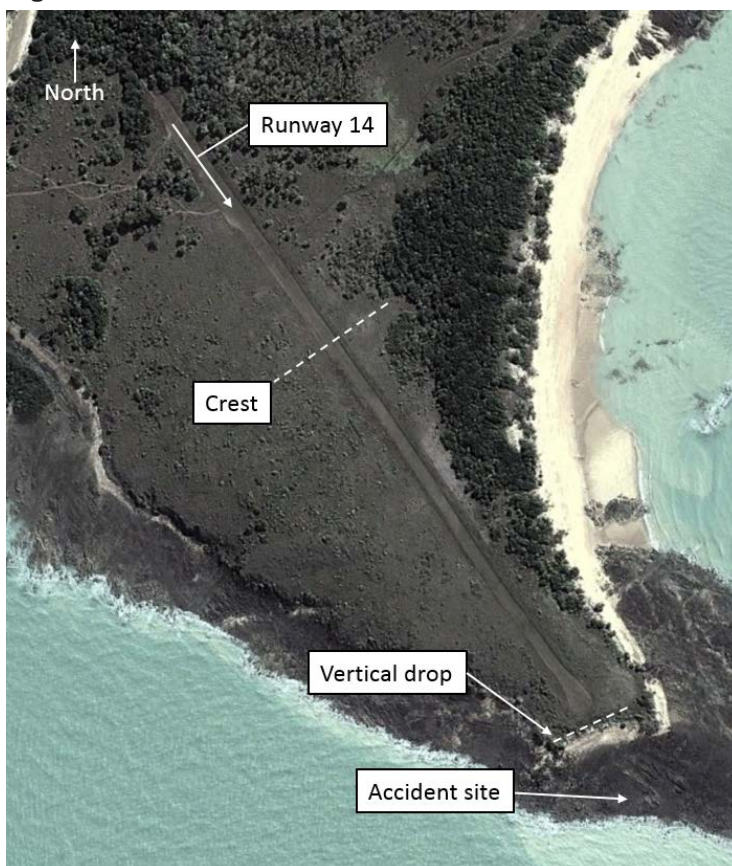
Figure 1: Avoid Island ALA

While preparing for the departure, the pilot observed a 5–10 kt wind from the south-east and elected to use runway 14 for take-off. Runway 14 was a grass runway, 800 m long and included a slight rise in the middle. At the end of the runway was a vertical drop of about 2 meters down to a rocky beach.

- After the accident, the grass on the runway was mowed and the runway was inspected. The operator found the significant deceleration toward the end of the take-off run was the result of an area of soft runway surface and mud. During the pilot's taxi after the previous landing, and during the accident take-off run, this area had been concealed by grass.
- The pilot had received training at Avoid Island ALA and had recently operated to the ALA.

- The operator has taking over management of maintenance of the Avoid Island ALA. This will enable the operator to ensure that the ALA is suitable for proposed operations.
- The operator is investigating the feasibility of works to improve drainage on the ALA.
- The guidance documents for all regularly used ALAs have been updated and significantly expanded.

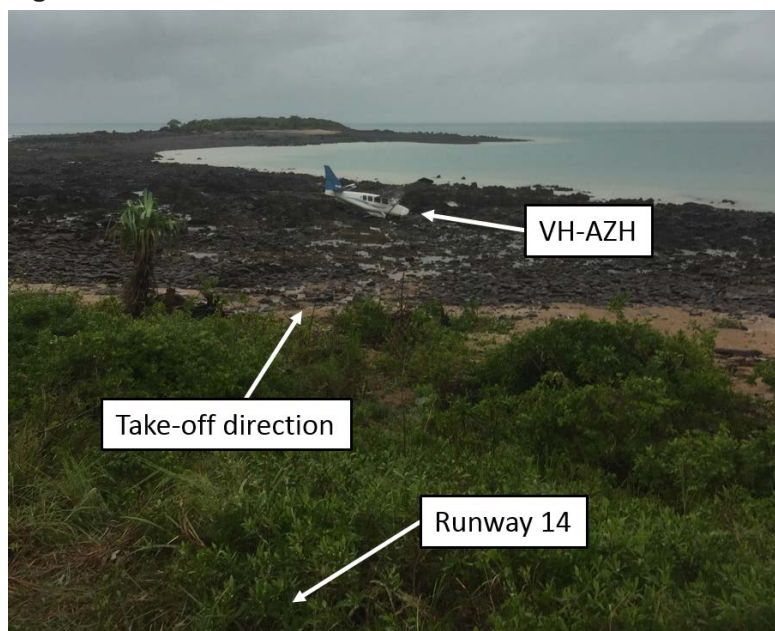
Figure 2: Accident site

The aircraft did not take-off before overrunning the runway and became airborne as it passed over the vertical drop at a speed of about 50 kt. While manoeuvring to avoid large rocks and obstacles (Figure 2), the pilot maintained a nose high attitude to minimise the effect of any impact. The aircraft was unable to maintain height and descended over about a further 100 m until the landing gear and underside of the rear fuselage impacted rocks. As the aircraft decelerated, the impact through the rudder pedals forced the pilot's ankle against the control column.

The pilot of the GA-8 suffered a fractured ankle, the passengers were uninjured in the accident.
