Hard landing involving Cessna 182, VH-JXX

Bathurst Airport, New South Wales, 1 April 2017

ATSB Transport Safety Report
Aviation Occurrence Investigation
AO-2017-038
Final – 27 July 2017

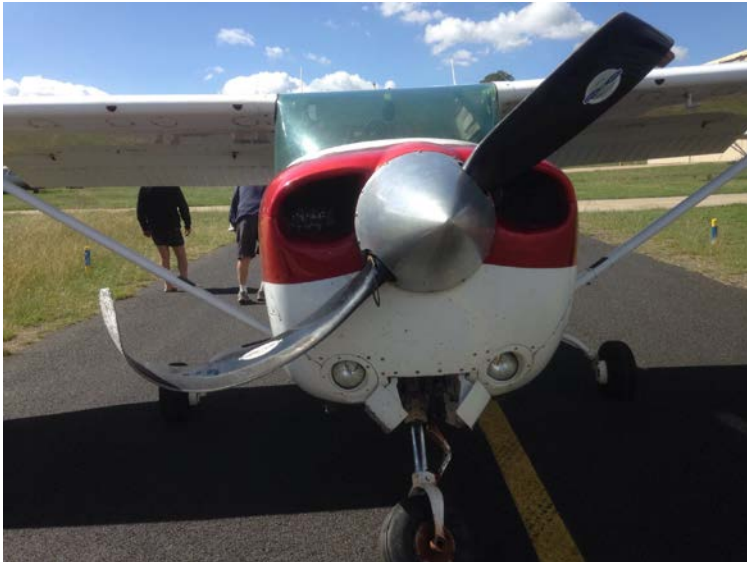
The aircraft sustained substantial damage and the pilot and passenger were uninjured (Figure 1).

Figure 1: VH-JXX showing damage to the propeller and nose landing gear

An aircraft maintenance engineer inspected the aircraft after the accident. The nose landing gear had collapsed and the gear doors were broken. The cowl flaps were damaged, the firewall was buckled and the area under the floor in the area near the pedals was bent. There was no evidence of any fault other than the damage sustained in the impact.

- The aircraft probably landed in a nose-low attitude resulting in a propeller strike and damage to the nose landing gear.
