Collision with water involving Robinson R44, VH-SCM

Talbot Bay, Western Australia, 23 April 2017

ATSB Transport Safety Report
Aviation Occurrence Investigation
AO-2017-047
Final – 27 July 2017

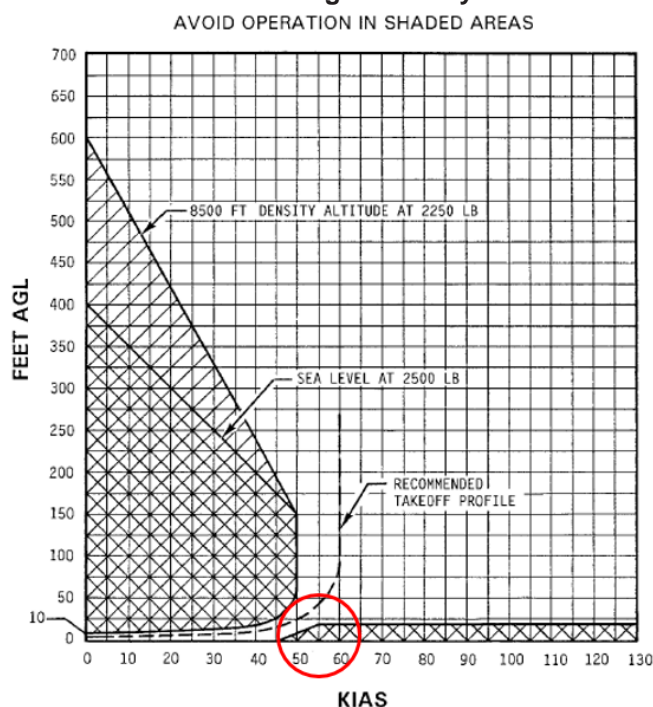
Figure 2: Robinson R44 II height-velocity curve

The pilot commented that their intention, in accordance with the height-velocity curve (Figure 2) published in the aircraft's pilot operating handbook, was to descend and remain in ground effect³ until the helicopter had sufficient forward speed to achieve translational lift.⁴

The take-off profile recommended by the manufacturer was for the helicopter to achieve a height of 25 ft at an airspeed of 50 kt. However, the helicopter was still at 5–10 ft at 50–60 kt, which provided the pilot with very little reaction time to the low rotor RPM warning.

According to the [FAA rotorcraft handbook](#), pilots should avoid the low altitude, high airspeed portion of the height-velocity diagram, because their 'recognition of an engine failure will most likely coincide with, or shortly occur after, ground contact. Even if you detect an engine failure, there may not be sufficient time to rotate the helicopter from a nose low, high airspeed attitude to one suitable for slowing, then landing.'
