# Collision with terrain involving a Jabiru J170-C, 24-5215

Yarram aerodrome, Victoria | 7 September 2016

**ATSB Transport Safety Report**  
Aviation Occurrence Investigation  
AO-2016-112  
Final – 31 July 2017

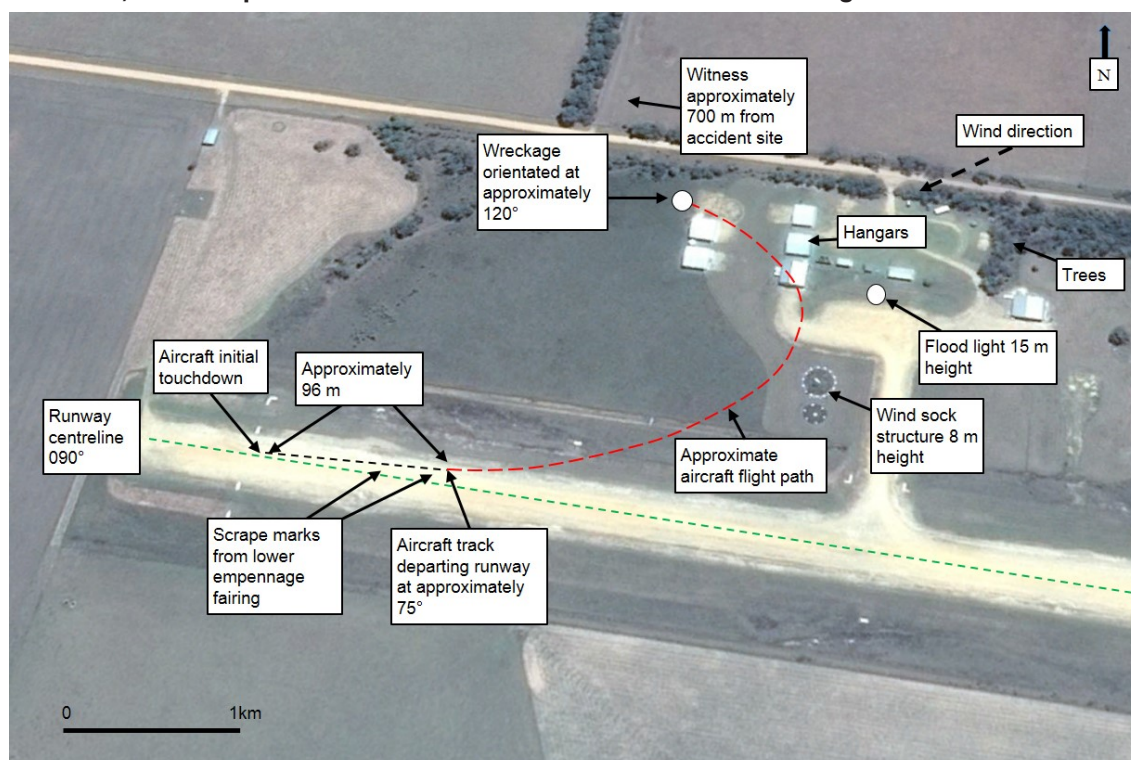
**Figure 1: Overhead view of Yarram aerodrome incorporating runway 09/27 with the ATSB assessment of post lift-off flight path, runway markings, pertinent landmarks, wind direction, barriers pertinent to mechanical turbulence and wreckage site**

Following the quick power burst, the witness then looked out of the shed window and observed the aircraft in the air, away from the runway centreline in a 30° left angle of bank. The witness estimated the aircraft to be 50-100 ft above the ground. The aircraft continued to the left and the bank angle increased. The lower wing then dropped and the aircraft descended in a near to vertical attitude. The aircraft had turned 180° from the original flight path. The witness then lost sight of the aircraft as it went behind the trees at the western end of the aerodrome boundary, but they heard the aircraft impact the ground (Figure 1).

It was reported that mechanical turbulence due to trees and hangars on the north-eastern perimeter of the aerodrome could be experienced when operating on runway 09 (Figure 1). This occurred when there was a north-easterly wind, and could catch pilots by surprise, particularly if they were not expecting it.

The witness and other pilots with experience of the conditions at Yarram stated that, when approaching runway 09 with the wind from the north-east at between 10-15 kts, the final 10 ft prior to landing could be quite turbulent and become 'a handful' for an unaware or inexperienced pilot. It is likely that, given the conditions on the day, the aircraft was subject to mechanical turbulence at the threshold of runway 09. In addition to the pilot's fatigue and level of experience (see below), it is likely this has resulted in the mishandled landing or 'touch-and-go' attempt.

The Wellington Shire Council, as the operator of the Yarram Aerodrome, initiated an entry into the En Route Supplement Australia entry for Yarram aerodrome highlighting the risk of an aircraft encountering mechanical turbulence on runway 09 during the gusty wind conditions present on the day of the accident. In a letter dated 29 June 2017, Wellington Shire Council informed the ATSB that:

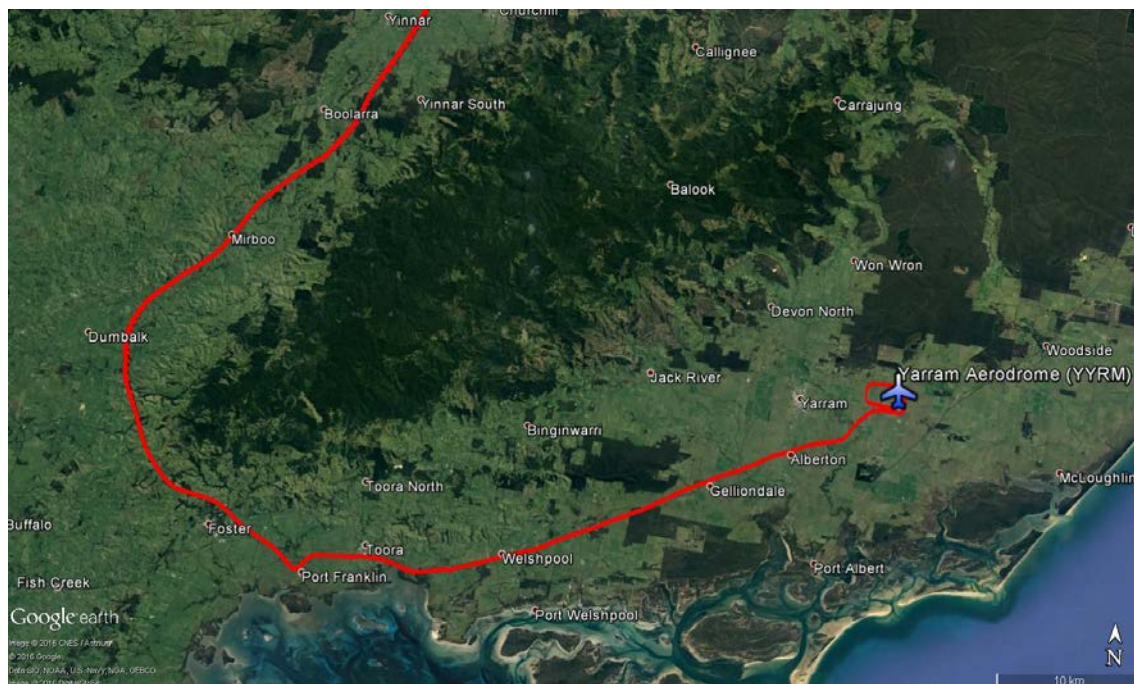
**Figure 2: Google earth image overlayed with the aircraft's actual flight route on the leg from Latrobe Valley to Yarram downloaded from the recovered hand held GPS unit bypassing Fish Creek – a required navigation point for the solo navigation exercise.**

The pilot was conducting a solo navigation exercise from Tooradin to the Latrobe Valley airport, Fish Creek, Yarram, Foster and return to Tooradin requiring that they conduct either a full stop landing or a 'touch-and-go' manoeuvre at Latrobe Valley airport and Yarram aerodrome. A review of the data from a hand held GPS device recovered from the aircraft showed that the actual flight route was similar to that planned. However, the track from Latrobe Valley was more consistent with overflying Foster Township rather than Fish Creek Township (Figure 2). The aircraft then tracked around the mountain ranges to Yarram.
