Fuel exhaustion and forced landing involving Beech 58, VH-PBU

6 km N of Normanton Airport, Queensland, 26 June 2017

ATSB Transport Safety Report
Aviation Occurrence Investigation
AO-2017-067
Final – 5 September 2017

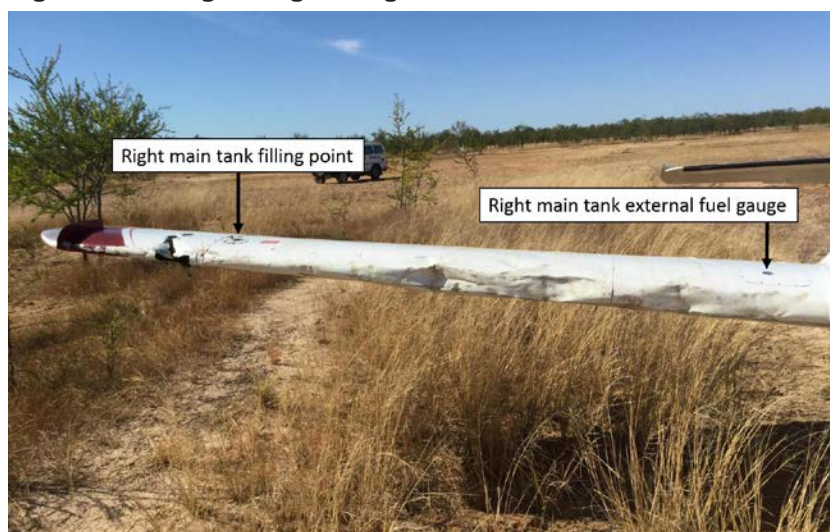
Figure 2: Damage to right wing

After determining that the aircraft would clear the powerline, the pilot lowered the landing gear and landed in the field. During the landing roll the aircraft impacted a number of bushes.

The pilot was not injured during the incident, however, the aircraft sustained substantial damage (Figure 2).
