Engine failure involving a Eurocopter AS350-BA VH-SFX

Whyanbeel Valley, Queensland | 2 November 2015

ATSB Transport Safety Report
Aviation Occurrence Investigation
AO-2015-124
Final – 17 October 2017

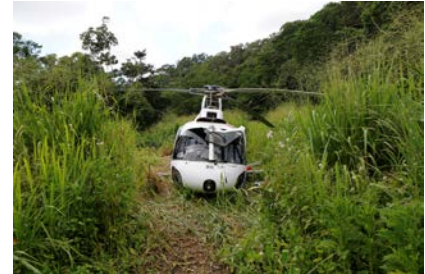
VH-SFX at accident site

The passengers adopted the brace position and the helicopter landed heavily with the skids digging into the uneven terrain and breaking off. The navigator in the front seat received minor injuries and the pilot received serious back injuries from the impact forces.

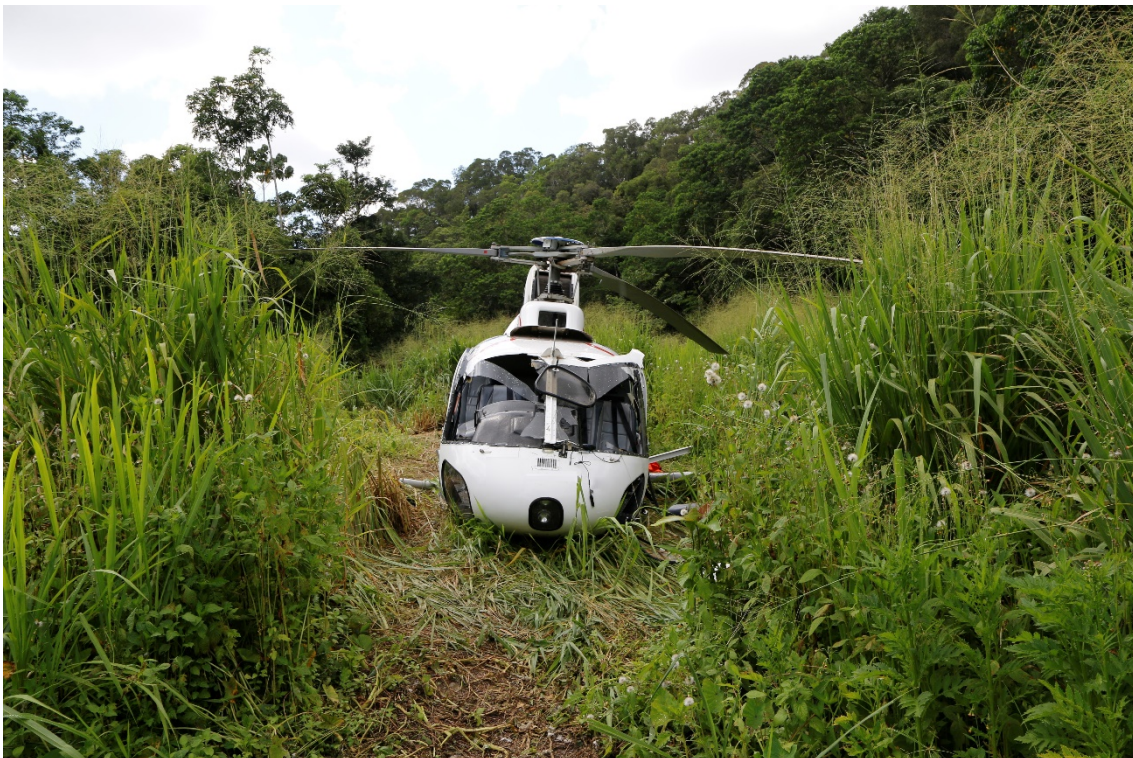
Figure 2: VH-SFX at the accident site

The on-site examination found that the helicopter struck the ground tail rotor first, with the skids subsequently digging into the uneven terrain and separating from the fuselage (Figure 2).

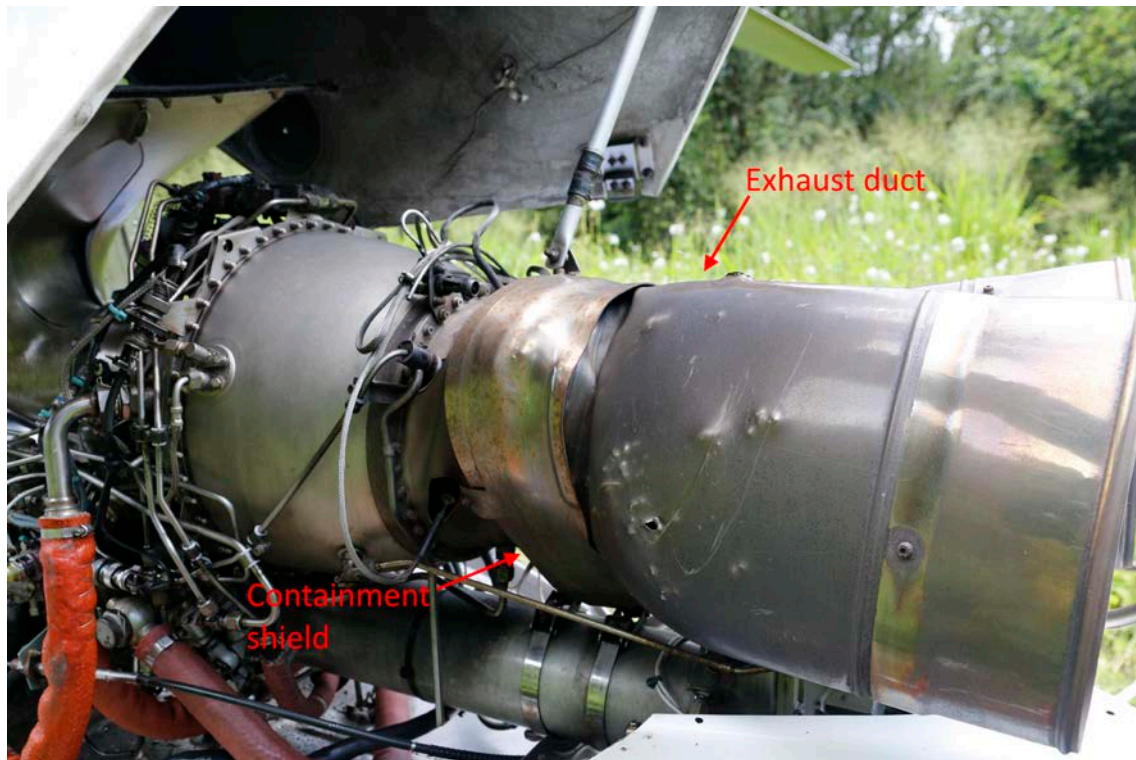
Figure 3: View of the helicopter engine at the accident site

The engine had sustained damage consistent with a high-energy failure. The power turbine separated from the disc and the containment shield was twisted and deformed. The exhaust duct was bulged and puncture marks from internally liberated engine debris was evident (Figure 3).

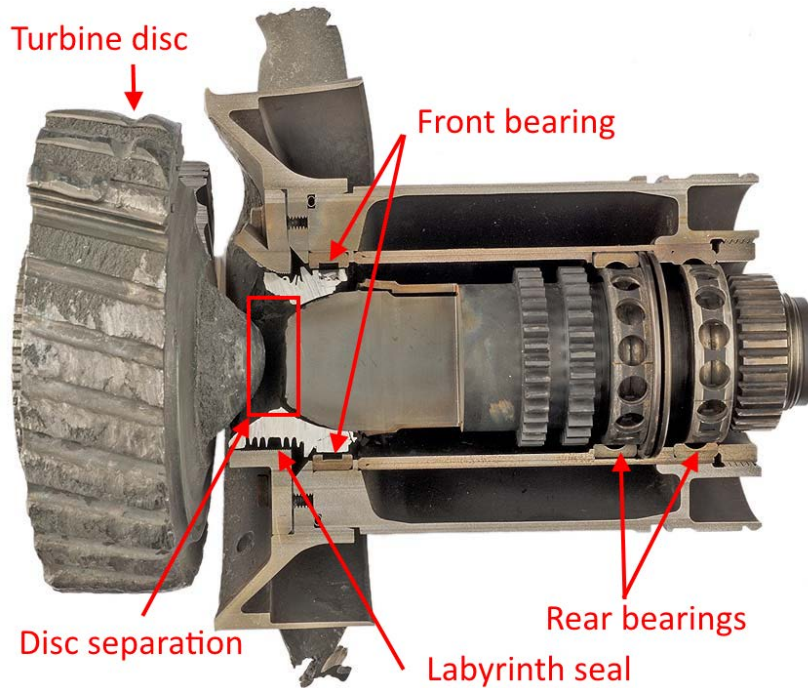
- The power turbine disc had fractured in overstress and separated from the power turbine shaft (Figure 6). The power turbine disc sustained a complete loss of power and the turbine blades had separated from their respective stations. Fracture of many of the blade inter-recesses within the disc had also occurred.

Figure 6: Cross-section through the power turbine assembly from the engine showing that the disc had separated from the shaft and the blades had fractured

The combined effects of the front bearing seizure and the axial coupling of the components led to excessive heating and a subsequent critical reduction in mechanical properties for the shaft. Consequently, the turbine shaft was unable to sustain the operating stresses and it eventually fractured at the interconnection with the disc.

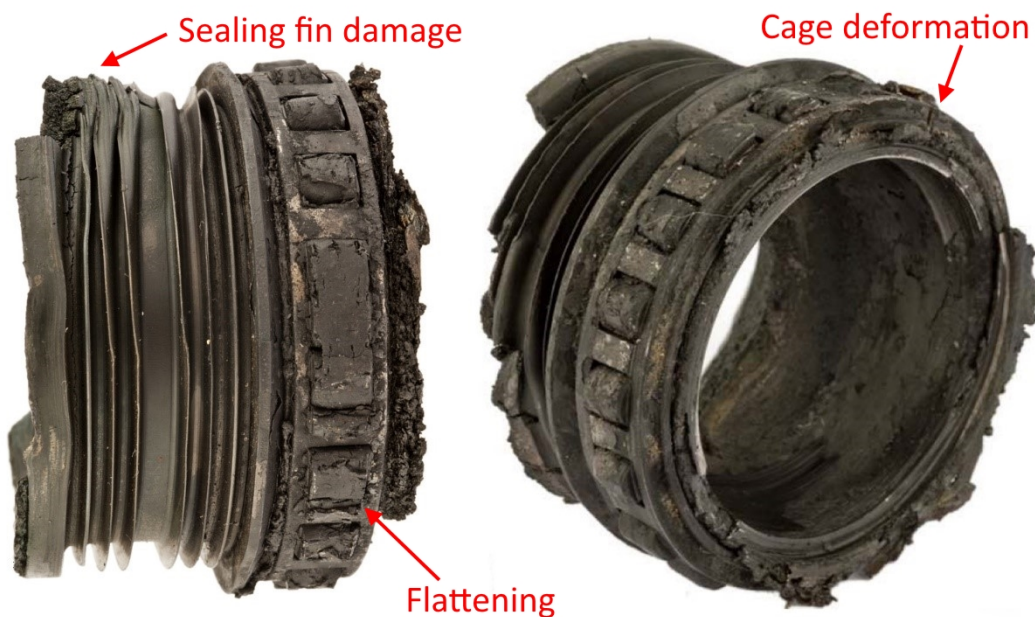
- The front bearing of the power turbine shaft had totally seized (Figure 7). Evidence of roller skidding, metal contamination and gross overheating was found within the bearing assembly. The accumulation of hardened coking products and varnish deposits from oil degradation was also found within the rolling elements.

- As a result of extreme frictional heating, the oil-air labyrinth seal, just forward of the front bearing, had melted and fused with the power turbine shaft.

Figure 7: The seized front bearing and labyrinth seal, showing blackening from severe heat distress, flattening of the rollers, deformation of the cage and sealing fins

The uncommanded yawing of the helicopter was the result of the engine failing from a seizure of the front bearing to the power turbine. The failure commenced rapidly when the oil supply to the front bearing became obstructed due to clogging of the bearing's oil jet by the accumulation of coke particles (a solid residue from the breakdown of the engine oil).

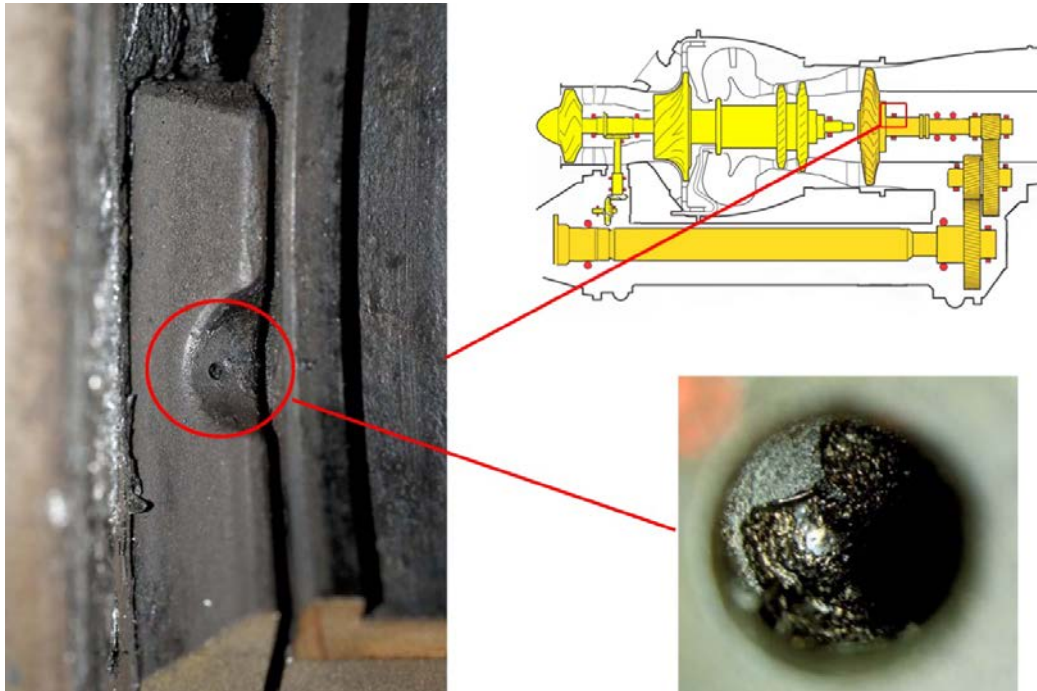
- Examination of the oil jet and surrounding oil ducts to the front bearing of the power turbine shaft identified that the jet outlet was blocked with an accumulation of coke particles (Figure 8).
- Examination of the splined nut that was threaded to the rear of the power turbine shaft assembly revealed evidence that it had tightened. The location of the nut determined the position of the shaft and any potential axial preload of the shaft bearings. No evidence was found of the adhesive that was required to have been applied between the threads on the rear shaft and the nut (Figure 9).

Figure 8: Close up of the blockage (circled) at the oil jet to the front bearing, as positioned in the general arrangement view

The observed coking of the front bearing and its oil jet duct was likely a result of the engine oil exposure to abnormally high temperatures in the area. While there were clogging inspection procedures of the power turbine rear bearings, no preventative maintenance actions existed that allowed for the identification of coking within the front bearing.

The engine manufacturer reported that a design trait of the power turbine is that the fluid velocity is lower at the bottom of the oil jet duct to the front bearing. For a given volume, this trait can lead to increased convective heating of the oil and depending on the temperatures in that region, may lead to coking.

The engine manufacturer (Safran Helicopter Engines) has amended their procedure manual to include systematic cleaning of the power turbine front bearing assembly oil jet and oil jet supply pipe. Safran HE have initiated a number of training and process changes to ensure the adhesive bonding between the power turbine and the rear nut is maintained during service.

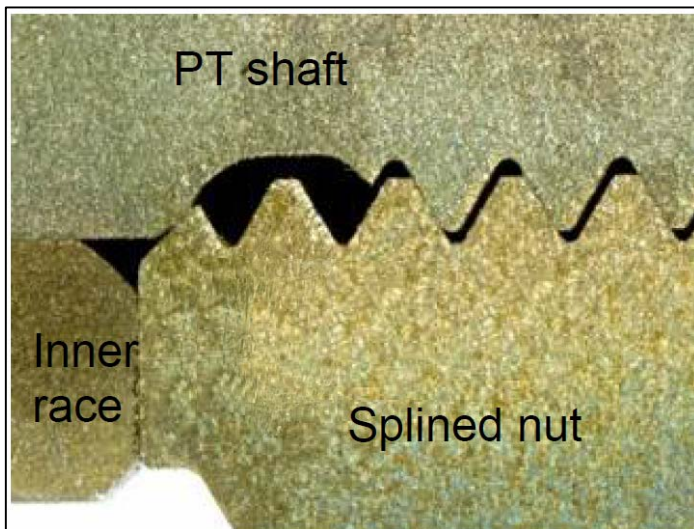
Figure 9: Cross-section of the rear splined nut contacting the rear bearing inner race

Failure to adequately bond the nut could result in a tightening of the rear nut when abrupt changes in torque occur, leading to axial displacement of the turbine shaft in excess of the designed amount. This displacement would result in contact between the turbine shaft and the front bearing inner race, resulting in frictional heating, and damage to the turbine shaft.

The engine examination identified that the rear nut fitted to the rear of the power turbine shaft had not been adhesively bonded, as required.

The engine would still have ceased operating if the appropriate adhesive had been present on the rear splined nut. However, the likelihood of the shaft failing would have been reduced and the failure sequence less severe. The failure sequence would likely have been extended, allowing greater time for the pilot to respond to the failing engine.

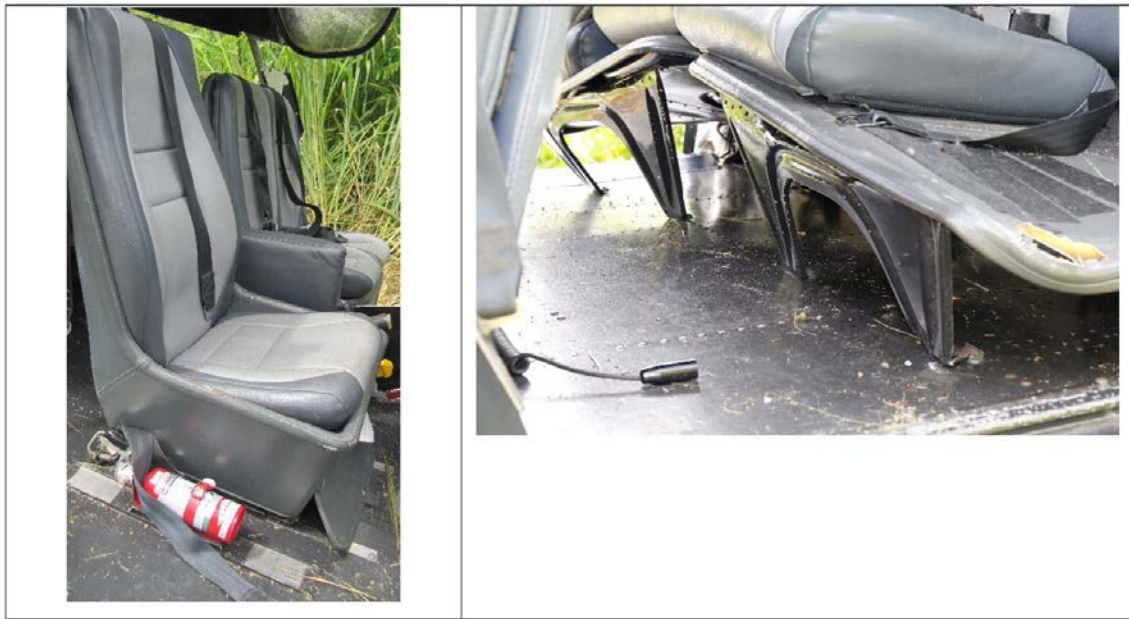
Figure 10: VH-SFX front seats (left) and rear passenger seats (right)

The helicopter was fitted with the original seats installed by the manufacturer (Figure 10). The rear passenger seats had deformed during the accident and likely absorbed some of the energy during the impact. The seat-belt attachments remained intact during the accident sequence. There was no observable deformation to the front seats of the helicopter.

The manufacturer also published a service bulletin (EC SB AS350 No. 25.00.57) recommending the installation of the energy-absorbing seats on AS350 helicopters. A European Aviation Safety Authority (EASA) safety information bulletin, SIB 2010-05, reiterated the safety benefits associated with the installation of energy absorbing seats.
