Derailment of ore train ND575

Near Tom Price, Western Australia | 15 December 2015

ATSB Transport Safety Report

RO-2015-025

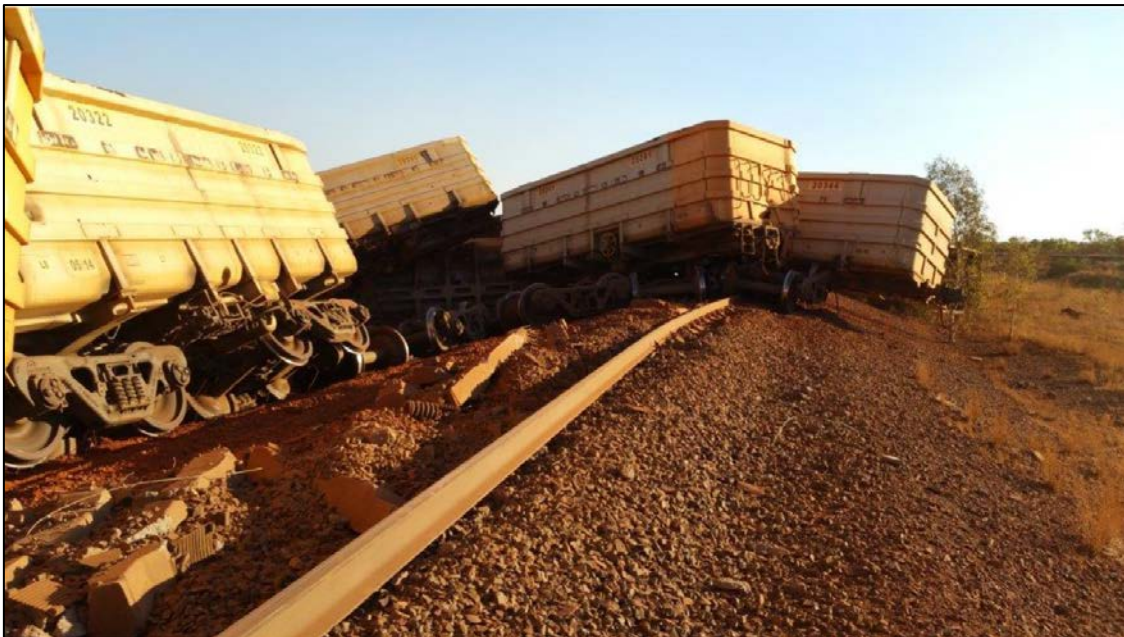
Derailed portion of train ND575, view looking north from ore car 20322

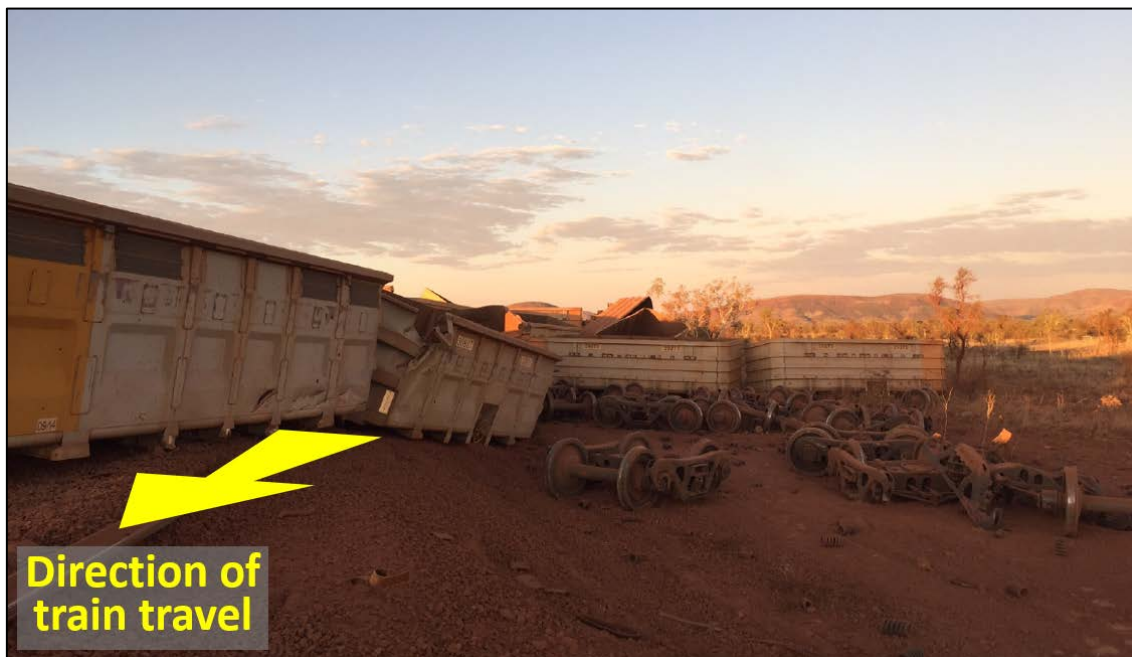
Figure 2: Derailed portion of train, ore car 35907 and 30907 in foreground near 234.500 km

On completing the inspection, he returned to the cab and communicated with train control, advising that 56-ore cars had derailed (Figure 2). The derailed wagons were located in positions 71 through to 126, and there was about 450 m of track damage.

As initially intact but derailed ore cars continued to move along the track, and bounce over sleepers, bogie wheels caused heavy damage within the four foot. This resulted in ore cars tilting to the left, dropping off their bogies, and eventually ejecting to the left side of the track. This gave rise to the multi-wagon pile-up shown at Figure 2.

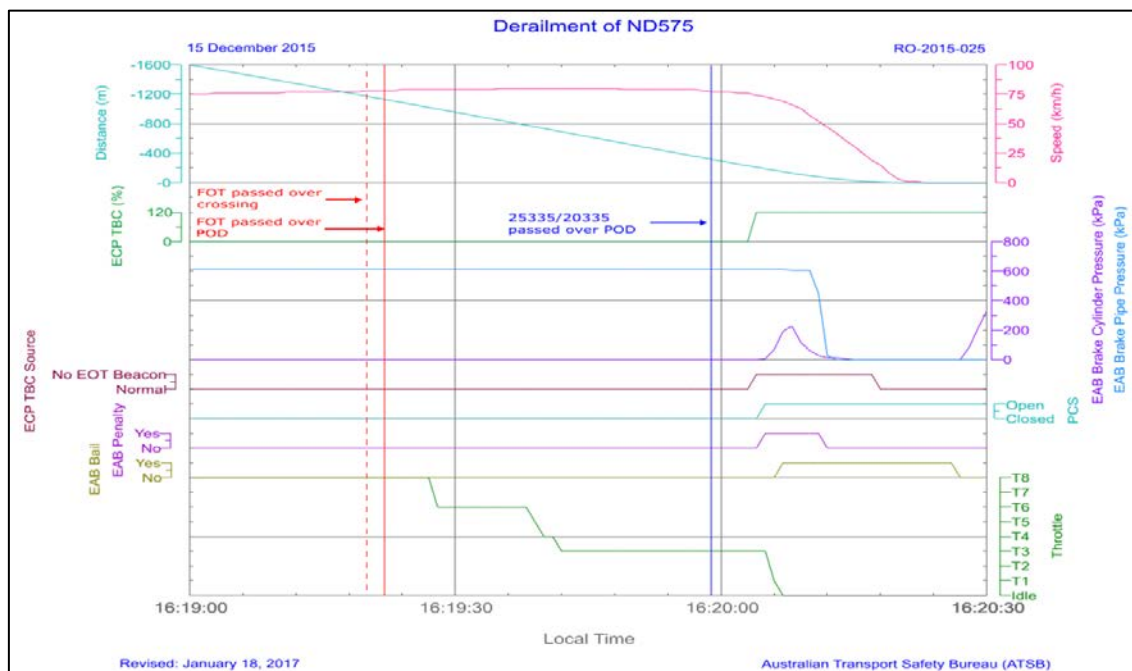
Figure 4: Graph derived from loco-log data, lead locomotive THL8180

- Train ND575 was travelling at 78 km/h (2 km/h below the permitted track speed) as it passed over the Mt Brockman Road railway crossing.
- During the period 1619:35 through to 1619:42, the driver moved the throttle from position T8 to T3 thereby maintaining a train speed below the track speed limit of 80 km/h.

- The speed of train ND575 dropped from 79 km/h (1 km/h below track speed) to 73 km/h as ore cars in the group 71 to 94 (ore cars numbered 25332 to 20353) passed over the point of derailment (PoD).

- At 1620:04, the electronically controlled pneumatic (ECP) brake parameters changed, followed by an emergency brake application.
- At 1620:06, the driver throttles off from T3 through to Idle, and bails off.

- At 1620:08, there is evidence of an initial reduction in brake pipe pressure (BPP).
- At 1620:11, there is a major BPP reduction.
- Train slowed down, coming to a stand at 1620:23, about 1 km past the PoD.

A review of loco-log data corroborated the driver's recollection of the final moments of the event, and showed that train handling, and driver performance was unlikely to have been factors that contributed to the derailment.

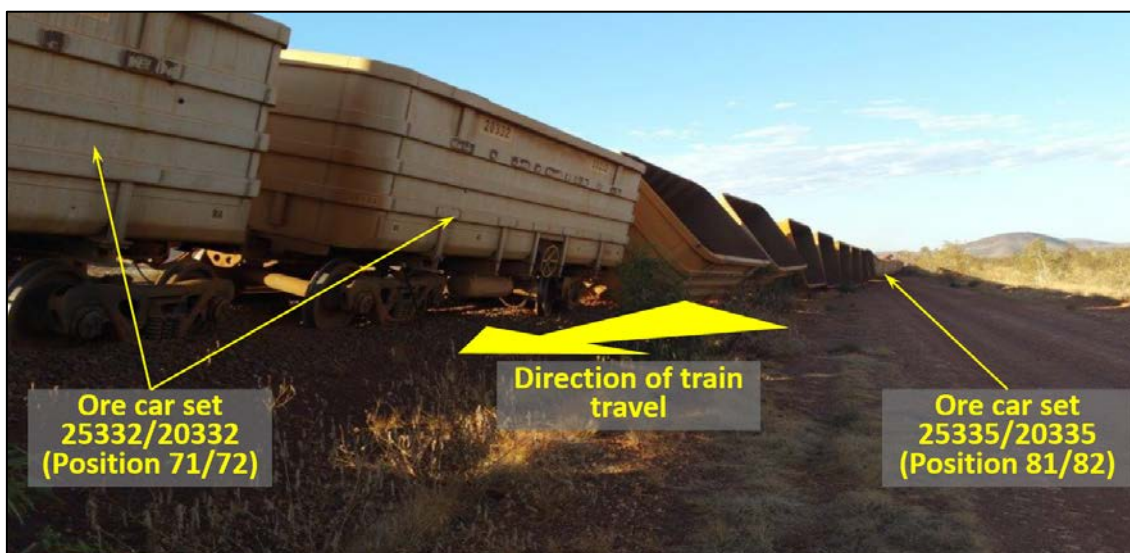
Figure 5: Looking north - derailed ore car 25332/20332 (foreground) and ore car 25355/20335 (background)

An examination of the non-corrupted data from IOC 30907 indicated a significant change in coupler forces at about the time ore car set 25335/20335 (position 81/82 - Figure 5) traversed the PoD. Based on the IOC data, and subsequent examination of damage to ore cars and the track, it was resolved that this probably coincided with the derailment event, and that ore car set 25335/20335 derailed first. Although ore car set 25332/20332 (position 71/72) was also in a derailed state, it was probably dragged off the track by ore car set 25335/20335 through to 25321/20321 (position 73/74).

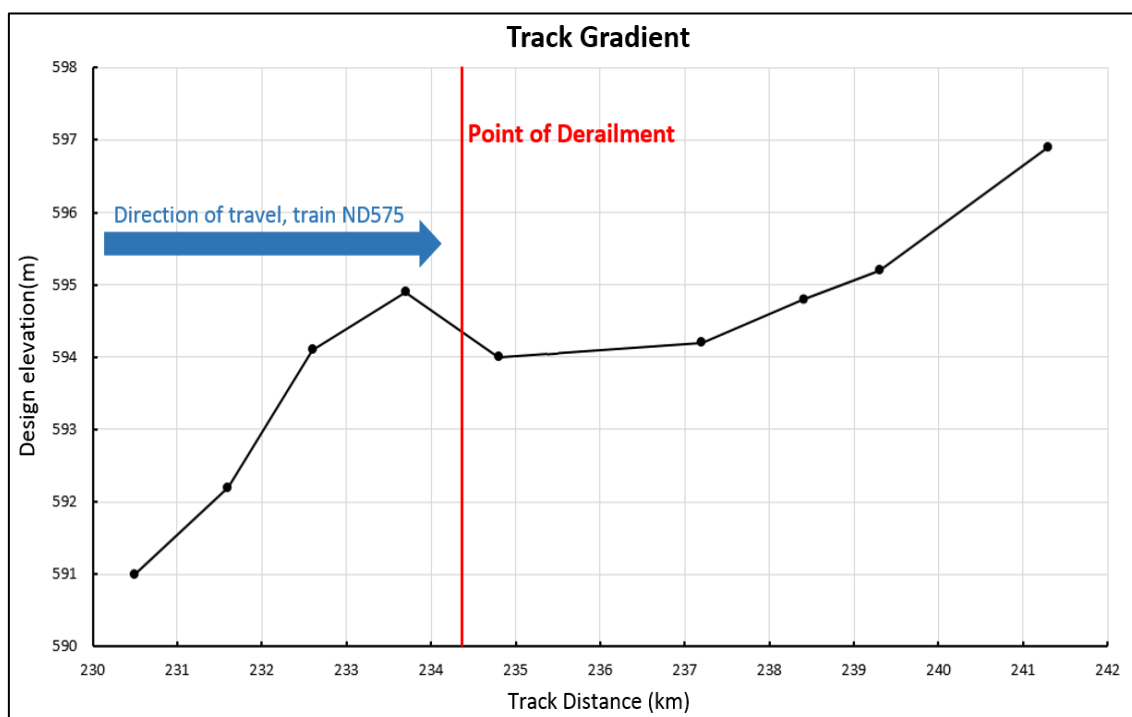
Figure 6: Design track elevation – 230 km to 242 km, showing point of derailment and direction of train travel

The derailment occurred on the east mainline just south of Possum Station (227.25 km), about 50 km north of Tom Price. The track leading into the derailment site (travelling from north to south) was straight (tangent track) and on a slight upgrade followed by a slight downgrade towards the point of derailment (Figure 6). The track comprised standard gauge (1,435 mm), 68 kg/m continuously welded rail (CWR) mounted on concrete sleepers at 650 mm centres. The sleepers had resilient fasteners (Pandrol Clips) on a nominal 200 mm layer of ballast below the sleepers.

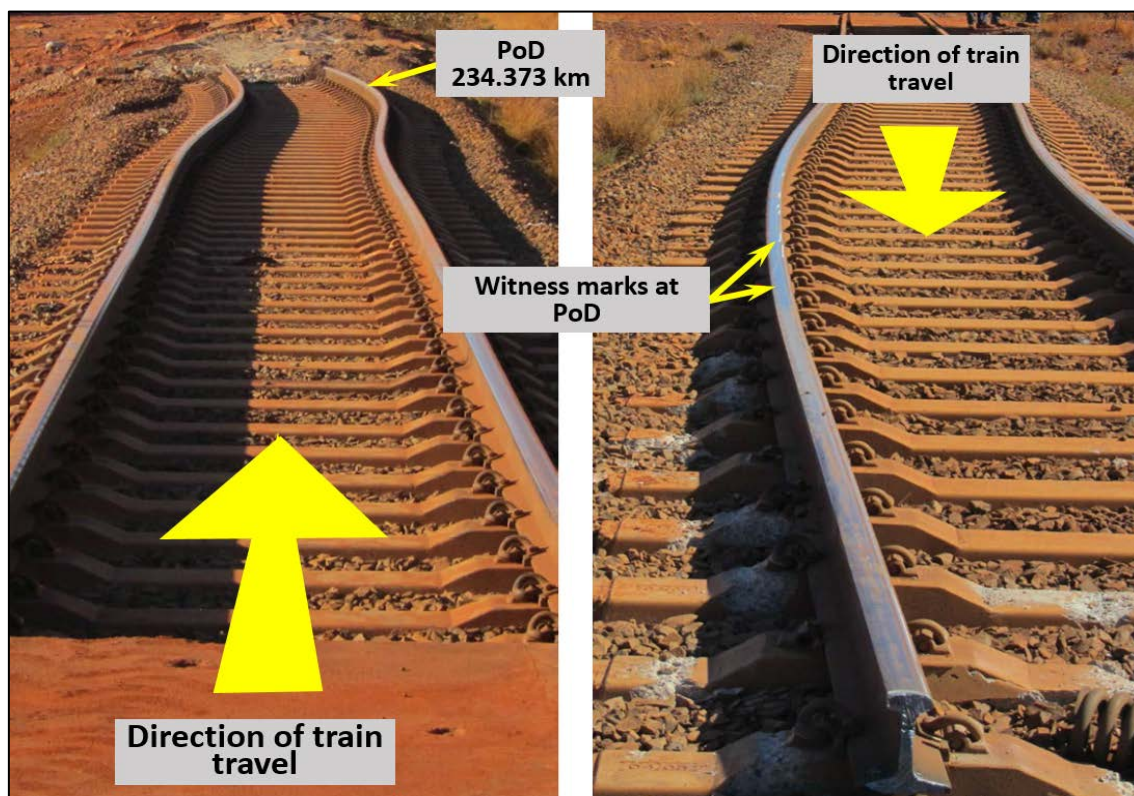
Figure 7: Witness marks at PoD (234.373 km) shown by line of arrows on railhead

The post derailment examination of evidence established that there were no apparent signs of track spread at or before the PoD, so gauge widening was discounted. Similarly, there were no signs of any broken/fractured rail immediately at or before the PoD. The track near the PoD (Figure 7) showed evidence of a significant horizontal displacement of the track to the right, in the direction of train travel, and was indicative of a track misalignment/buckling event. The railhead⁶ at 234.373 km (Figure 7 – right image) showed evidence of wheel flange climb⁷ on the right side running rail (direction of travel) followed by witness marks (about 4 – 5 m in length) consistent with a wheel flange crossing the railhead.

Damage to sleepers (Figure 7– right image and Figure 8) was only evident after the point where the wheel(s) dropped off the railhead. Beyond the drop-off point, the wheels and bogies of derailed ore cars advancing along the track progressively damaged the track structure, both within the four foot,⁸ and to the right side of the track (direction of travel).

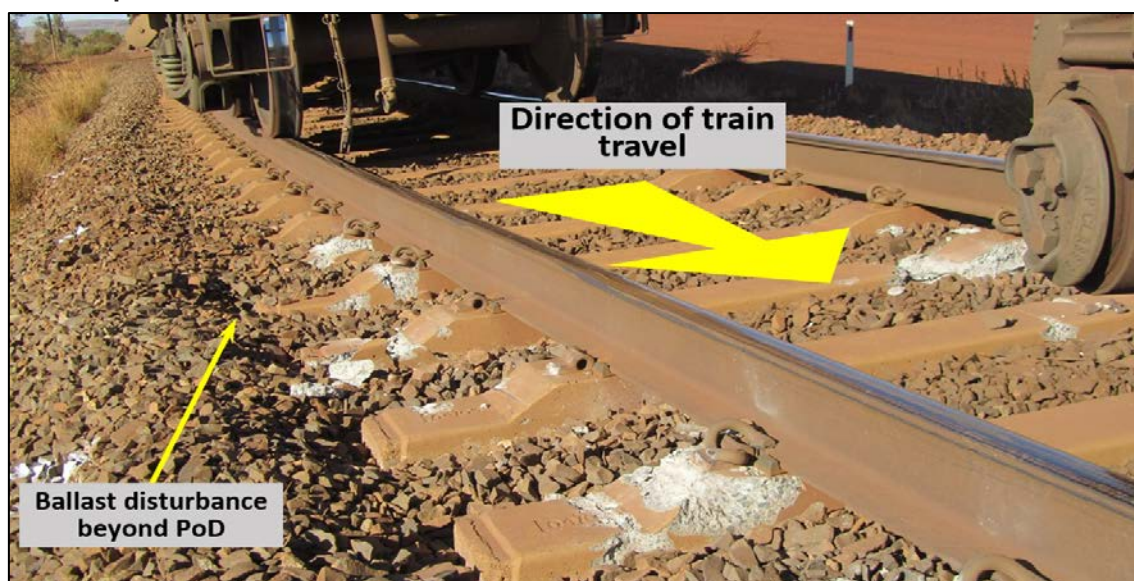
Figure 8: Ballast condition before PoD indicate profile and quality in accordance with Rio Tinto requirements

The ATSB assessed the ballast and ballast profile for compliance against Rio Tinto standards using photographs and other information provided by Rio Tinto. The amount of ballast (Figure 8) within the cribs,⁹ and the shoulder¹⁰ width and height was all in accordance with requirements. There was no indication of ballast fouling at or near the derailment site.

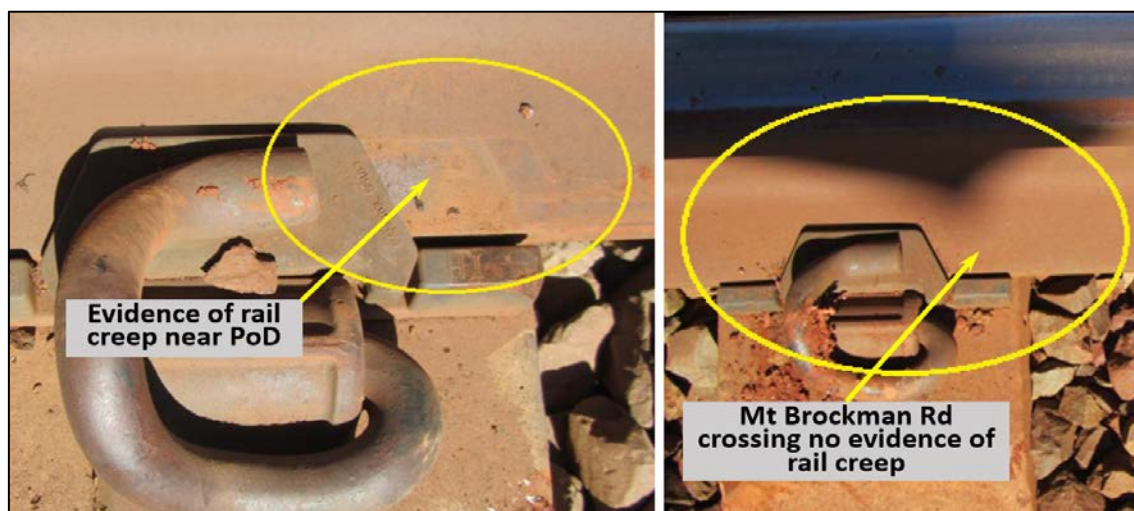
Figure 9: Evidence of rail creep through resilient fastener at PoD

While the track leading into the derailment was in good condition, there was evidence of rail creep¹¹ (Figure 9 – left image) between the PoD and the Mt Brockman Road railway crossing. The observed rail creep was in a northerly direction, that is, from the PoD towards the Mt Brockman Road railway crossing, which was acting as a fixed point. There was no observed rail creep at and to the north of the crossing (Figure 9 – right image).

During the period 19 November through to 13 December 2015, 666 loaded ore trains travelled in a northerly direction on the east mainline, compared to just 16 empty trains travelling in a southerly direction. The predominant traffic tonnage was therefore travelling north towards the Mt Brockman Road railway crossing. These loaded ore trains were also approaching the railway crossing on a slight downhill gradient and in trying to maintain a track speed of 80 km/h were probably braking. Therefore, with trains braking and the predominant traffic tonnage into the crossing, this would cause rail bunching (high compressive forces) on the southern side of the crossing.

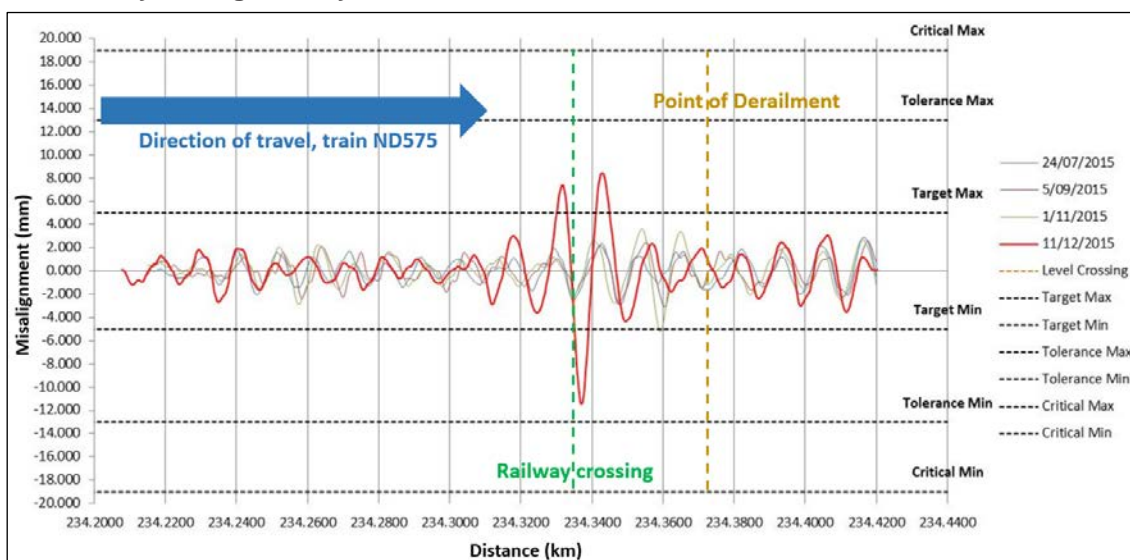
Figure 10: Graph showing growth of horizontal track misalignment at PoD from data obtained by track geometry car US6.

- Regularly inspected by track patrol (road/rail vehicle). The last inspection was on 12 December 2015, three days before the derailment. No defects were identified.
- Regularly examined using a track geometry car US6. The last inspection was on 11 December 2015 (Figure 10 – red line), four days before the derailment. While the red line in Figure 10 shows that there was evidence of a growing horizontal track misalignment at the railway crossing, the magnitude of the misalignment was well below the Rio Tinto maintenance intervention limit (Figure 10 – ‘Critical Max’).

Rio Tinto advised that they do not usually record the date of on-train inspections, and therefore, could not advise if the last on-train inspection was done within the six-month period leading up to the derailment. However, Rio Tinto had an established process for monitoring track condition through a range of parameters (longitudinal, vertical and lateral acceleration) that indicated the ride quality of the fleet of IOCs. This data was progressively being optimised, by Monash University (Victoria) for Rio Tinto, to assist with the determination and evaluation of track irregularities. The setting and monitoring of pre-determined IOC track irregularity limits was intended to allow Rio Tinto to instigate site inspections on an as required basis to enable a maintenance response strategy before exceedances are reached.

- Update the track geometry condition management process to consider minor irregularities in multiple geometry parameters.
- Utilise the instrumented ore car fleet for identification of sites at risk of rapid failure due to deterioration of minor irregularities in multiple ore car response parameters.
- Develop and implement an improved rail stress management process.
- Implement a tonnage balance strategy and deviation authority process.
