Collision with water in dark-night conditions involving Robinson R22 helicopter, VH-YLY

6 km south of Cape Tribulation, Queensland | 7 April 2016

ATSB Transport Safety Report
Aviation Occurrence Investigation
AO-2016-031
Final – 18 December 2017

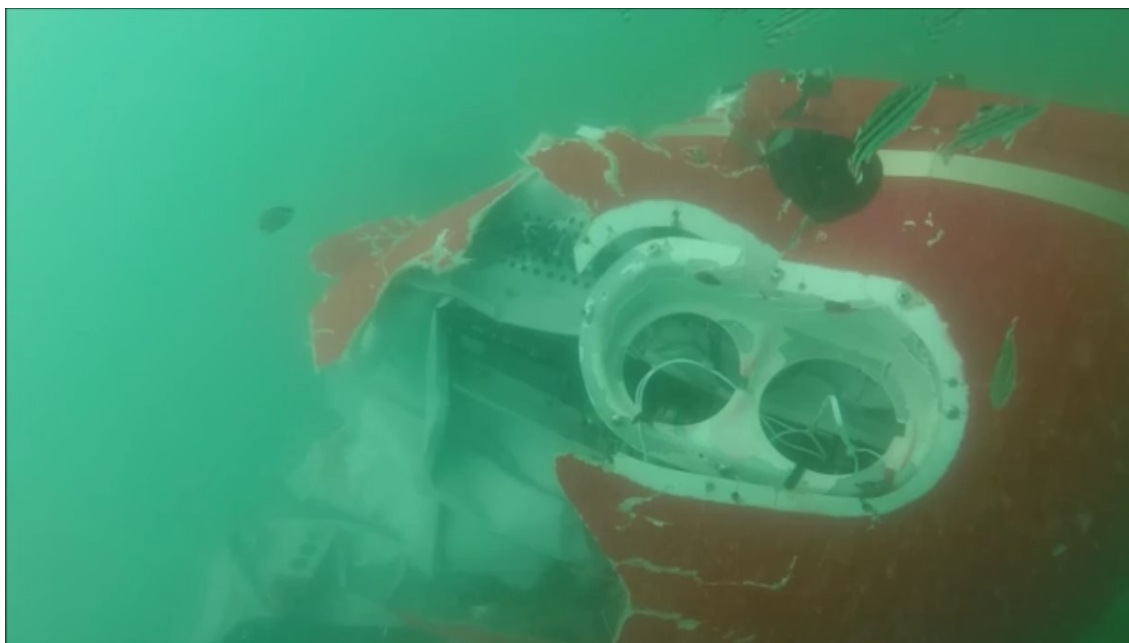
Figure 2: Underwater image of VH-YLY showing significant damage to the nose and belly panel of the helicopter particularly to the right forward section and loss of the cockpit upper portion

Extensive damage to the right side of the helicopter, including the pilot's seat belt fitting found torn from its mount, indicated a significant right-side impact with the water. The main rotor blades and transmission were present and similarly damaged. The tailboom was not identified in the footage and it likely became detached during the accident sequence. The damage to the helicopter and rotor system was consistent with powered flight into the water.
