Descent below segment minimum safe altitude during a non-precision instrument approach involving Airbus A320, PK-AXY

17 km WSW Perth Airport, Western Australia | 19 February 2016

AO-2016-012

Final – 16 January 2018

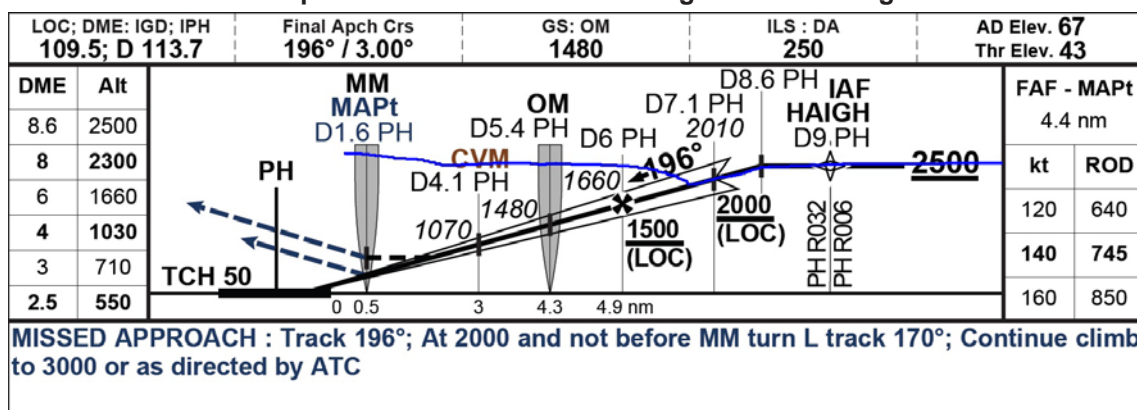
The flight crew recognised the increasing engine thrust and airspeed but they did not understand why it occurred. The captain told the first officer, 'make a go-around'¹⁷ and then advised ATC that they were conducting a go-around. From 2144:57, there was a period of 25 seconds where dual sidestick control inputs occurred. During this time, the autopilot automatically disengaged and the captain disconnected the autothrust system.¹⁸ The recorded data indicated that neither the captain nor first officer pressed the priority takeover button¹⁹ during this period. The captain recalled that at about 2,500 ft, at the flap 0 speed, he stated 'okay, my control' and took over as PF with the first officer taking the PM responsibilities. Recorded data indicates the captain had sole control of the aircraft at 2145:24, at an altitude of about 2,500 ft.

Figure 2: Profile view of the runway 21 ILS approach with aircraft flight profile (blue). The aircraft was on the ILS profile until the increase in engine thrust and go-around

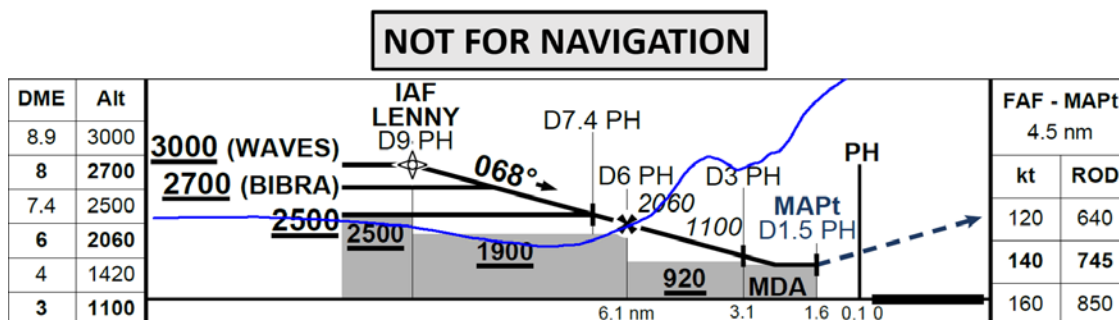
To assist in locating the runway, the first officer asked ATC if they were on the 'left side of the runway or right side of the runway'. At about the same time, the ATC radar displayed a minimum safe altitude warning (MSAW). In response, the approach controller instructed the flight crew to 'go round, you are low, low altitude alert, go round'. The flight crew acknowledged the alert and immediately conducted a missed approach. The aircraft had descended to an altitude of 1,473 ft, before the climb was initiated, which was about 400 ft below the segment minimum safe altitude (Figure 3). Aircraft track and flight data for the approach is available in Appendix B.

Figure 3: Profile view of first runway 06 VOR approach with aircraft flight profile (blue). The flight profile shows the crew descending the aircraft below the 2,500 ft segment minimum safe altitude and continuing below the 1,900 ft segment minimum safe altitude before conducting a go-around.

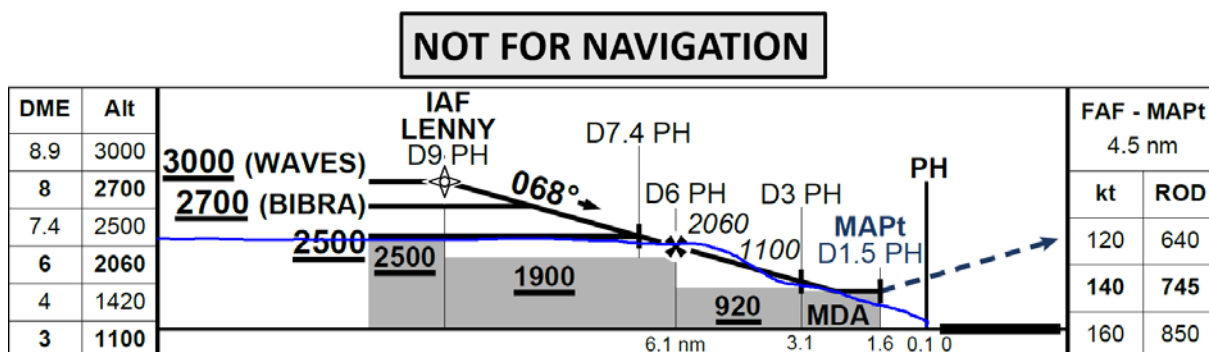
Due to the late commencement of the descent from 2,500 ft, the aircraft exceeded the recommended rate of descent (700 ft/min) for the aircraft's groundspeed until 1,100 ft above the height of the runway threshold. In addition, the aircraft's rate of descent was greater than 1,200 ft/min²⁷ for a period of 40 seconds, from an altitude of about 2,100 ft to 1,200 ft. In this period, the rate of descent averaged 1,380 ft/min. When the aircraft was 1,000 ft above the height of the runway threshold, the rate of descent was below 700 ft/min. For a period of 22 seconds, from 430 ft to 120 ft above ground level (AGL), the aircraft's vertical speed exceeded 700 ft/min and increased to a maximum of 1,100 ft/min. As this decent rate was below 1,200 ft/min, it did not require a callout by the first officer. At 300 ft AGL, the engine thrust reduced briefly to idle and at this point, the aircraft did not meet the stabilised approach criteria. Aircraft track and flight data for the approach is available in Appendix C.

Recorded flight data indicated dual sidestick control inputs occurred, one at 300 ft AGL for one second, then three times from 120 ft AGL until landing with durations of 3 to 5 seconds, these inputs would have resulted in a dual control input alert. However, the aircraft landed without further incident.

Figure 4: Profile view of second runway 06 VOR approach with aircraft flight profile (blue)

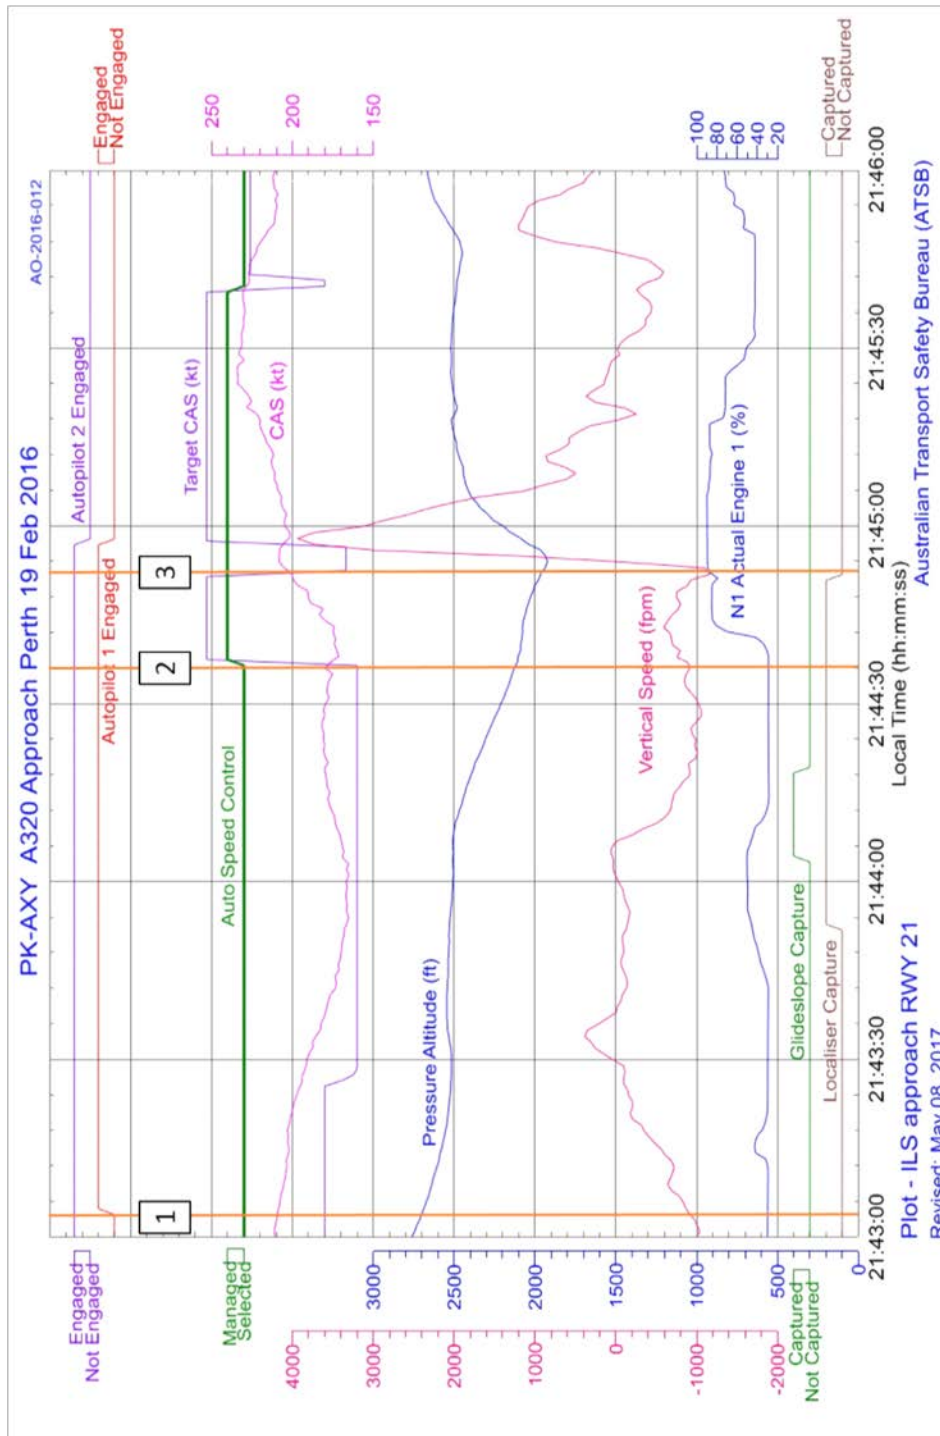
When the flight crew engaged AP1 during the first approach, they did not recognise that the subsequent cabin pressure fault was related to the engagement of AP1 and its utilisation of FMGC1 data. Additionally, the crew did not realise that the FMGC1 target speed at the time of failure (253 kt) would be utilised when the speed mode was changed from a selected mode (which had a target speed of 160 kt at the time), to a managed mode after AP1 was engaged.

Figure A2: Flight data showing autopilot and mode selections with a resulting thrust and speed increase during the runway 21 ILS approach. The descent depicted is from 3,000 ft to 2,000 ft.

- Note:
1. At 2143:04 AP1 was engaged
 2. At 2144:37 the auto speed was changed to a managed mode resulting in an increase in the target airspeed (to 253 kt)
 3. At 2144:51 the go-around was initiated

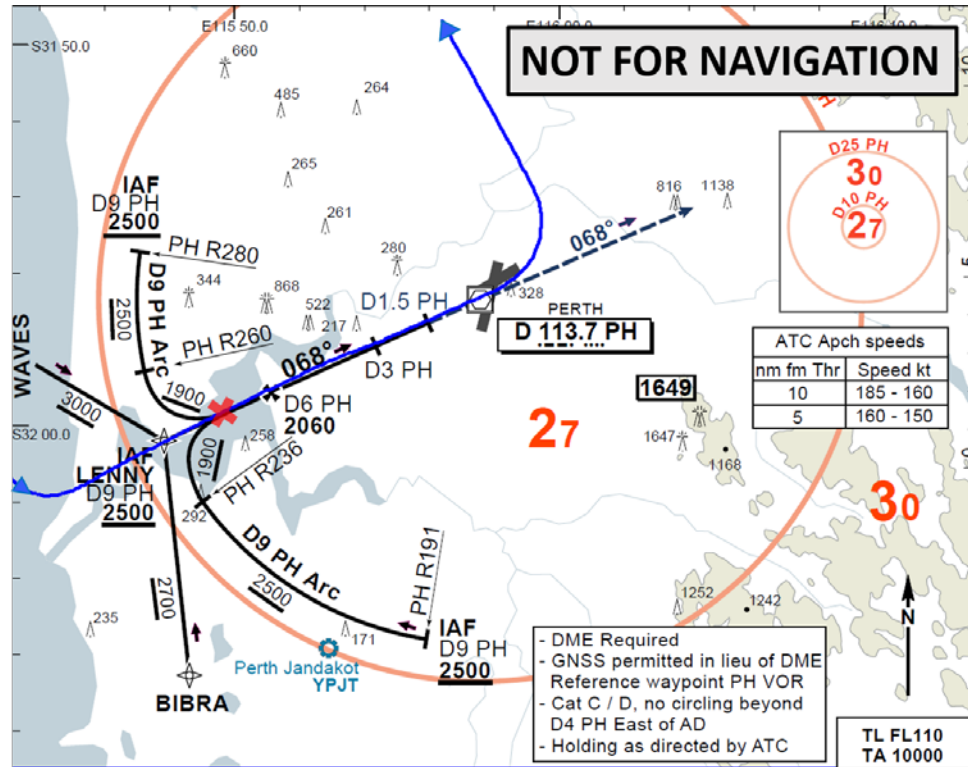
Figure B1: First runway 06 VOR approach with aircraft track (blue) and approximate location of go-around (red cross)

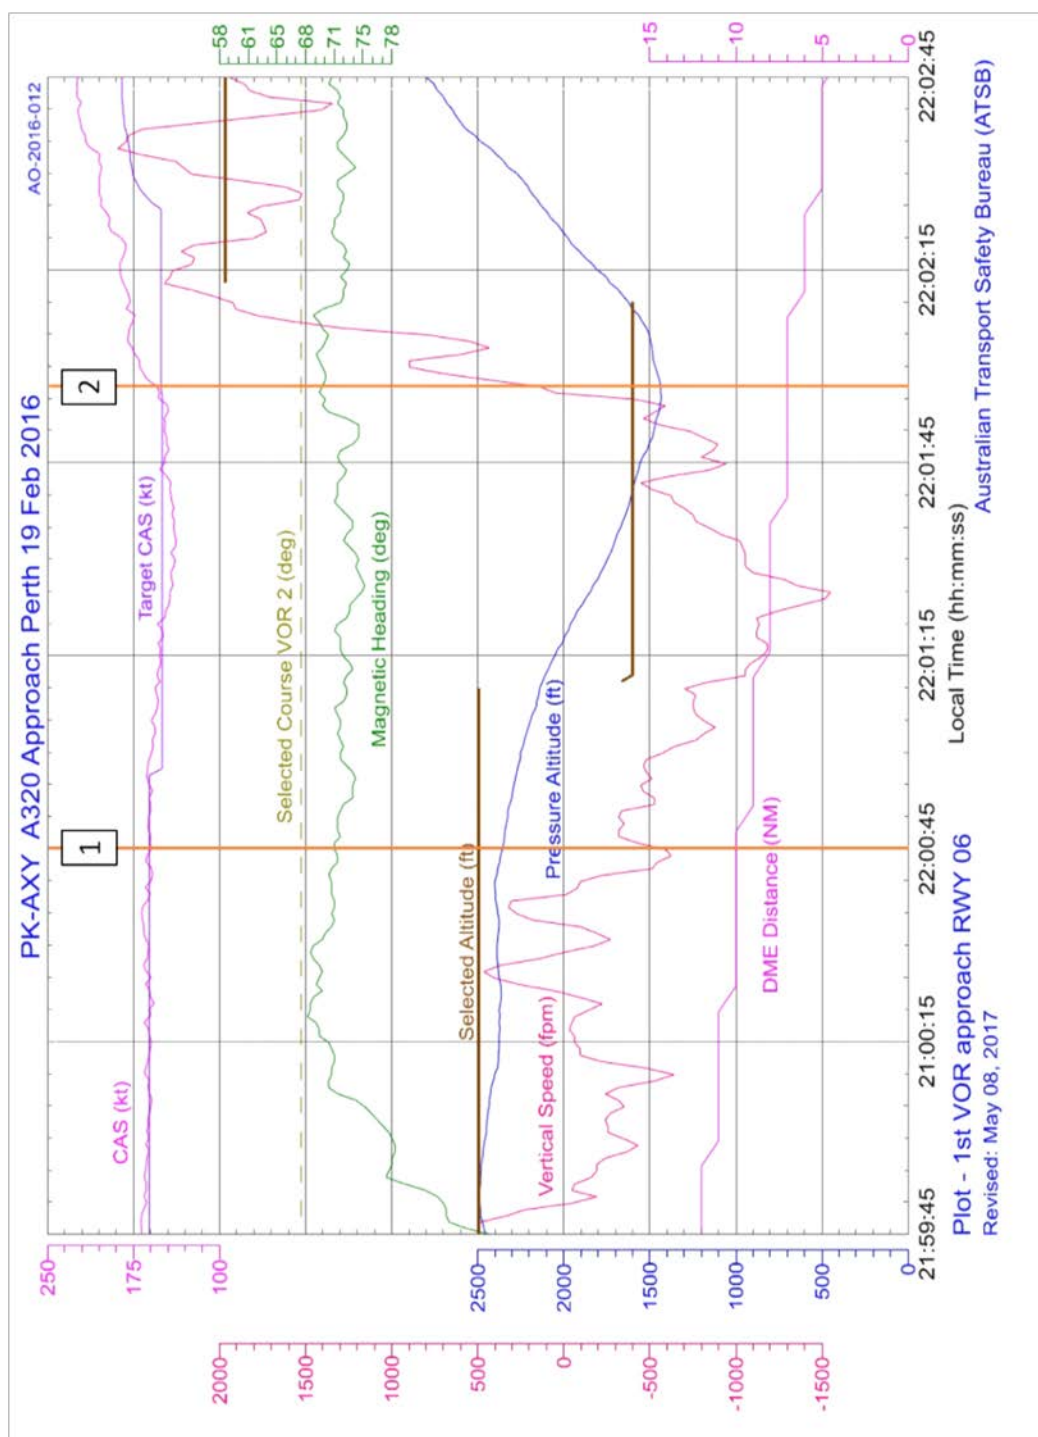
Figure B2: Flight data from first runway 06 VOR approach from 2,500 ft to 1,473 ft

Note: 1. At 2200:45 descent initiated

2. At 2201:57 the go-around was initiated, at an altitude of 1,473 ft

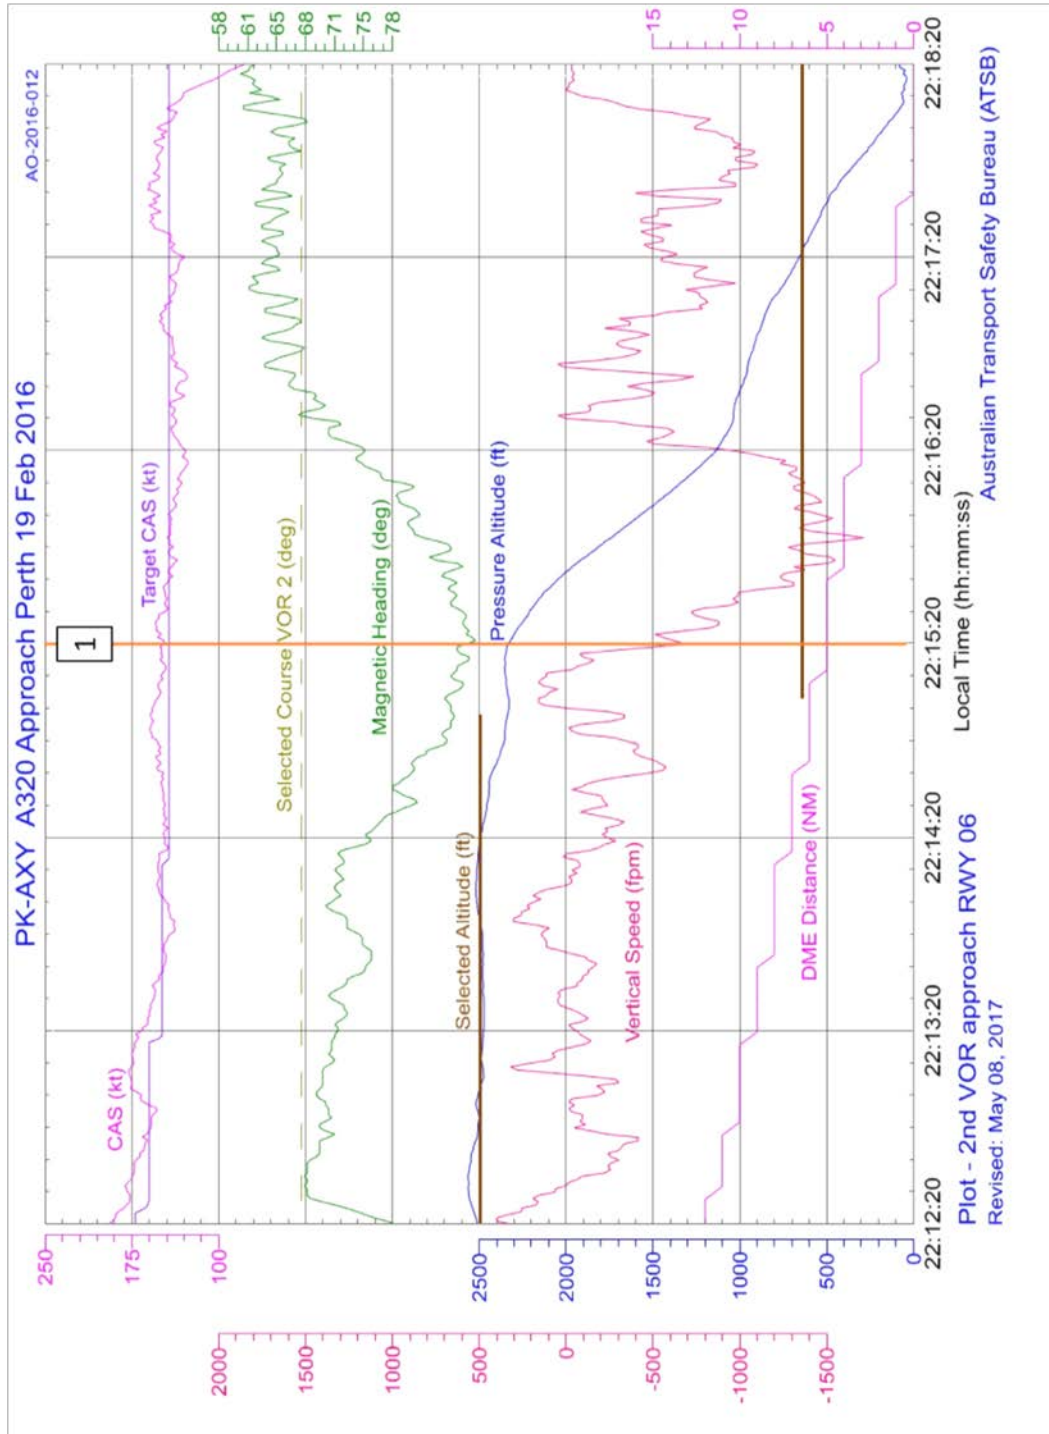
Figure C2: Flight data from second runway 06 VOR approach from 2,500 ft to landing

Note: 1. At 2215:20 descent was initiated, at about 5 DME
