Collision with water involving de Havilland Canada DHC-2 Beaver aircraft, VH-NOO, at Jerusalem Bay, Hawkesbury River, NSW on 31 December 2017

ATSB Transport Safety Report
Aviation Occurrence Investigation
AO-2017-118
Preliminary – 31 January 2018

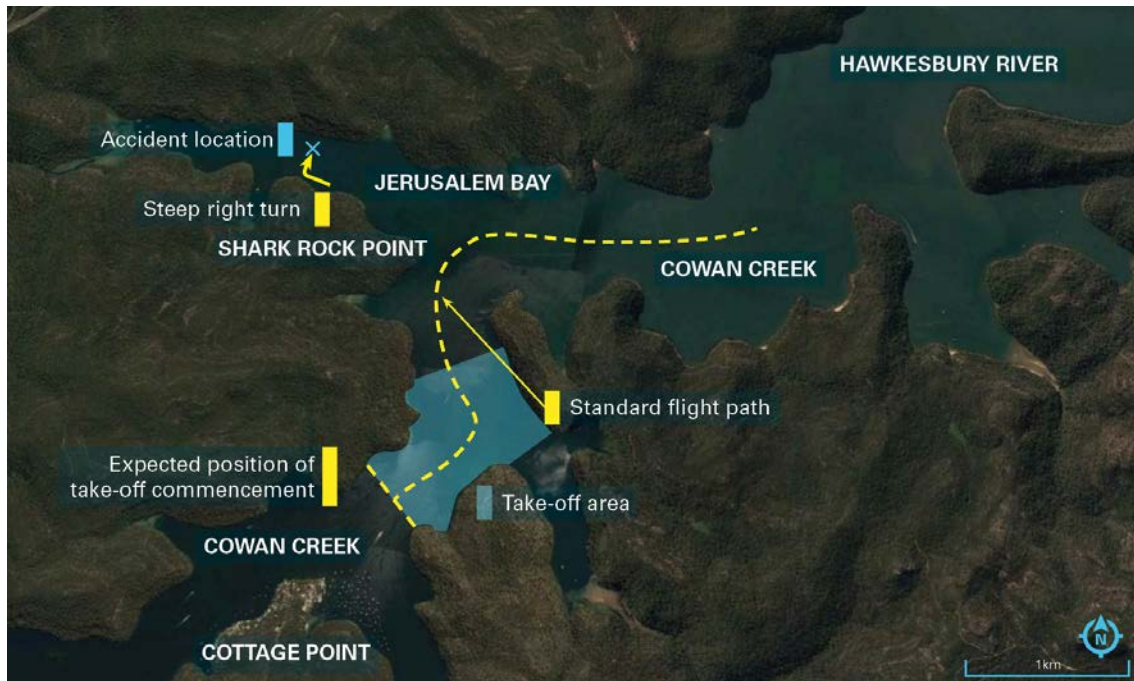
Figure 1: Cottage Point area, standard flight path and accident location

The operator reported that the aircraft's expected and standard flight path³ after departing Cottage Point was to climb initially to the north then turn right along Cowan Creek toward the main body of the Hawkesbury River, until sufficient altitude was gained to fly above terrain and return to Rose Bay (Figure 1). While the exact take-off path from Cottage Point has yet to be established, the aircraft was observed by witnesses to enter Jerusalem Bay (Figure 1). The aircraft was observed to enter the bay at an altitude below the height of the surrounding terrain (Figure 2). Several witnesses also reported hearing the aircraft's engine and stated that the sound was constant and appeared normal.

Shortly after entering Jerusalem Bay, numerous witnesses reported seeing the aircraft suddenly enter a steep⁴ right turn and the aircraft's nose suddenly drop before the aircraft collided with the water in a near vertical position. The aircraft came to rest inverted and with the cabin submerged. Witnesses reported the entire tail section and parts of both floats were initially above the waterline. The aircraft took over 10 minutes to completely submerge. A quantity of fuel was also observed in the water. A number of witnesses who heard or observed the impact responded to render assistance. All six occupants received fatal injuries.

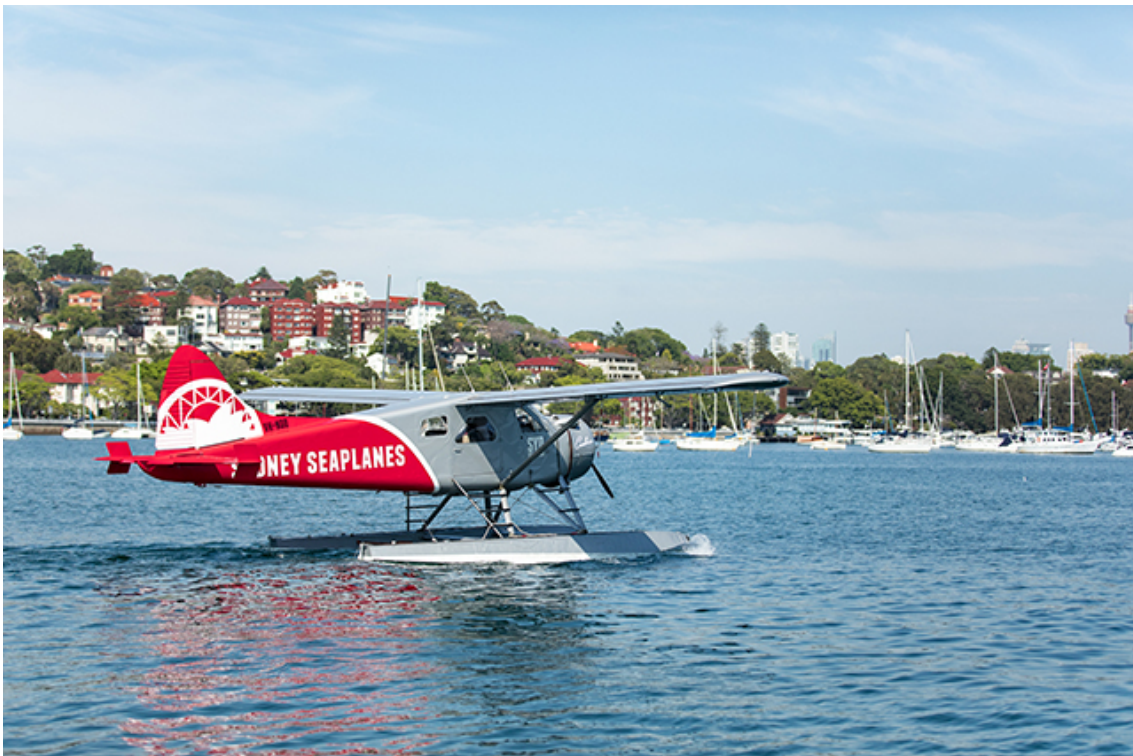
Figure 3: de Havilland Canada DHC-2 Beaver floatplane, registered VH-NOO

The float-equipped DHC-2 Beaver is a predominately all-metal high-wing aircraft designed to carry one pilot and seven passengers. VH-NOO was manufactured in 1963 and first registered in Australia in 1964 (Figure 3). Viking Air (Canada) has been the type certificate holder since 2006. The aircraft was powered by a Pratt & Whitney 'Wasp Junior' R-985 nine-cylinder, single-row, air-cooled radial engine, which drove a Hartzell HC-B3R30-4B three-blade propeller. The aircraft was operated in the charter category.

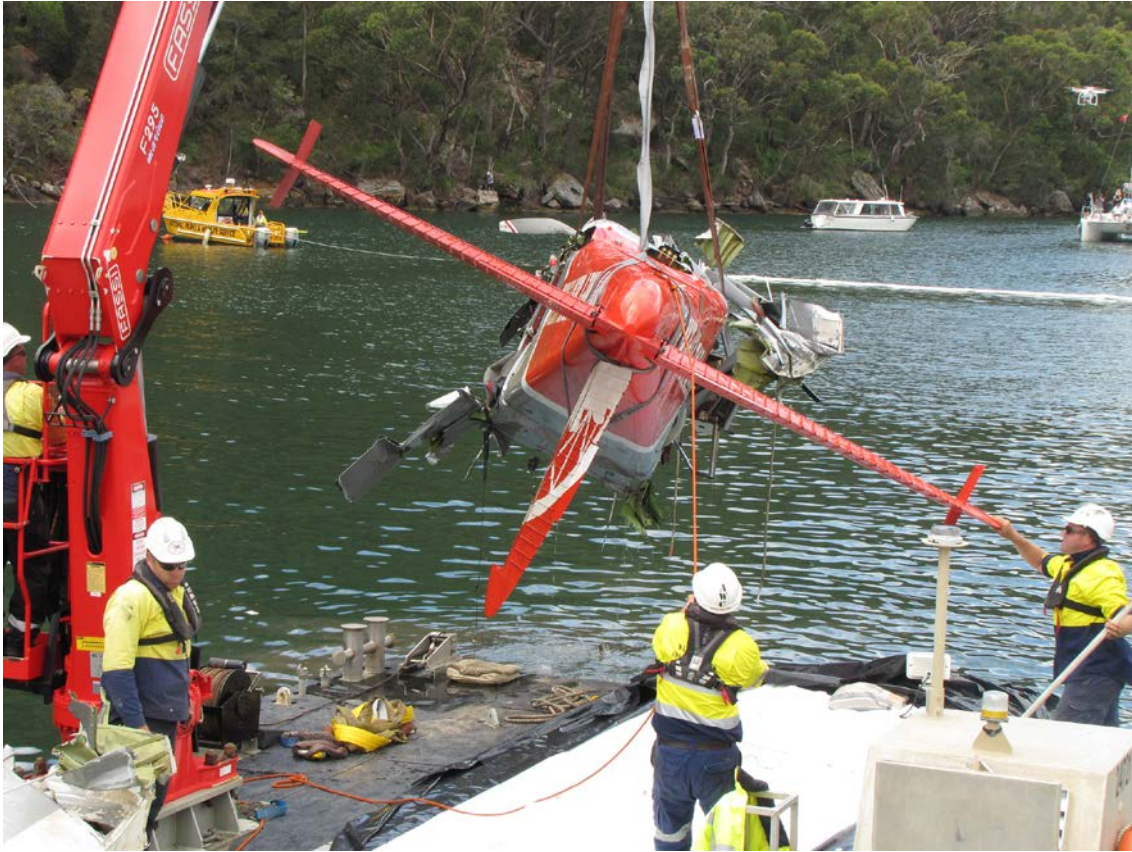
Figure 4: VH-NOO recovery from Jerusalem Bay

On 4 January 2018, the aircraft was recovered from the water, where it was established that both wings and floats had become separated from the fuselage (Figure 4). The aircraft was retrieved during three 'secure and lift' operations undertaken by the New South Wales Police Force Diving Unit and a barge operated crane crew. These were:

- all major sections of the aircraft structures were recovered
- no evidence of a birdstrike or collision with an object prior to take-off or in-flight
- no evidence of an in-flight break-up or pre-impact structural damage
- the front of the aircraft and float tips had been significantly damaged
- both the wings and floats had separated from the fuselage during the impact sequence
- damage to wings was consistent with the aircraft being banked to the right at the time of impact
- flight control continuity throughout, indicating no evidence of flight control issues⁶
- the flaps were in the 'climb' position of 15 ± 1 degrees
- there was no cockpit voice or flight data recorder (nor was there a regulatory requirement for an aircraft this size to be fitted with one)
- there was no commercial video recording equipment fitted to the aircraft.
