Tailstrike and runway overrun Airbus A340-541, A6-ERG

Melbourne Airport, Victoria | 20 March 2009

ATSB Transport Safety Report
Aviation Occurrence Investigation
AO-2009-012
Final

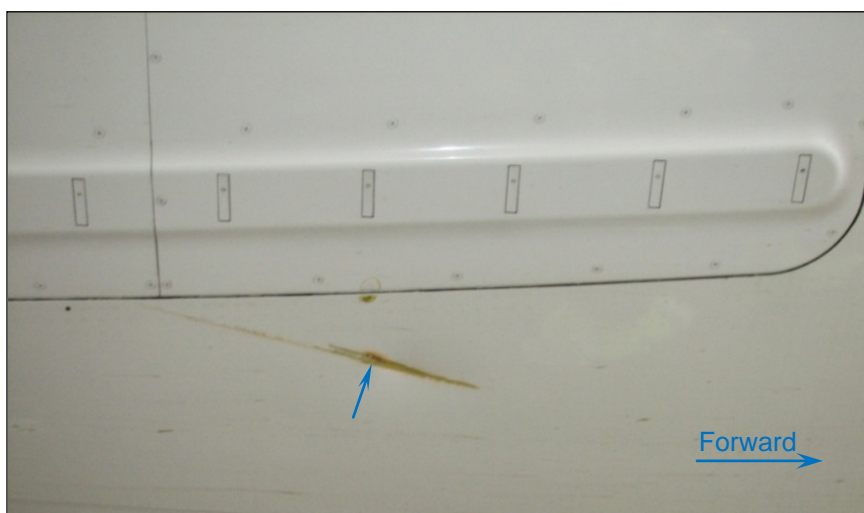
The right side rear fuselage contained several contact marks. One contact mark, forward of the abraded area and immediately below the rear cargo door (Figure 4), was orange in colour consistent with the orange paint on the localiser near-field monitor antenna. Another contact mark was located adjacent to the skin abrasion and consisted of several fine, divergent marks running rearwards and slightly upwards (Figure 5).

Figure 4: Contact mark below rear cargo door

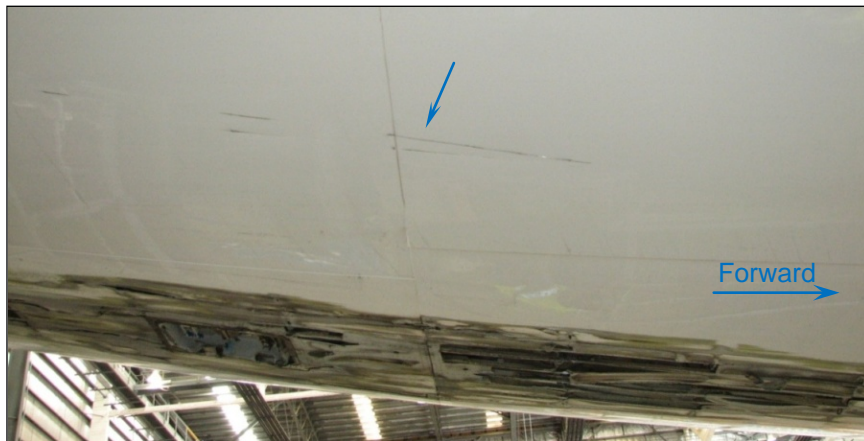
Figure 5: Contact marks adjacent to the skin abrasion

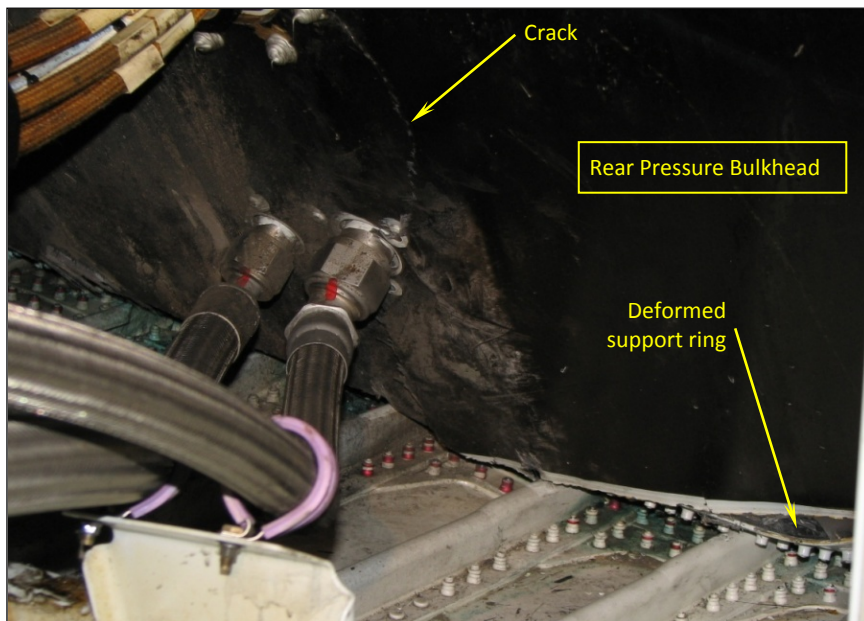
Numerous fuselage frames and stringers in the rear fuselage area were damaged by the abrasion and contact forces during the tailstrike. The damaged frames were deformed and several were cracked. The composite rear pressure bulkhead¹² had cracked, and the bulkhead diaphragm support ring was deformed (Figure 6).

Figure 6: Example of rear pressure bulkhead damage

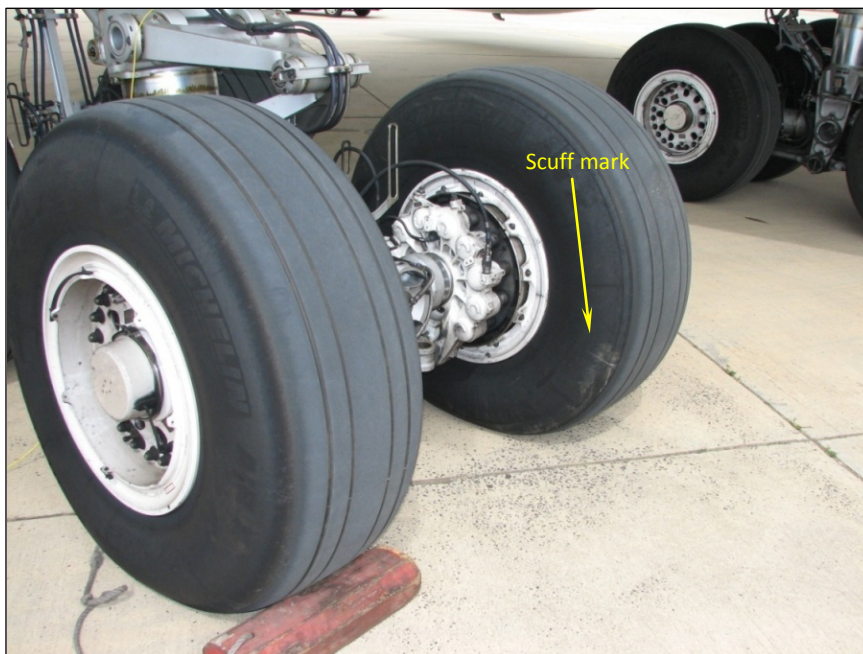
The inboard rear tyre on the left main landing gear had a scuff mark on its sidewall (Figure 7). The mark contained transferred material that was the same orange colour as the localiser antenna system.

Figure 7: Contact mark on the left main landing gear, inboard rear tyre

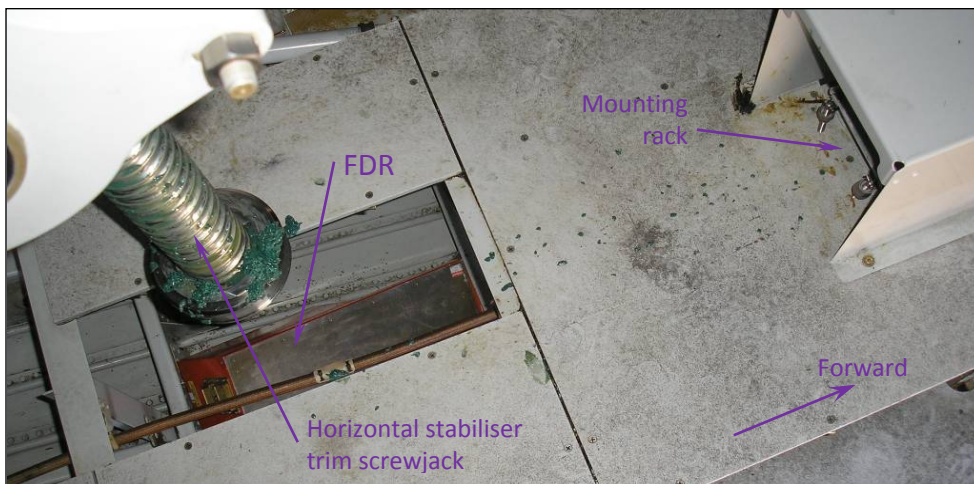
The flight data recorder (FDR) was dislodged from its mounting rack immediately behind the rear pressure bulkhead and was found lying on the lower fuselage skin below and slightly to the rear of the mounting rack (Figure 8). The FDR was undamaged and contained recorded data from the commencement of the take-off roll until the dislodgement at 2232:05. The results of an examination of the FDR rack are at Appendix A.

Figure 8: Location of the dislodged FDR and its mounting rack

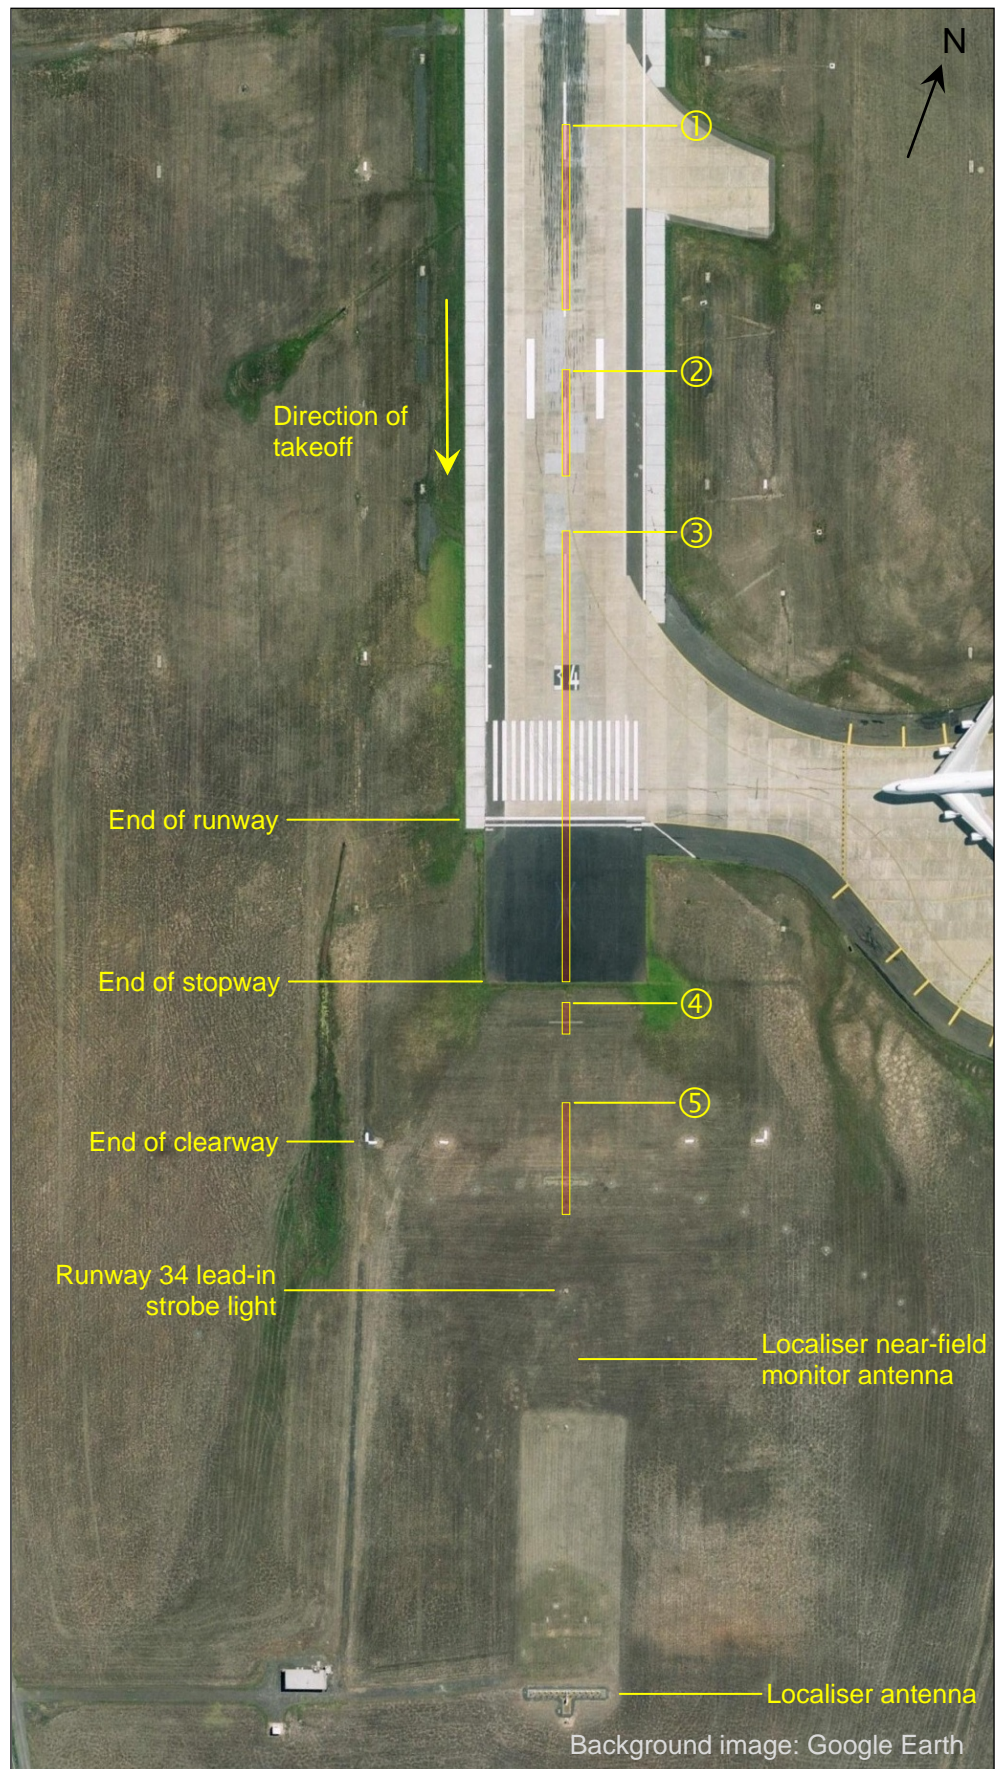
An inspection of the runway, stopway, clearway, and overrun areas identified multiple contact marks, consistent with the tailstrike and overrun (Figure 9). The aircraft's tail contacted the runway at three locations, starting at 265 m, 173 m, and 110 m from the end of the runway, respectively (indicated by ①, ②, and ③ in

Figure 9: Ground contact marks

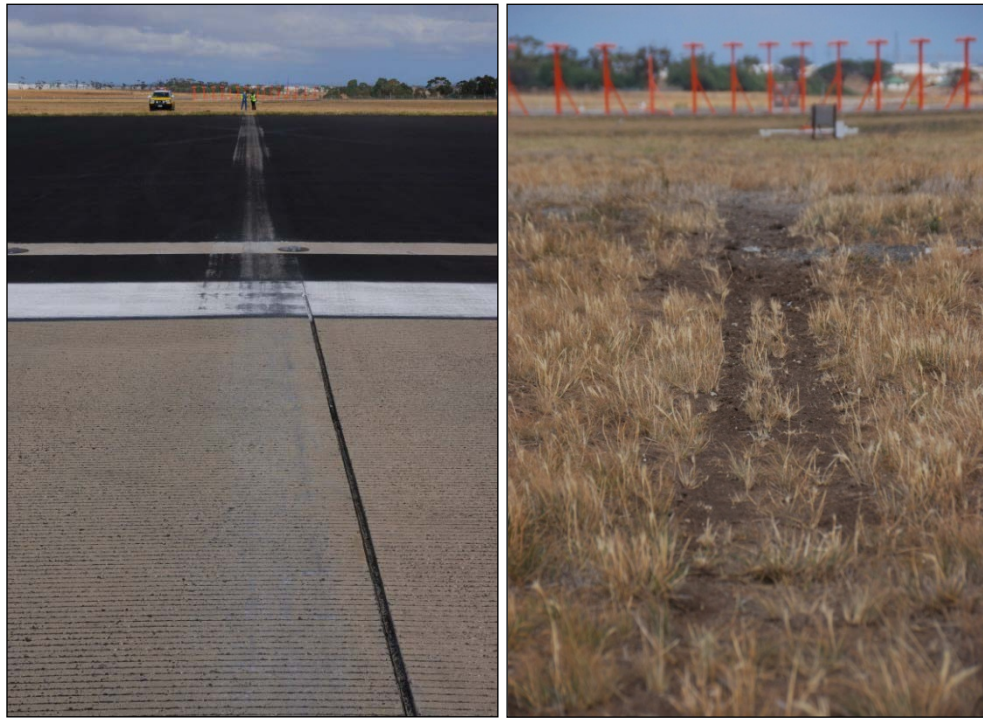
Figure 10: Typical contact marks on runway, stopway and grassed areas

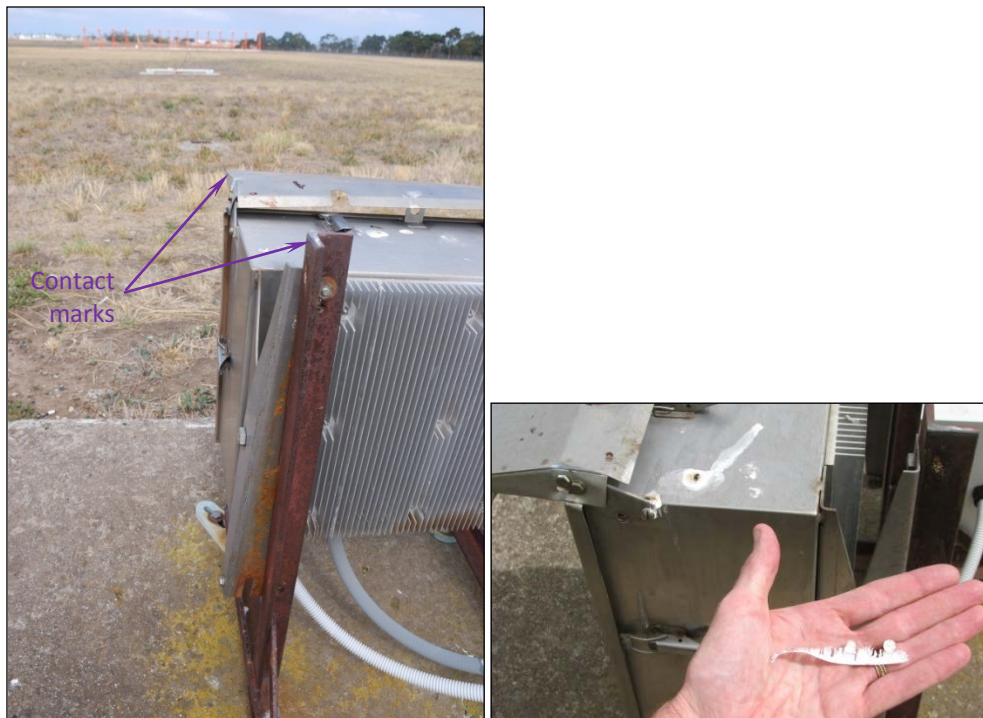
To the south of the last ground contact mark, the fuselage contacted the runway 34 lead-in strobe light that was closest to the runway 16 end (Figure 11). That contact was slight and resulted in scrape marks on the support post and slight deformation of the lens shield. A small strip of white paint was located adjacent to the strobe light (Figure 11).

Figure 11: Lead-in strobe light

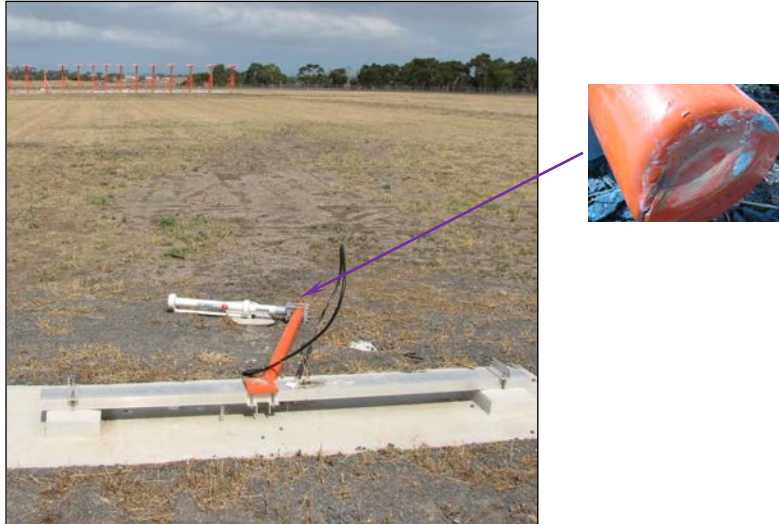
The aircraft struck the runway 16 localiser near-field monitor antenna and the main localiser antenna array. The localiser near-field monitor antenna support post was fractured at the base and fell in the approximate direction of takeoff (Figure 12). The antenna was damaged and the top of the support post was indented and exhibited white paint transfer.

Figure 12: Localiser near-field monitor antenna

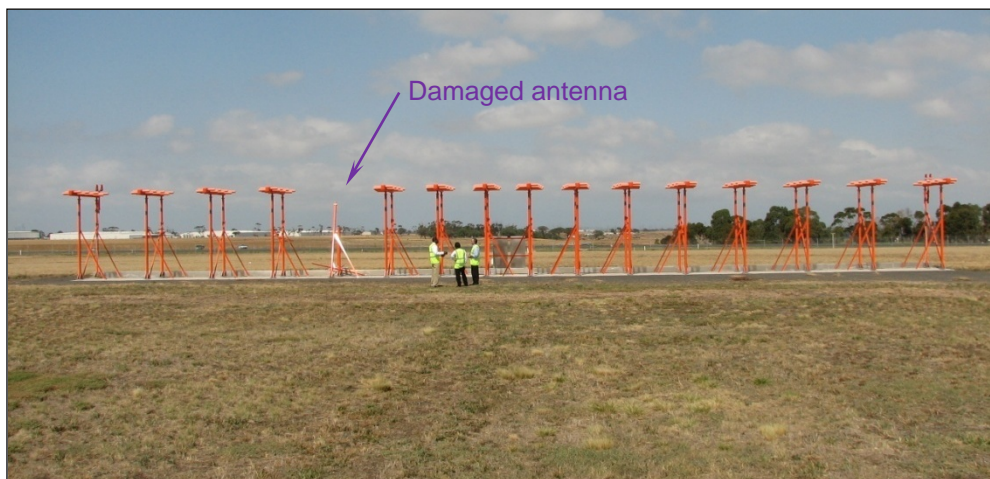
Damage to the localiser antenna array was limited to one of the 16 antennae (Figure 13). The forward (runway) end of the damaged antenna was deformed and the composite cover was severely disrupted. The top of the forward end of the antenna had a black, rubber-like marking and the deformation of the antenna was consistent with an impact (Figure 14).

Figure 13: Localiser antenna array

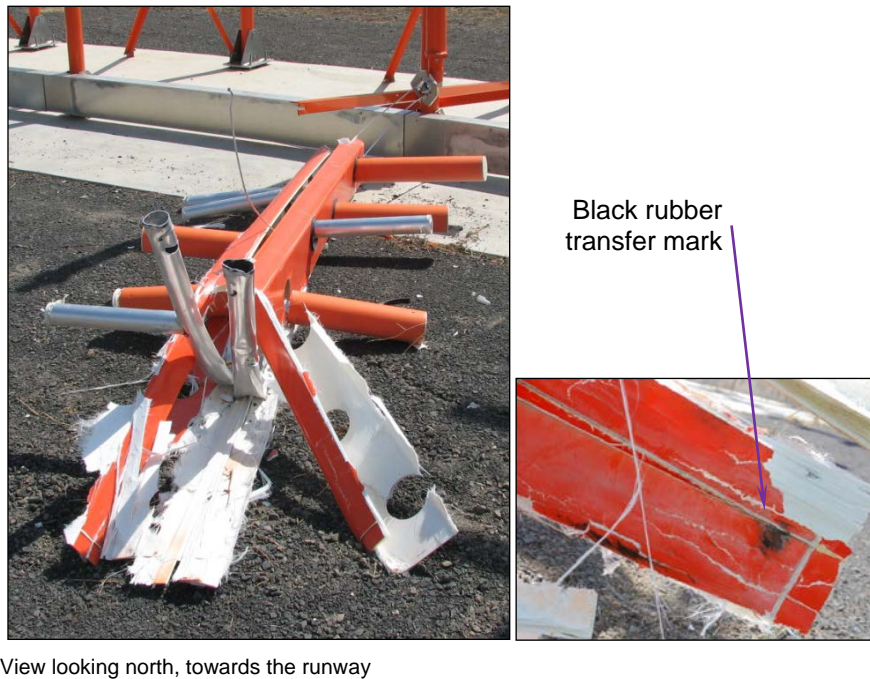
Figure 14: Damaged localiser antennae

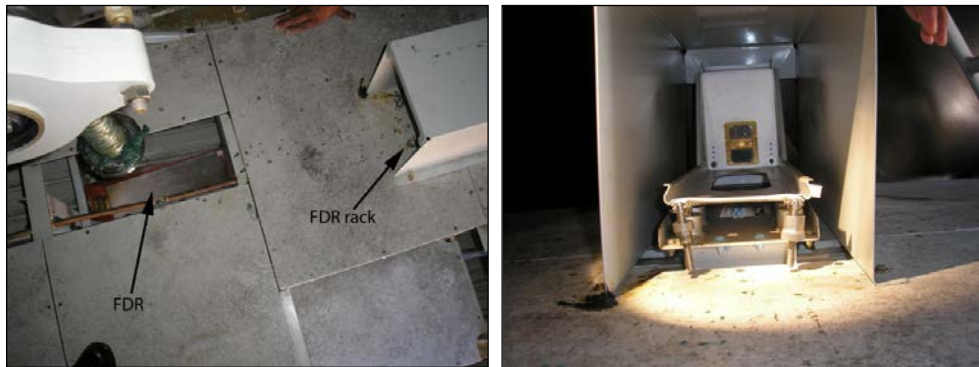
Figure A1: FDR and rack as found on-site

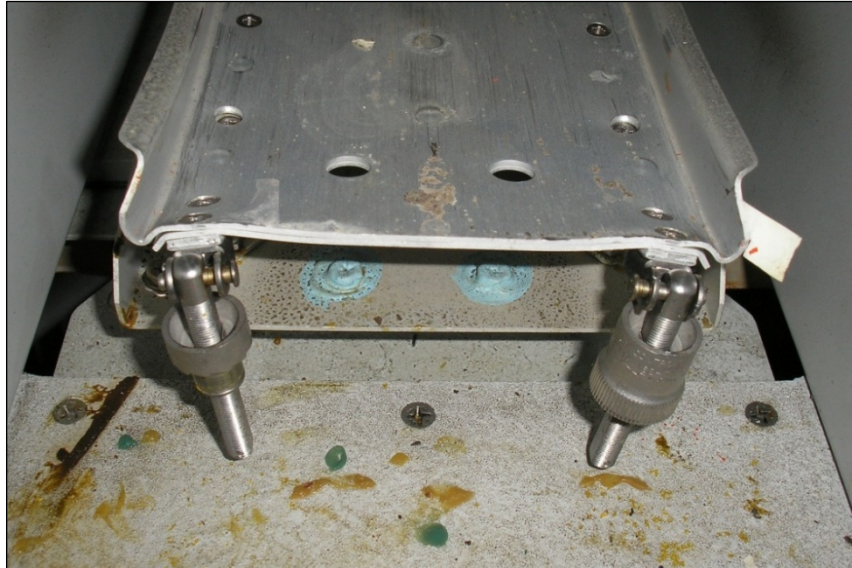
Figure A3: On-site photograph showing the original position of the threaded fasteners following the occurrence

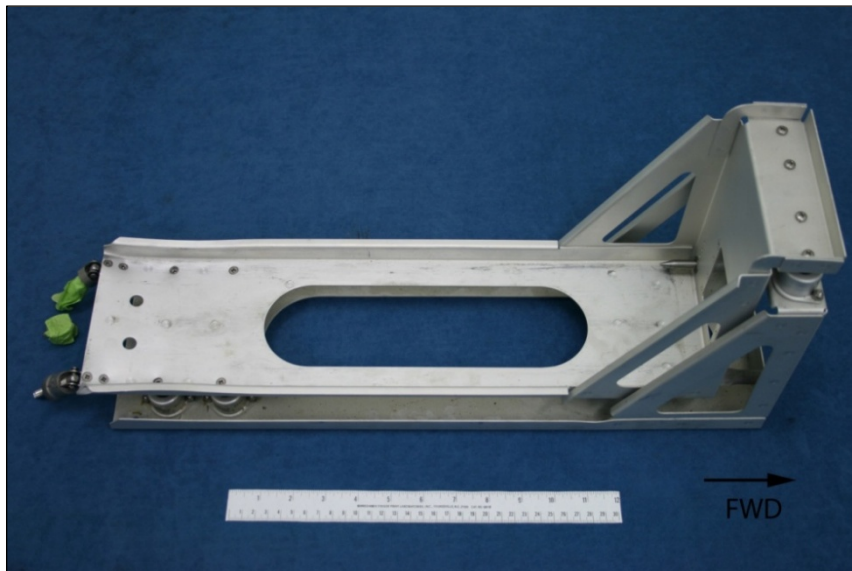
Examination of the FDR rack revealed moderate plastic deformation towards the front end of the rack, that is the end facing the rear of the aircraft (Figure A4).

Figure A4: FDR rack as received

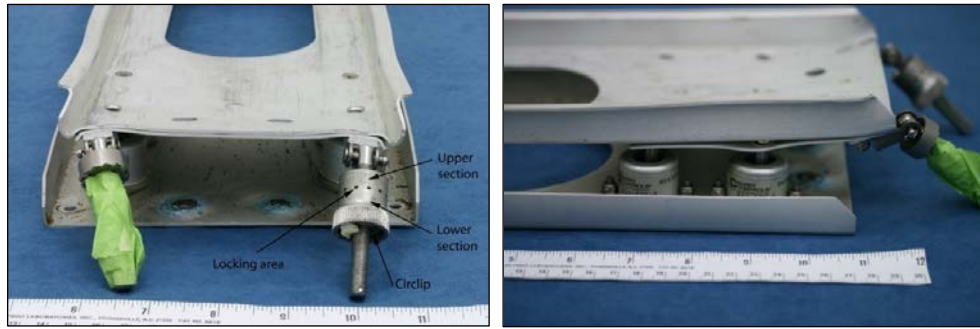
The upper shelf of the rack had deformed upwards, and some distortion across the width of the rack was also observed (Figure A5). The heads of the screws holding the upper tray in position had been pulled through their recesses.

Figure A5: Magnified views of the damaged end of the FDR rack

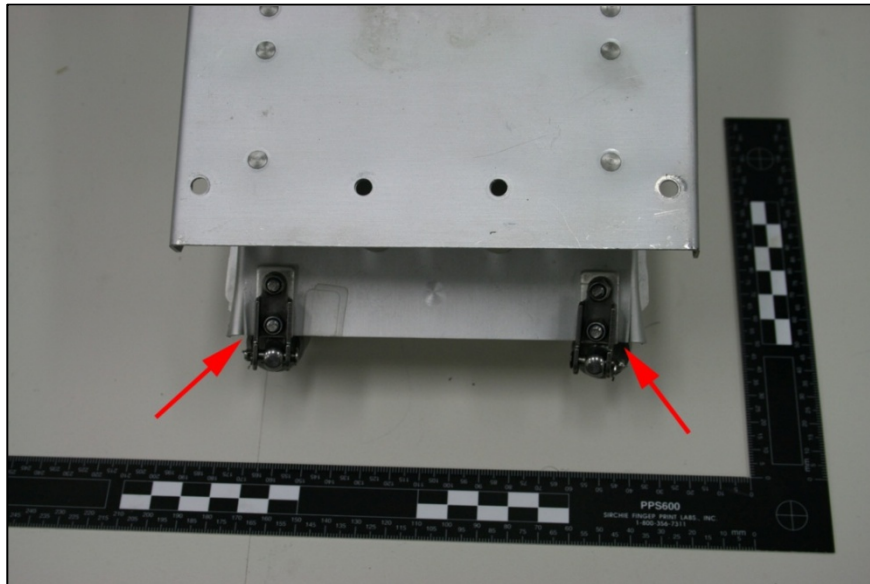
Plastic deformation was also observed on the underside of the upper tray in the areas adjacent to the fasteners (Figure A6). Note the plastic deformation appeared to have affected the upper tray of the rack only, displacing it upwards and outwards. No contact marks were evident on the underside of the rack or fasteners.

Figure A6: Underside of rack showing deformation in the region adjacent to the fasteners
