Forced landing involving a Piper PA-28, VH-SWV

near Camden Airport, New South Wales, 20 April 2017

ATSB Transport Safety Report
Aviation Occurrence Investigation
AO-2017-046
Final – 12 February 2018

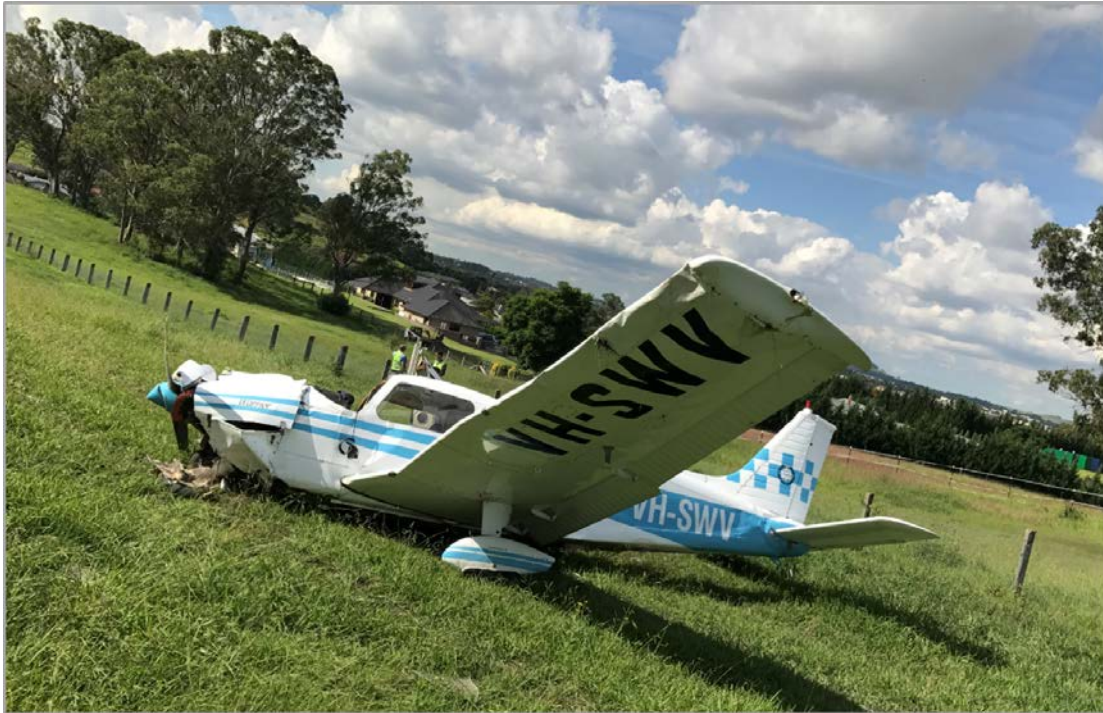
The pilot identified a small clearing between trees to the right and turned the aircraft toward that area. The aircraft continued to descend and about 8 seconds later, its right wing contacted the top of a tree. The aircraft then collided with the ground, spun around, and came to rest. The aircraft was substantially damaged (Figure 2) and fuel began leaking from its ruptured right fuel tank. The damaged right wing blocked the exit door; however, the front windscreen fractured on impact and provided an egress path for the occupants.

Figure 2: Accident site of Piper PA-28-161, VH-SWV

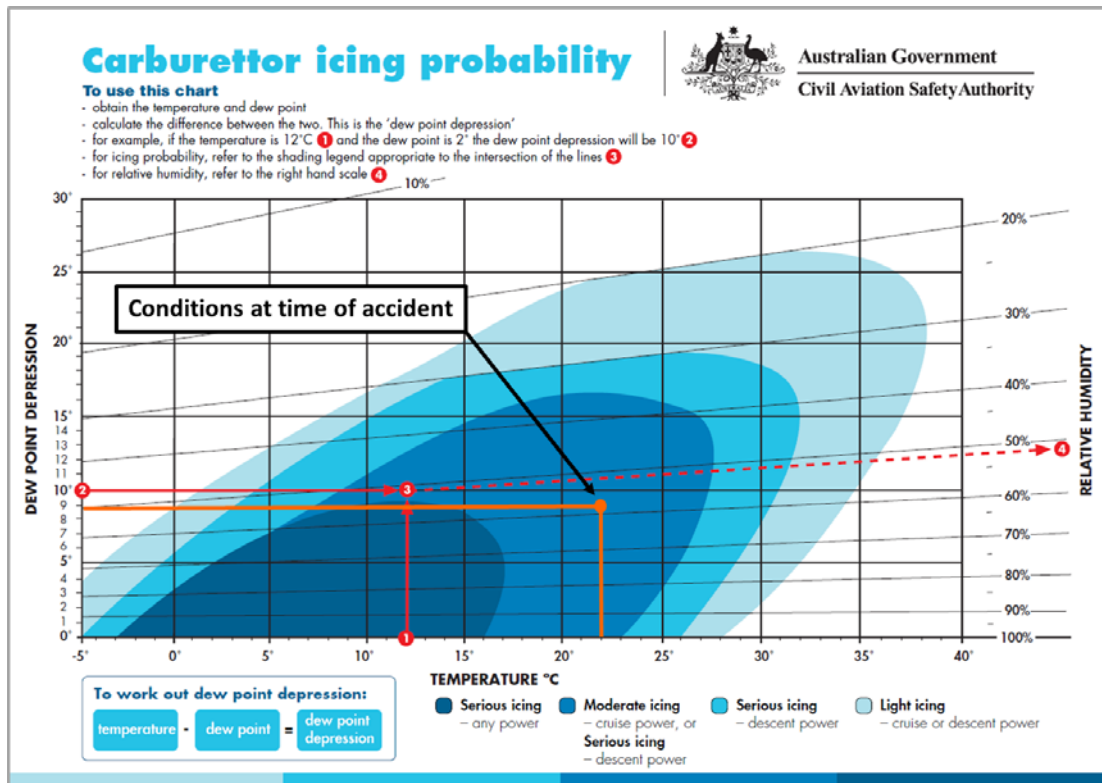
Figure 3: Carburettor icing probability chart (prevailing conditions shown in orange)

The carburettor icing probability chart indicated that the probability of icing in the weather conditions at the time of accident was in the shaded royal blue area (orange dot in Figure 3). Therefore, moderate icing could be expected at cruise power setting and serious icing at descent power. The chart does not show icing probability at the higher take-off power setting at the time of the accident. However, based on the advice in the Lycoming service letter, the short period of operation at low power following the engine run-up and the icing probability chart, significant carburettor icing was considered unlikely.
