# Fuel starvation and forced landing involving Piper PA-28, VH-BDB

15 km WSW of Bankstown Airport, New South Wales, 19 September 2017

**ATSB Transport Safety Report**  
Aviation Occurrence Investigation  
AO-2017-094  
Final – 13 February 2018

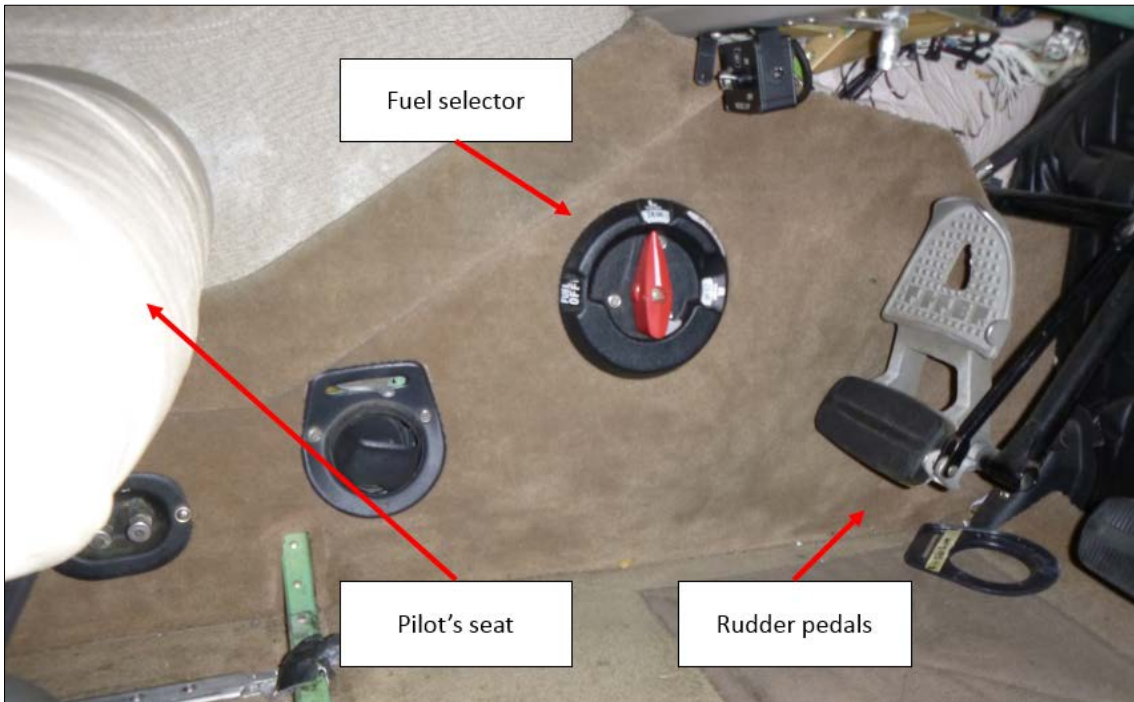
**Figure 1: Aircraft fuel tank selector**

A representative of the insurance company examined the aircraft about 3 hours after the forced landing. That examination found the fuel selector in the LEFT tank position (Figure 1) and no usable fuel in the left tank, which was not breached. The right tank, which was breached, was about one quarter full. The aircraft wreckage was recovered to facilities on 21 September and further inspections were conducted on 26 September. The inspections found no fuel in the engine fuel lines, and about 20 ml and 40 ml of fuel in the fuel filter bowl drain valve and carburettor respectively.

Believing the aircraft had full fuel on board, the pilot intended to conduct the 30-40 minute flight on the left fuel tank. It was more likely than not that the pilot believed the fuel quantity on board was full at the start of the flight due to his inspection of another aircraft earlier in the day. However, BDB was not refuelled prior to the flight and had about 35 minutes of fuel available in the left tank and about 78 minutes in the right tank. Despite having sufficient fuel on board for the planned flight, when returning to Bankstown, the engine lost power due to fuel starvation associated with use of the left fuel tank. This resulted in a forced landing.

- The pilot had refuelled another aircraft to full earlier in the day, which he more likely than not misattributed to the fuel state of VH-BDB.
- The loss of engine power was due to fuel starvation associated with the left fuel tank, which resulted in the pilot conducting a forced landing.
