# Engine malfunction involving British Aerospace Jetstream 3206, VH-OTE

near Canberra, Australian Capital Territory, 30 March 2017

**ATSB Transport Safety Report**  
Aviation Occurrence Investigation  
AO-2017-037  
Final – 9 March 2018

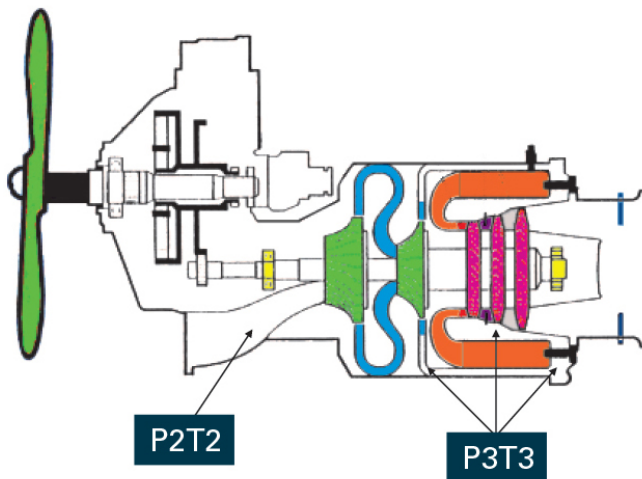
The first officer retrieved the appropriate section of the quick reference handbook (QRH), which they then actioned. The most common cause of low torque was icing on the compressor inlet pressure (P2T2) sensors (Figure 1). The QRH response was to turn on heat to melt the ice and wait 5 minutes to see if there was a power response.

**Figure 1: Schematic diagram of Garrett TPE331 engine showing P2T2 inlet**

The facility engineers had previously advised the aircraft operator that the engine inlet P2T2 sensor was known to be a possible cause of a non-responsive power lever and lack of control of engine power. An inspection of the sensor was carried out but no defect was found.

Honeywell advised that leakage of the FCU P3 piston in to the P2 section can result in the inability of the FCU to reach the max fuel schedule. The symptoms of this condition would be similar to icing of the P2 inlet due to the increased pressure within the P2 section.

The FCU and P2T2 sensor were replaced and the issue did not recur.
