# Loss of control and collision with terrain involving Air Tractor Inc. AT-802A, VH-NIA

33km W Narromine, New South Wales | 21 November 2016

**ATSB Transport Safety Report**  
Aviation Occurrence Investigation  
AO-2016-157  
Final – 13 March 2018

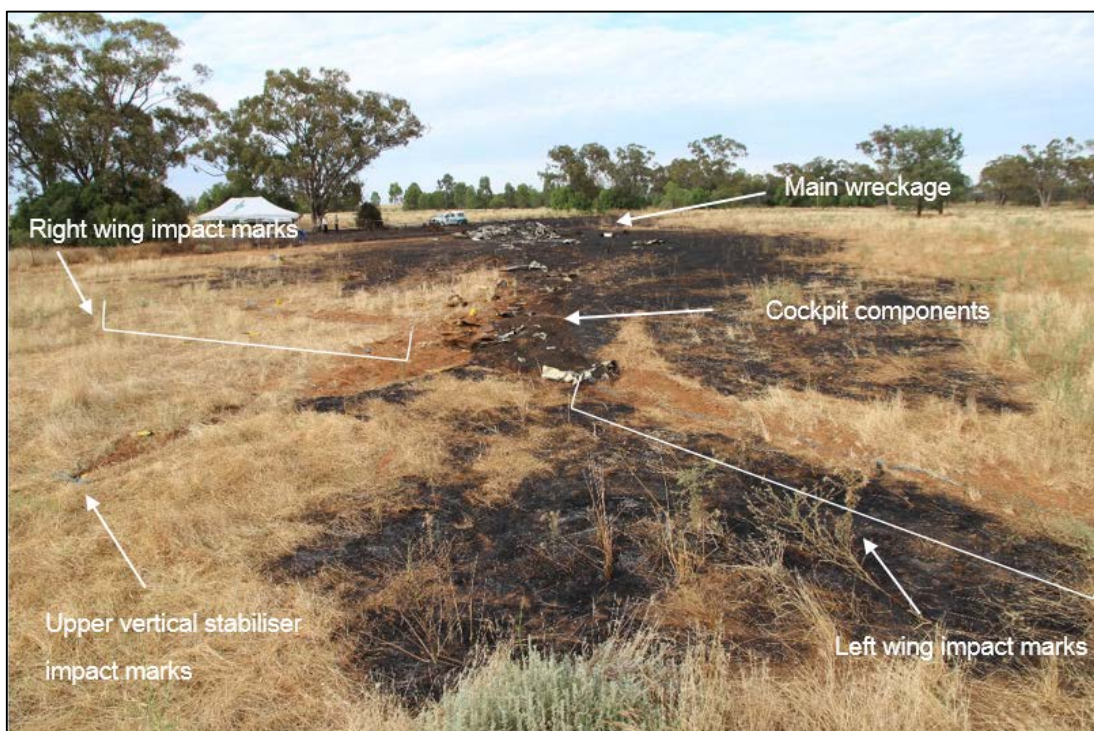
**Figure 3: Accident site, showing ground impact marks and the main wreckage in the background**

The accident site was located adjacent to a road on cleared flat farmland, about 33 km west of Narromine, NSW. The wreckage trail was about 70 m long, towards the south-west. The initial ground impact marks were from the upper part of the vertical stabiliser, left and right wings, upper cockpit area, engine and propeller (Figure 3). Those marks and items such as navigation lights, tail and cockpit components indicated that the aircraft impacted with terrain inverted, with the left wing striking the ground first, oriented on the right side of the wreckage trail.

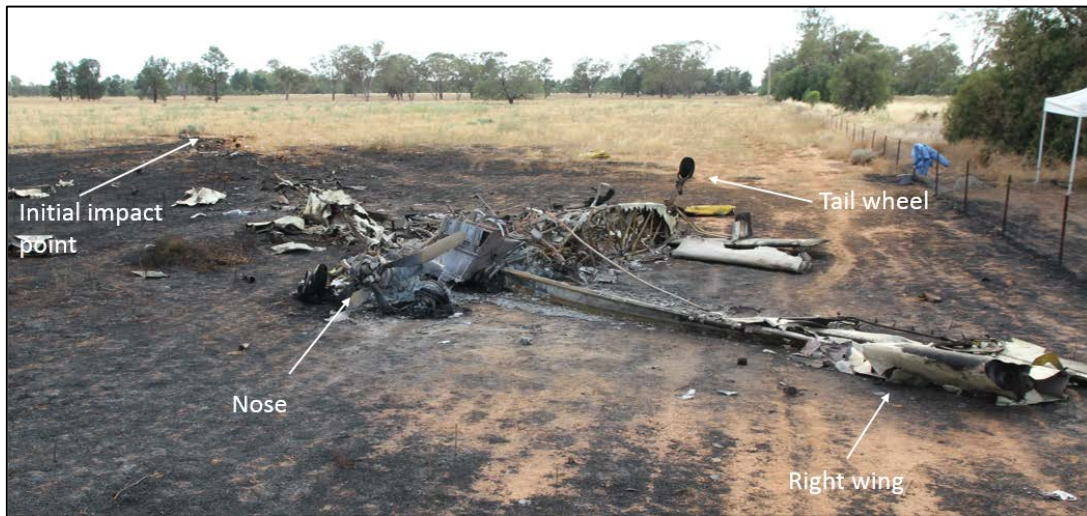
**Figure 4: Main wreckage inverted with the nose (engine and propeller) in the foreground**

A post-impact fuel-fed fire began during the accident sequence and consumed the majority of the aircraft wreckage. Figure 4 shows the remaining sections of the main wreckage, which were inverted. The level of disruption and fire damage significantly reduced the amount of evidence available to be examined.

- there was no evidence of impact with trees, powerlines, or birds
- all of the aircraft's main structural components were in the immediate area of the accident site
- the main support structure had no identified pre-impact defects
- the left wing had bending damage to the main and rear spars that was greater than that observed on the right wing structure, indicating that the left wing most likely struck the ground first
- the vertical stabiliser had separated from the empennage due to downward and back bending forces, which was a further indication of an inverted impact with terrain
- sections of the upper cockpit area, vertical stabiliser, and wing secondary structure had separated from the fuselage.

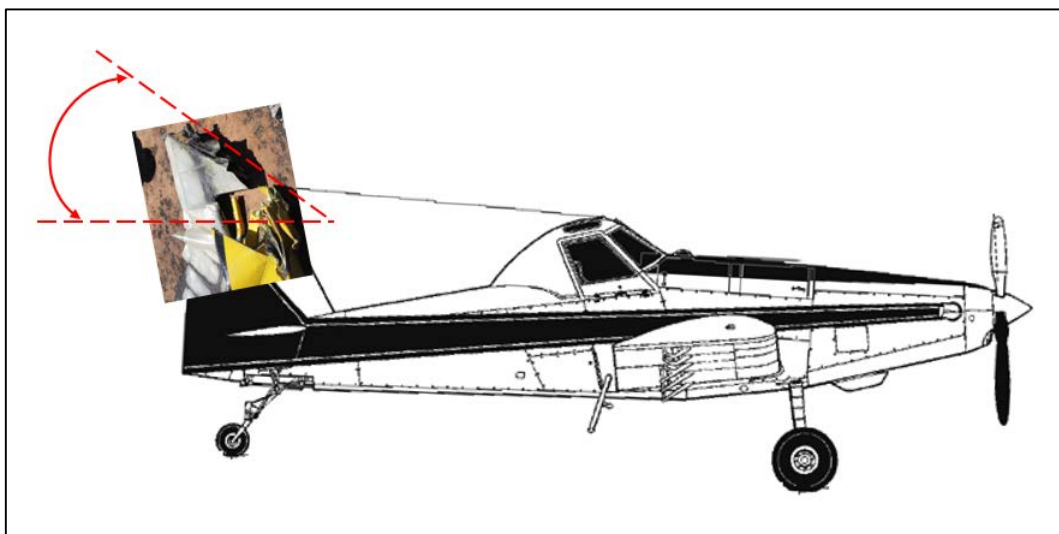
**Figure 5: Side view of an AT-802 aircraft with superimposed tail and rudder showing angled crush damage**

The aircraft's approximate angle of entry was calculated using the position of aircraft components and angled crush damage to the tail section of the aircraft (Figure 5). The aircraft most likely impacted the ground inverted, at an angle of about 30-40° nose down.

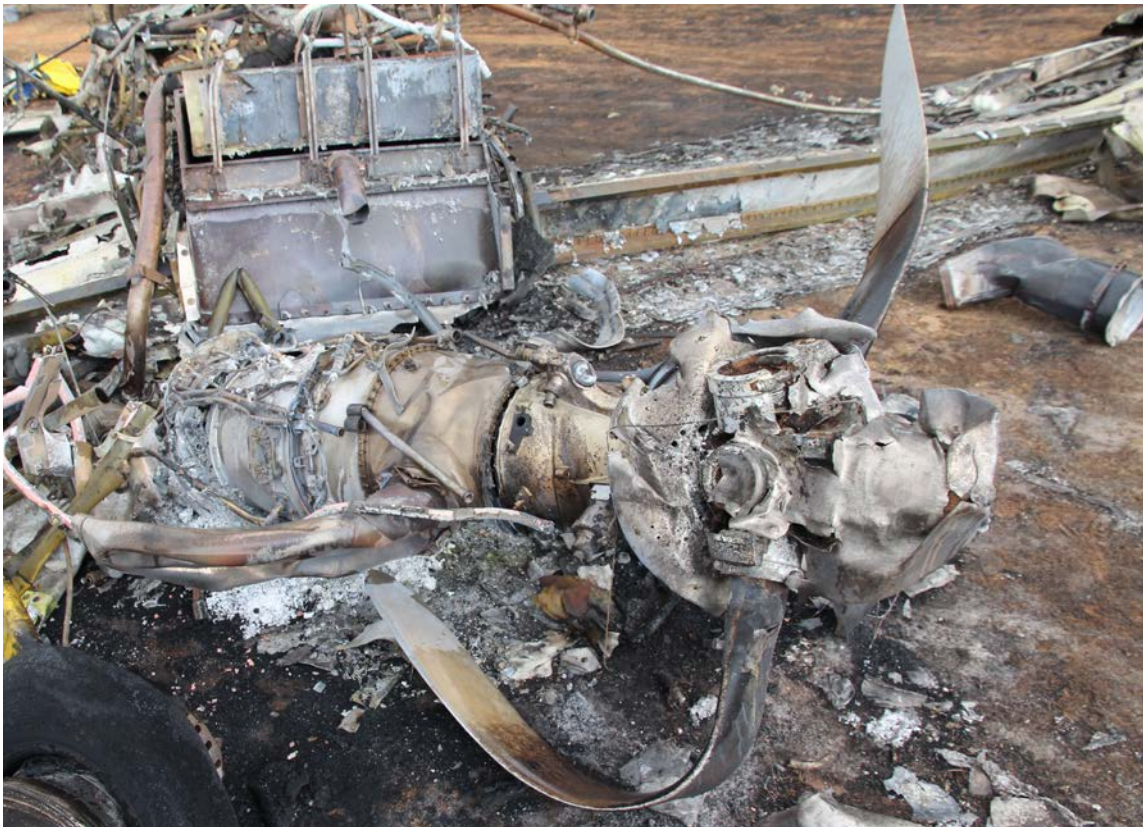
**Figure 6: Engine and propeller assembly**

An external examination of the engine did not identify any pre-impact defects (Figure 6). The engine first stage compressor was inspected through the inlet and the second stage power turbine through the exhaust outlet. No pre-impact defects that would indicate an internal failure were identified.

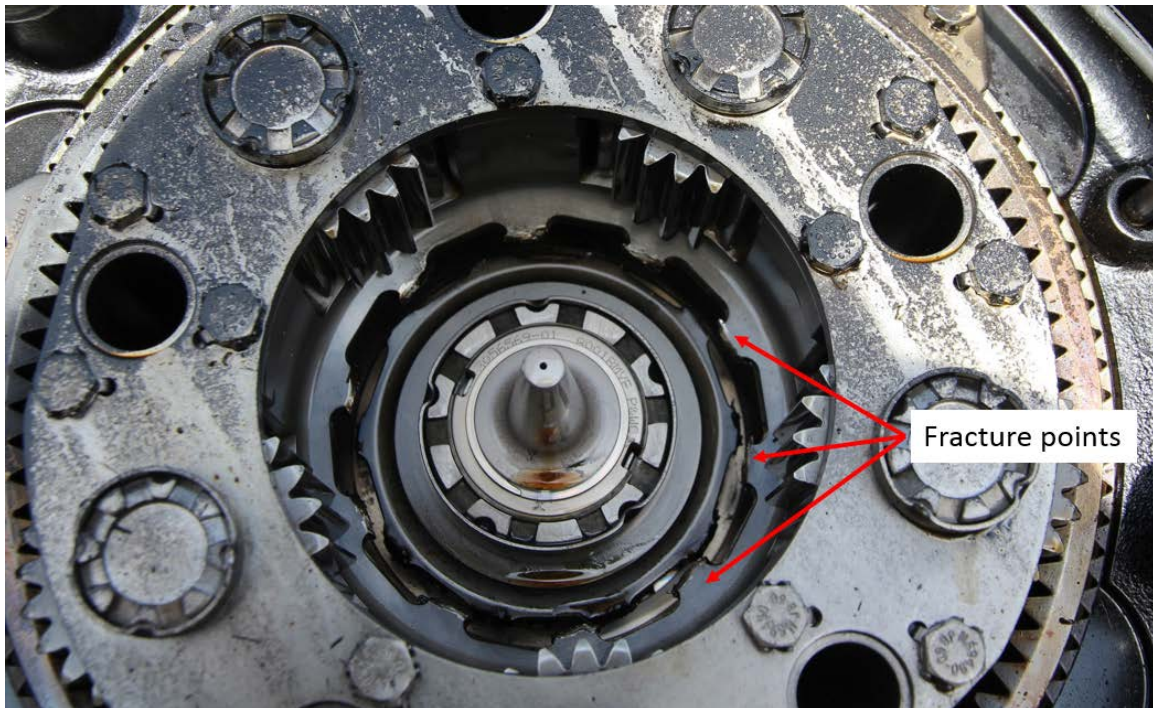
**Figure 7: Reduction gearbox drive section viewed from the rear with three of the ten fracture points arrowed**

The engine reduction gearbox was removed from the accident site for further examination of the engine to propeller drive components, in an area of what appeared to be overload failure (Figure 7).

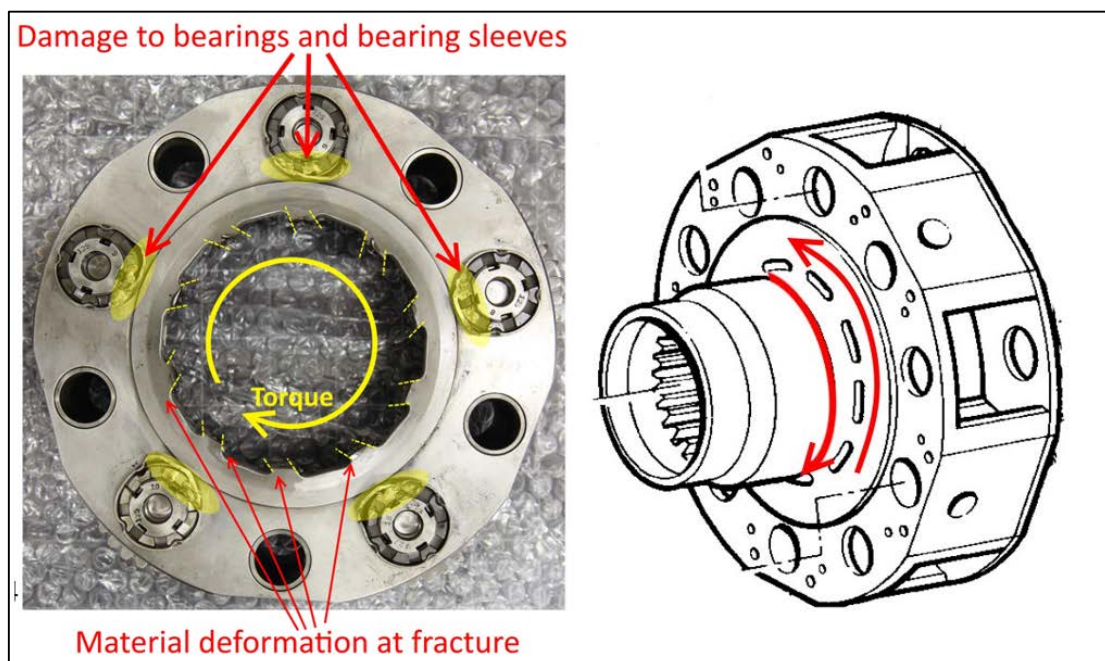
**Figure 8: Reduction gearbox drive section showing fracture points, damage to bearing sleeves and an illustration showing direction of failure.**

- the fractures observed were overstress, due to high torsional loads
- the direction of overstress failure was consistent with a sudden propeller stoppage while the engine was driving the propeller (Figure 8).

The engine manufacturer confirmed that the damage observed in the drive components was indicative of the engine producing power at the time of impact.
