# Collision with terrain involving Robinson R44, VH-HBV

Julatten, Queensland, 15 August 2017

**ATSB Transport Safety Report**  
Aviation Occurrence Investigation  
AO-2017-083  
Final – 22 March 2018

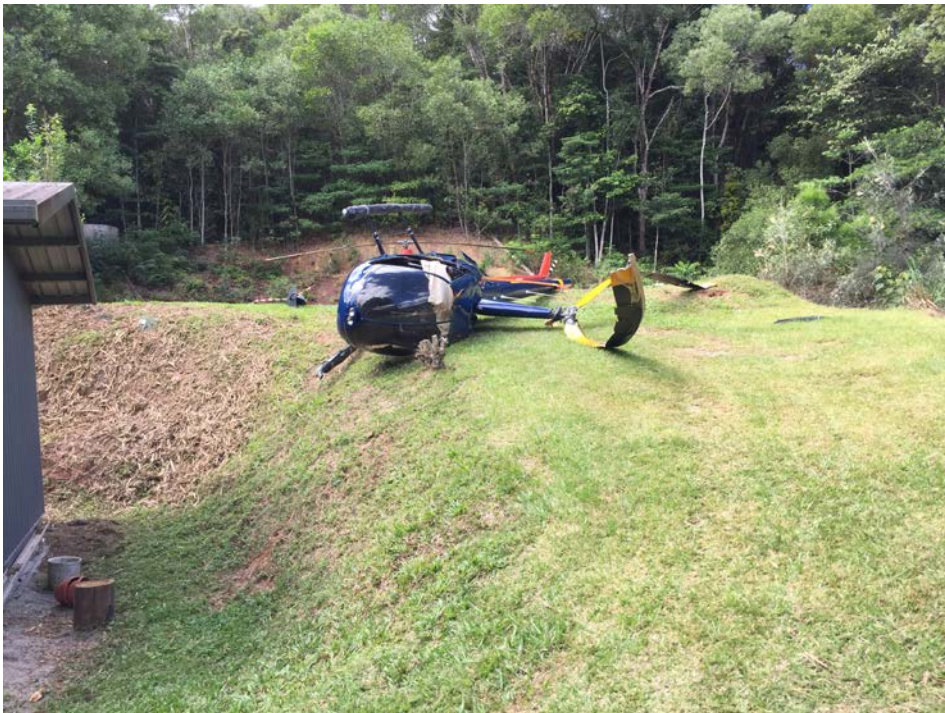
As the helicopter completed a 360 degree turn with the skids about 3–5 ft above the ground, the pilot lowered the collective<sup>4</sup> in an attempt to land on the helipad. The helicopter was still yawing as the skids contacted the helipad. It rolled over, the main rotor blades struck the ground and the helicopter came to rest on its left side.

The pilot was uninjured and the helicopter sustained substantial damage (Figure 1).

**Figure 1: Accident site showing damage to VH-HBV**

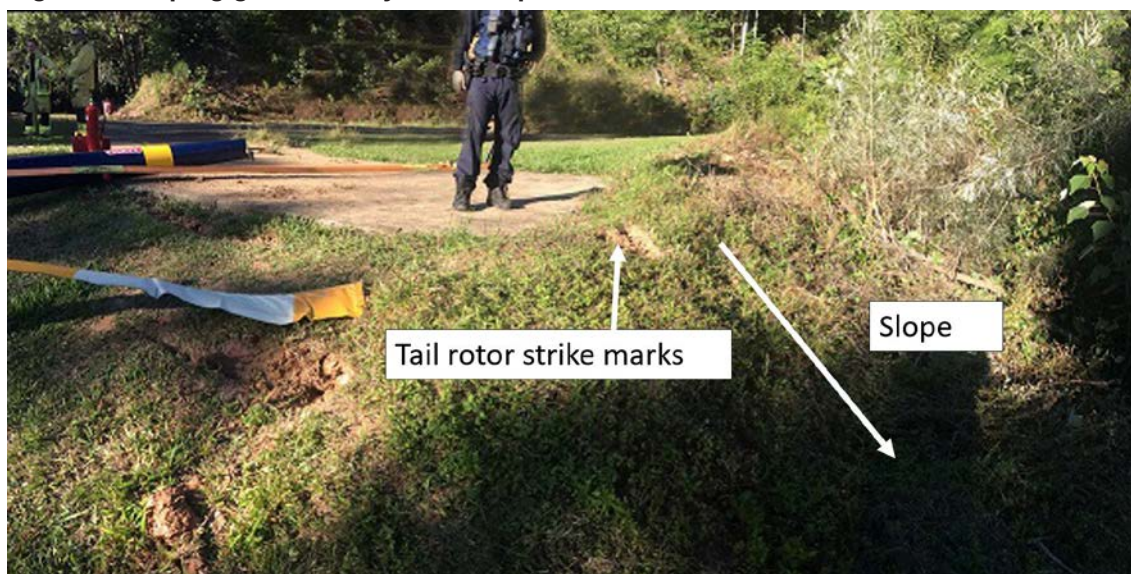
The pilot applied aft cyclic just prior to touchdown, which resulted in a slightly tail-low attitude for landing. The tail stinger would normally contact the ground and prevent a tail rotor strike. However, because the ground sloped away behind the concrete landing pad, the stinger was over the slope, allowing the tail rotor to strike the ground and detach without prior warning (Figure 2).

**Figure 2: Sloping ground away from helipad and tail rotor strike marks**

- The pilot applied aft cyclic just prior to touchdown, resulting in a tail-low attitude.
- The ground sloped downwards away from the landing pad and as a result, the tail stinger did not protect the tail rotor from ground contact.
- The tail rotor struck the ground and detached, resulting in the helicopter yawing rapidly to the right. The pilot did not roll off throttle to reduce the yaw rate prior to lowering the collective, which probably led to the helicopter rolling over as the skids contacted the ground.

- Company pilots were briefed immediately following the accident, and subsequently trained, with regard to flying alone or with very little cargo. R44s are inclined to have a nose-high attitude when light, which often results in tail and stinger encroaching too close to terrain.

- The company hazard register was updated to highlight the issue and company pilots were required to read the updated register. Pilots were advised that higher flare and slower approaches can mitigate the hazard.

- Company pilots were briefed regarding hazards associated with helicopter landing sites and bush landing sites with sloping terrain and any obstacle that may come into contact with tail rotor or helicopter.
