Collision with terrain involving Cessna Aircraft Company 172S, VH-ZEW

Millbrook, Victoria | 8 September 2015

ATSB Transport Safety Report
Aviation Occurrence Investigation
AO-2015-105
Final – 17 April 2018

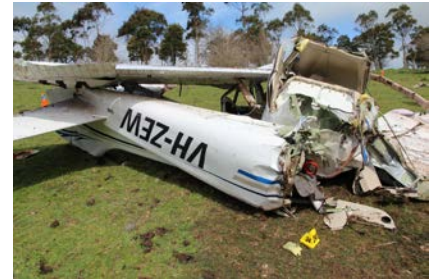
VH-ZEW main wreckage

At about 1410 Eastern Standard Time on 8 September 2015, the pilot of a Cessna Aircraft Company 172S, registered VH-ZEW, departed Point Cook Airfield, Victoria, on a solo navigational training flight via waypoints that included Ballarat Airport, Victoria. GPS data showed that the aircraft was on the third leg of the planned journey, cruising at about 3,000 ft above mean sea level when it started to descend rapidly. The aircraft impacted rising terrain at about 2,200 ft and was destroyed. The pilot who was the sole occupant, was fatally injured.

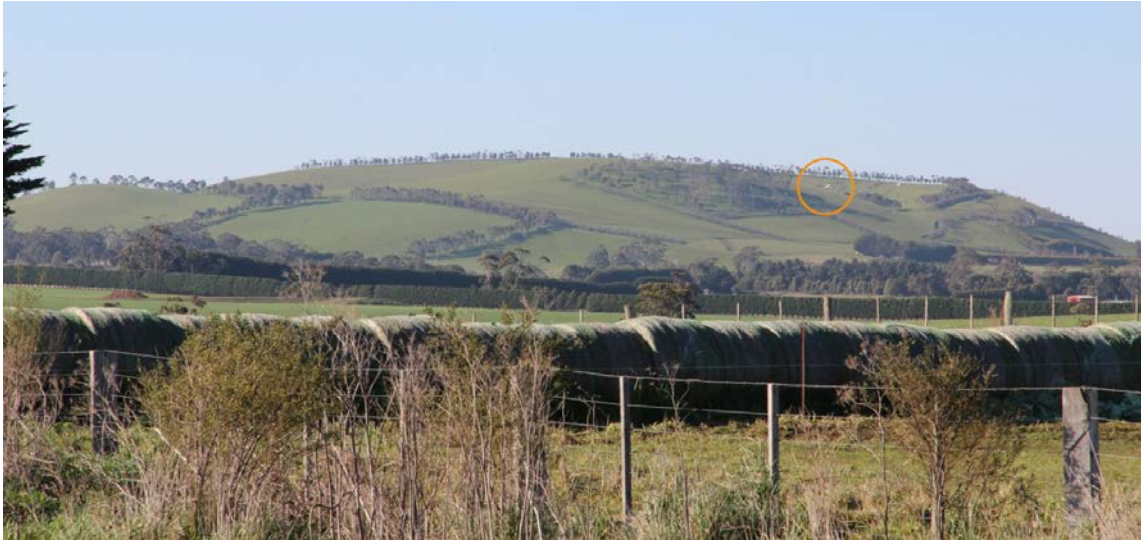
Figure 7: Area of accident site on high ground with aircraft impact point highlighted

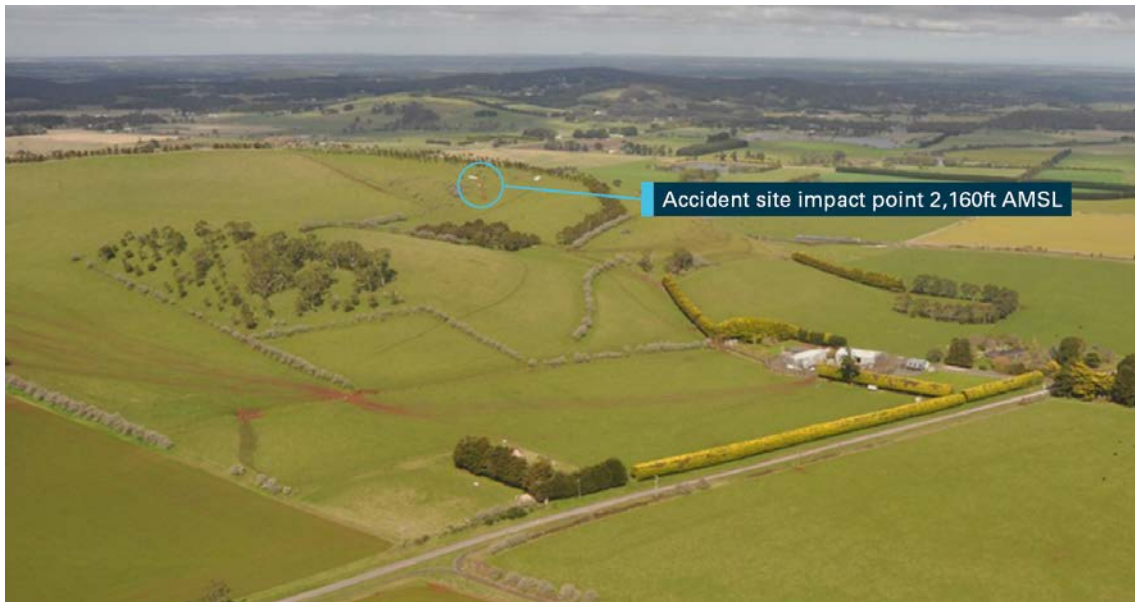
Black Mount was a U shaped feature, which was covered in grass on the south-eastern side that matched the surrounding landscape. That created a visual illusion that the high terrain appeared to be a relatively flat area when viewed from the southwest.

Figure 8 is a picture of Black Mount taken in line with the aircraft's direction of flight at about 1,000 ft AGL. The picture illustrates the ill-defined rising terrain.

Figure 8: Black Mount viewed at about 1,000 ft AGL in the direction of flight, showing the accident site

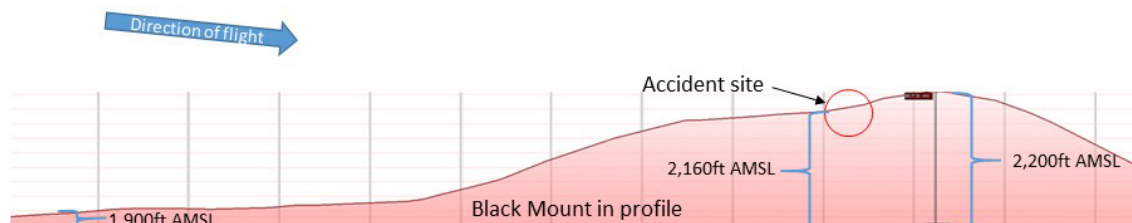
Figure 9 is a profile representation of Black Mount, which shows the rising terrain and location of the accident site.

Figure 9: Black Mount in profile showing the rising terrain, direction of flight, accident site, and peak altitudes

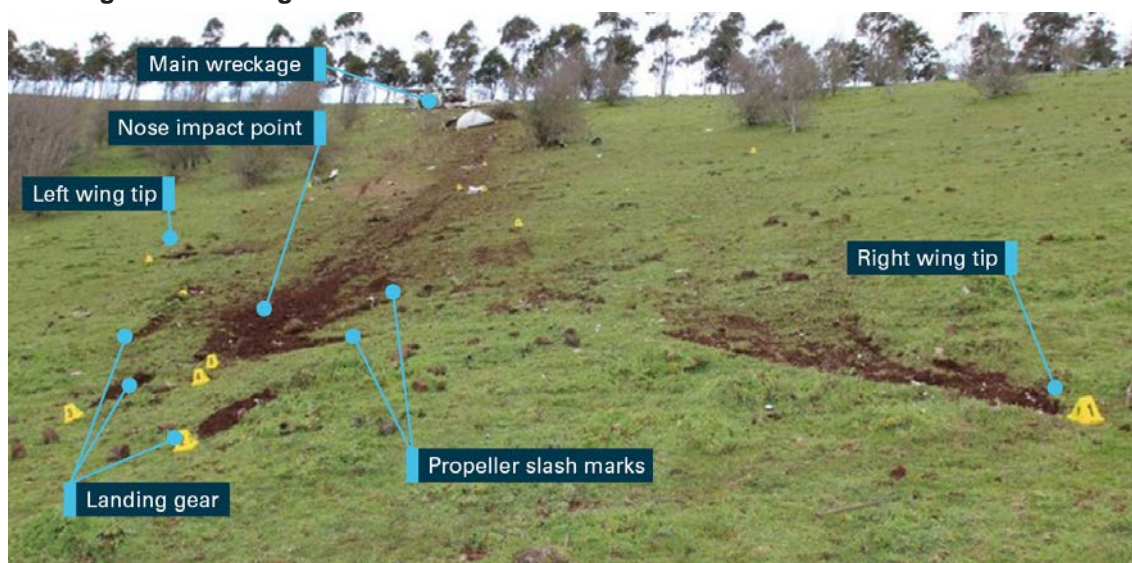
There were several identifiable impact marks in the initial part of the wreckage trail. They consisted of right and left wing impact marks, left, right and nose gear marks, propeller slash marks and nose impact point (Figure 10). Examination of the ground impact marks, wreckage splay, distribution, disruption and location indicated that the aircraft:

- was travelling at a relatively high speed when it impacted with terrain
- was slightly right wing low (in a turn to the right)
- was about level on its pitch axis (in a level attitude)
- travelled a distance of 70 m from the point of impact to the position that the aircraft came to rest.

Figure 10: Overview of accident site, location of aircraft impact marks and main wreckage in the background

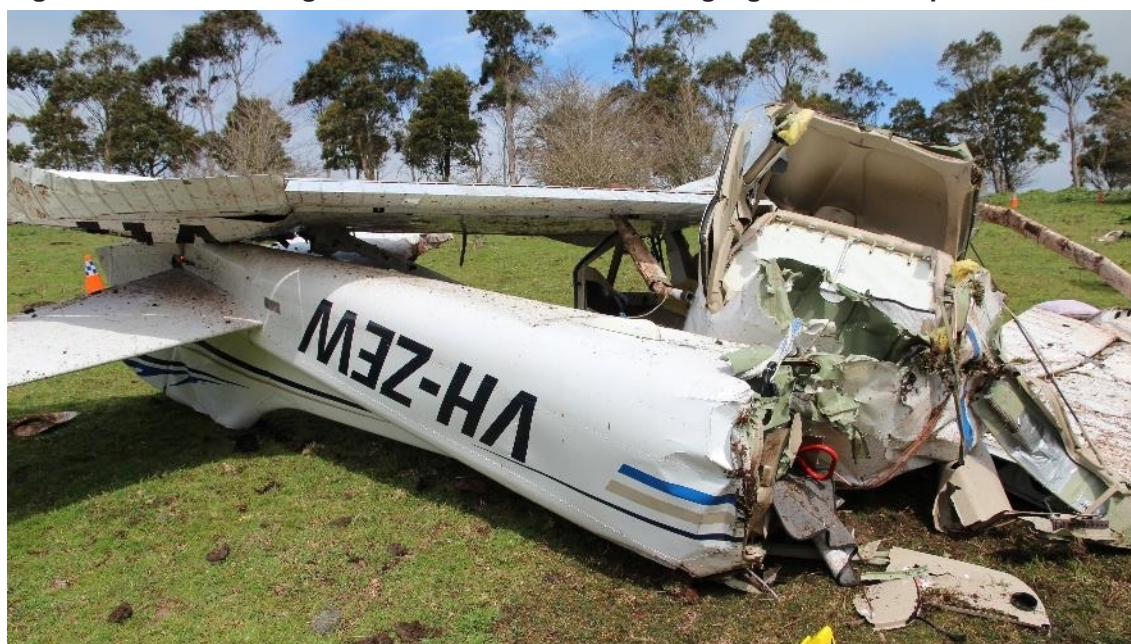
Figure 11 shows the aircraft viewed from the rear, displaying the significant structural damage.

Figure 11: Main wreckage viewed from the rear showing significant disruption

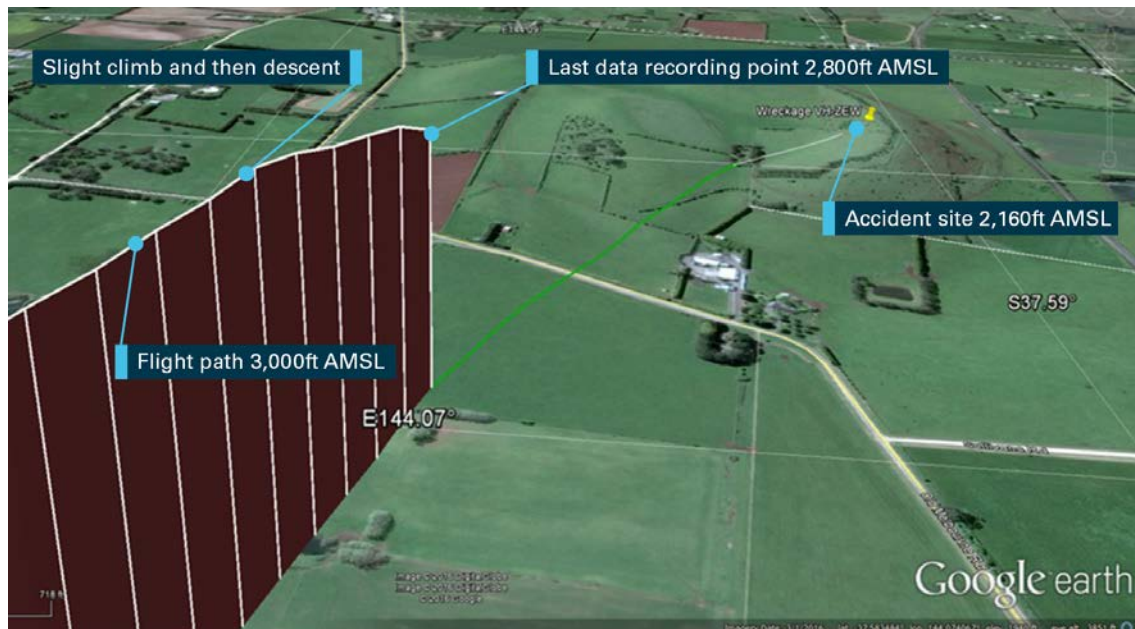
The data indicated a normal flight through all planned waypoints up until about 8 seconds before recording stopped, when the aircraft started climbed slightly before descending from 3,000ft AMSL at an increasingly rapid rate (Figure 12). The maximum vertical descent rate recorded was about 2,500 ft/min. The aircraft travelled a distance of about 900 m and descended a further 640 ft following the end of the recording. The time from the start of the descent until impact with terrain was estimated to be no more than about 20 seconds.

Figure 12: Recorded GPS flight track showing descent before recording ends, estimated track and impact point on Black Mount

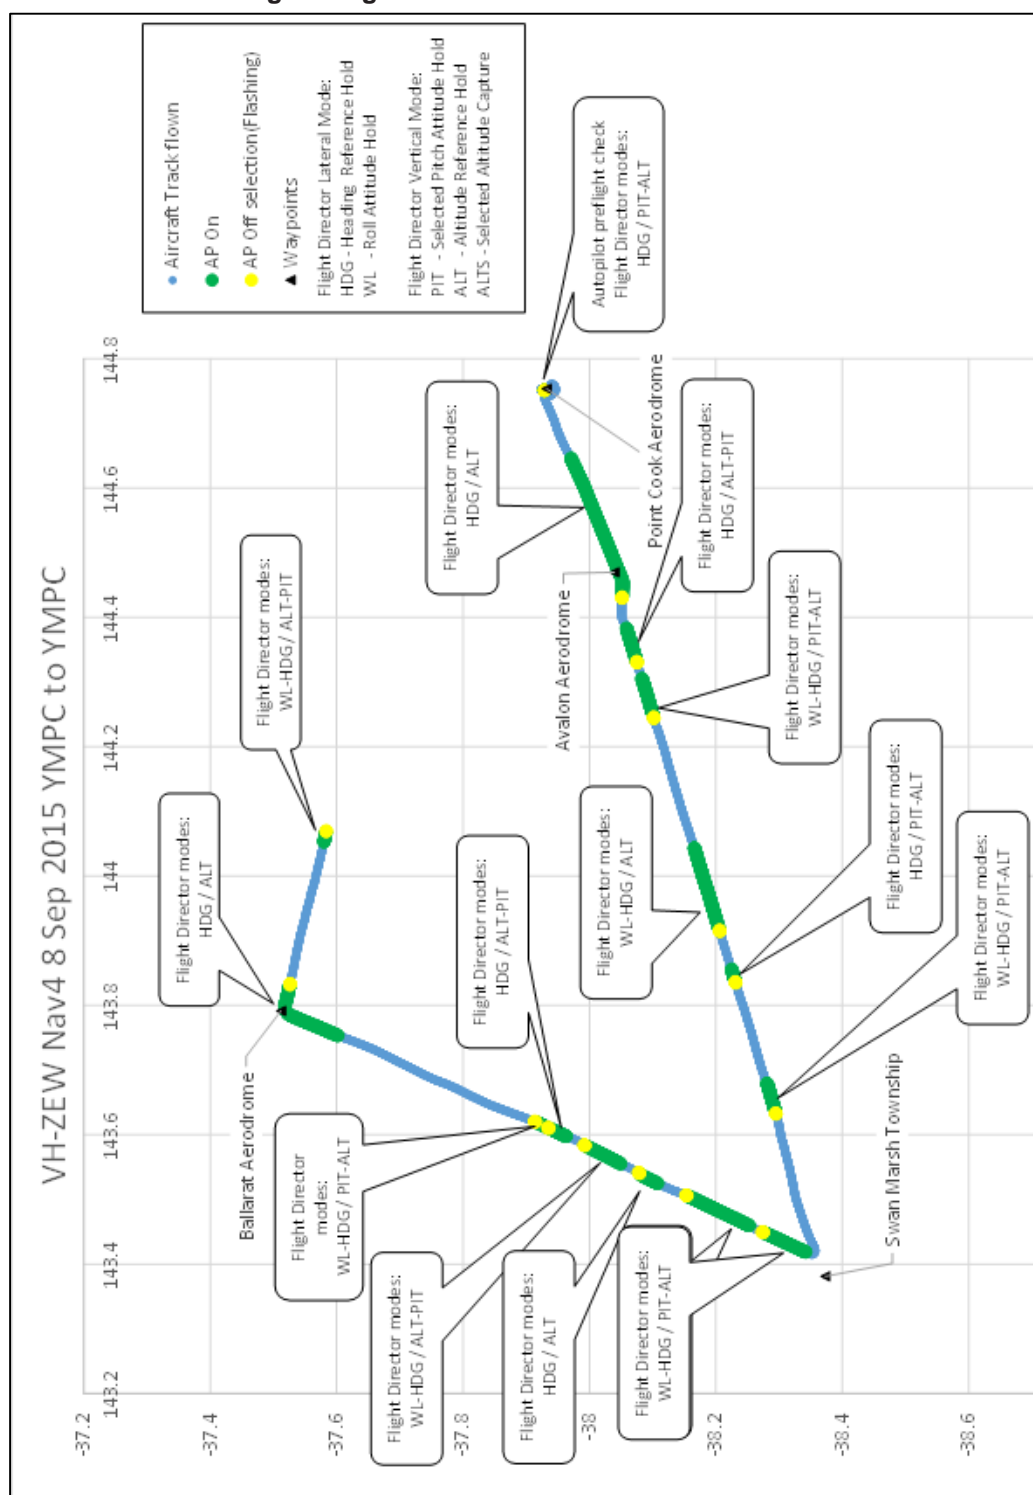
- the pilot had conducted an autopilot function check as part of the pre-flight checks just prior to take-off.
- the autopilot was utilised for about one third of the flight in total, with various heading and vertical modes selected
- the autopilot had been switched on and off 14 times, not including the ground function test (Figure 13).

Figure 13: Flightpath plot showing the aircraft's flight track with autopilot usage and modes utilised during the flight

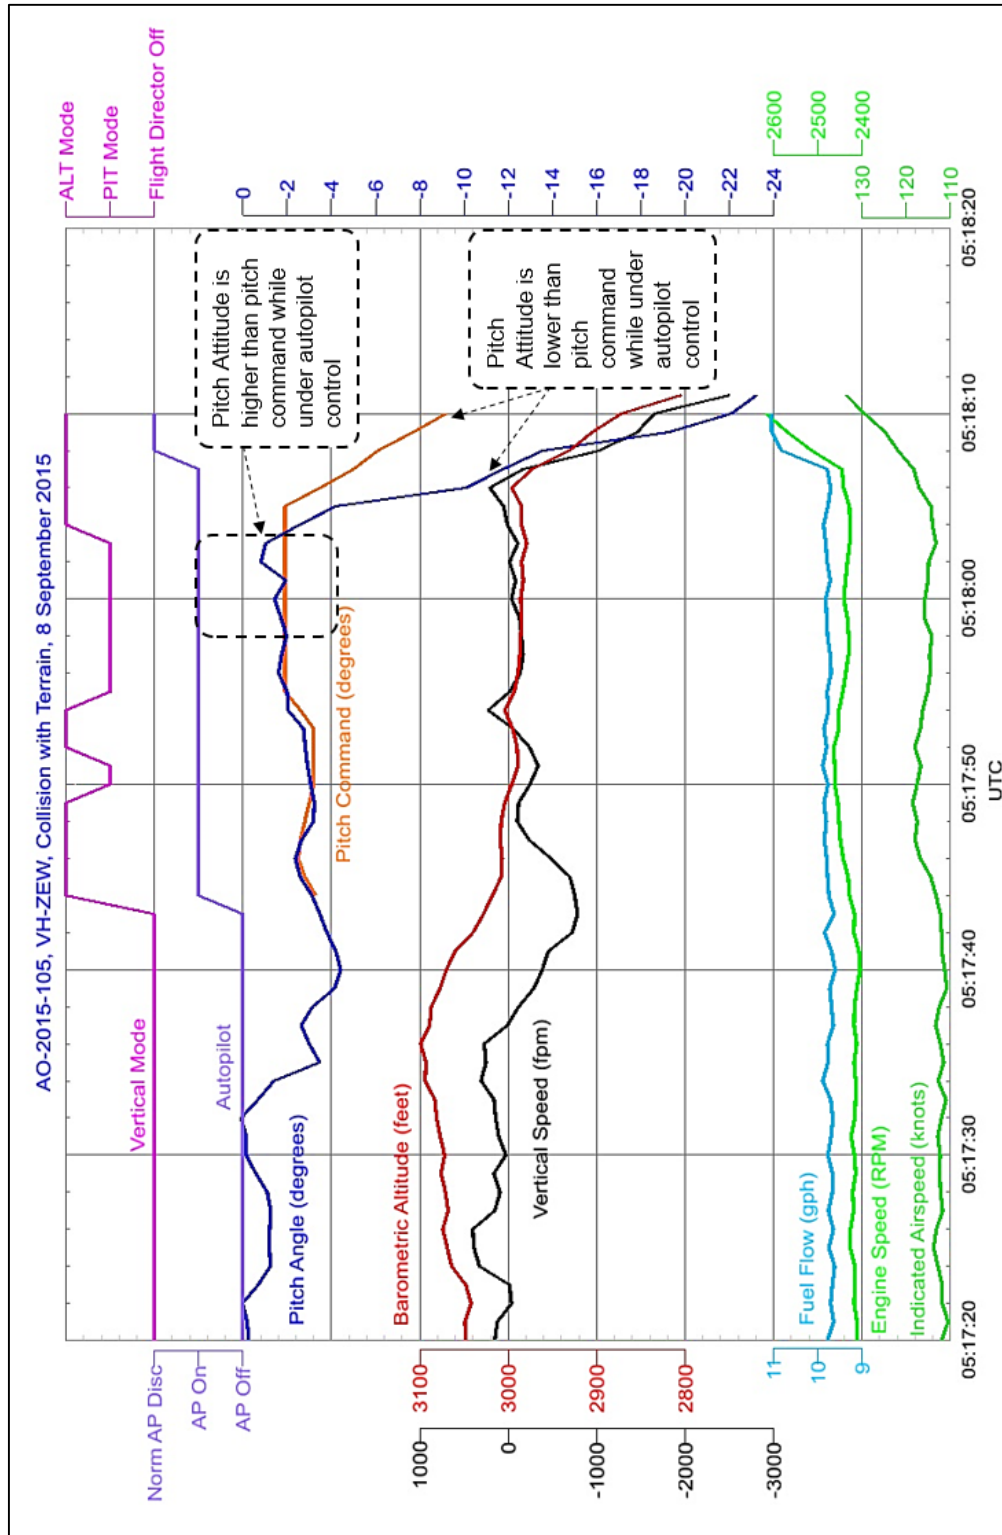
In normal AFCS operation with the autopilot engaged in a vertical mode, the pitch command and pitch attitude should follow each other closely. Towards the end of the recovered data, this was not the case. The data shows a slight pitch up attitude and then a significant pitch down attitude, which is different to the pitch command. This indicated a manual control input from the pilot while the autopilot was on and engaged in a vertical mode. Figure 14 is a graph of the last 50 seconds of flight showing the time of autopilot engagement in the various modes, the flight director pitch

commands, and actual aircraft pitch attitude. The graph also shows an increase in engine RPM and fuel flow, which indicates that the pilot did not reduce power before descent.⁵

Figure 14: Data from the last 40 seconds of flight showing flight parameters, the autopilot selections, when the autopilot was disengaged, and the end of the recorded data

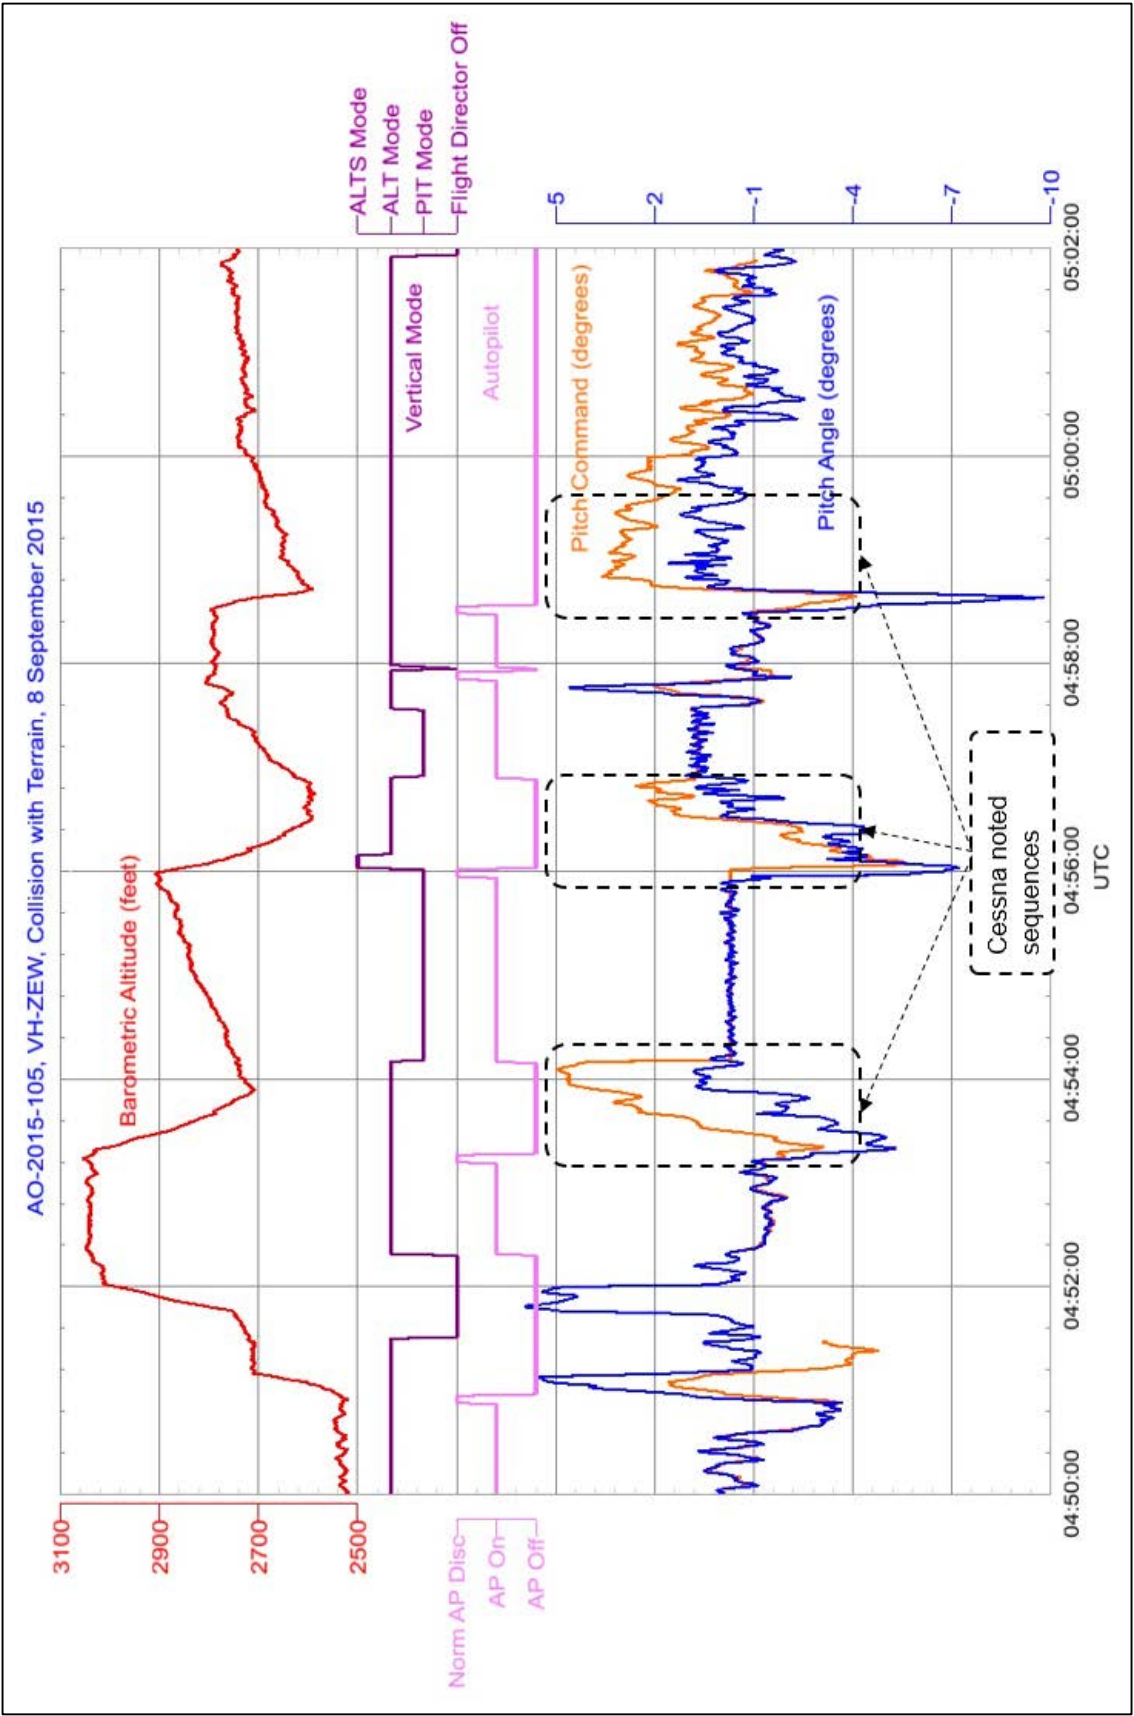
The avionics and aircraft manufacturers contended that the pilot may have been experimenting with the autopilot during the three sequences identified. The ATSB considered that it was also possible that the pilot did not have a sound understanding of the difference between PIT and ALT modes. During the three highlighted climbs and descents, PIT was set with a positive attitude reference, meaning that the aircraft climbed at the set positive pitch attitude. The autopilot was then switched off and the aircraft manually descended. That indicated that the pilot may have been unaware that when PIT is selected it will hold an aircraft attitude rather than altitude. In summary, a lack of understanding and/or experimentation could have resulted in the altitude variation seen in the data.

Figure 15: Autopilot operation and altitude variations on the accident flight sector between Swan Marsh and Ballarat waypoints

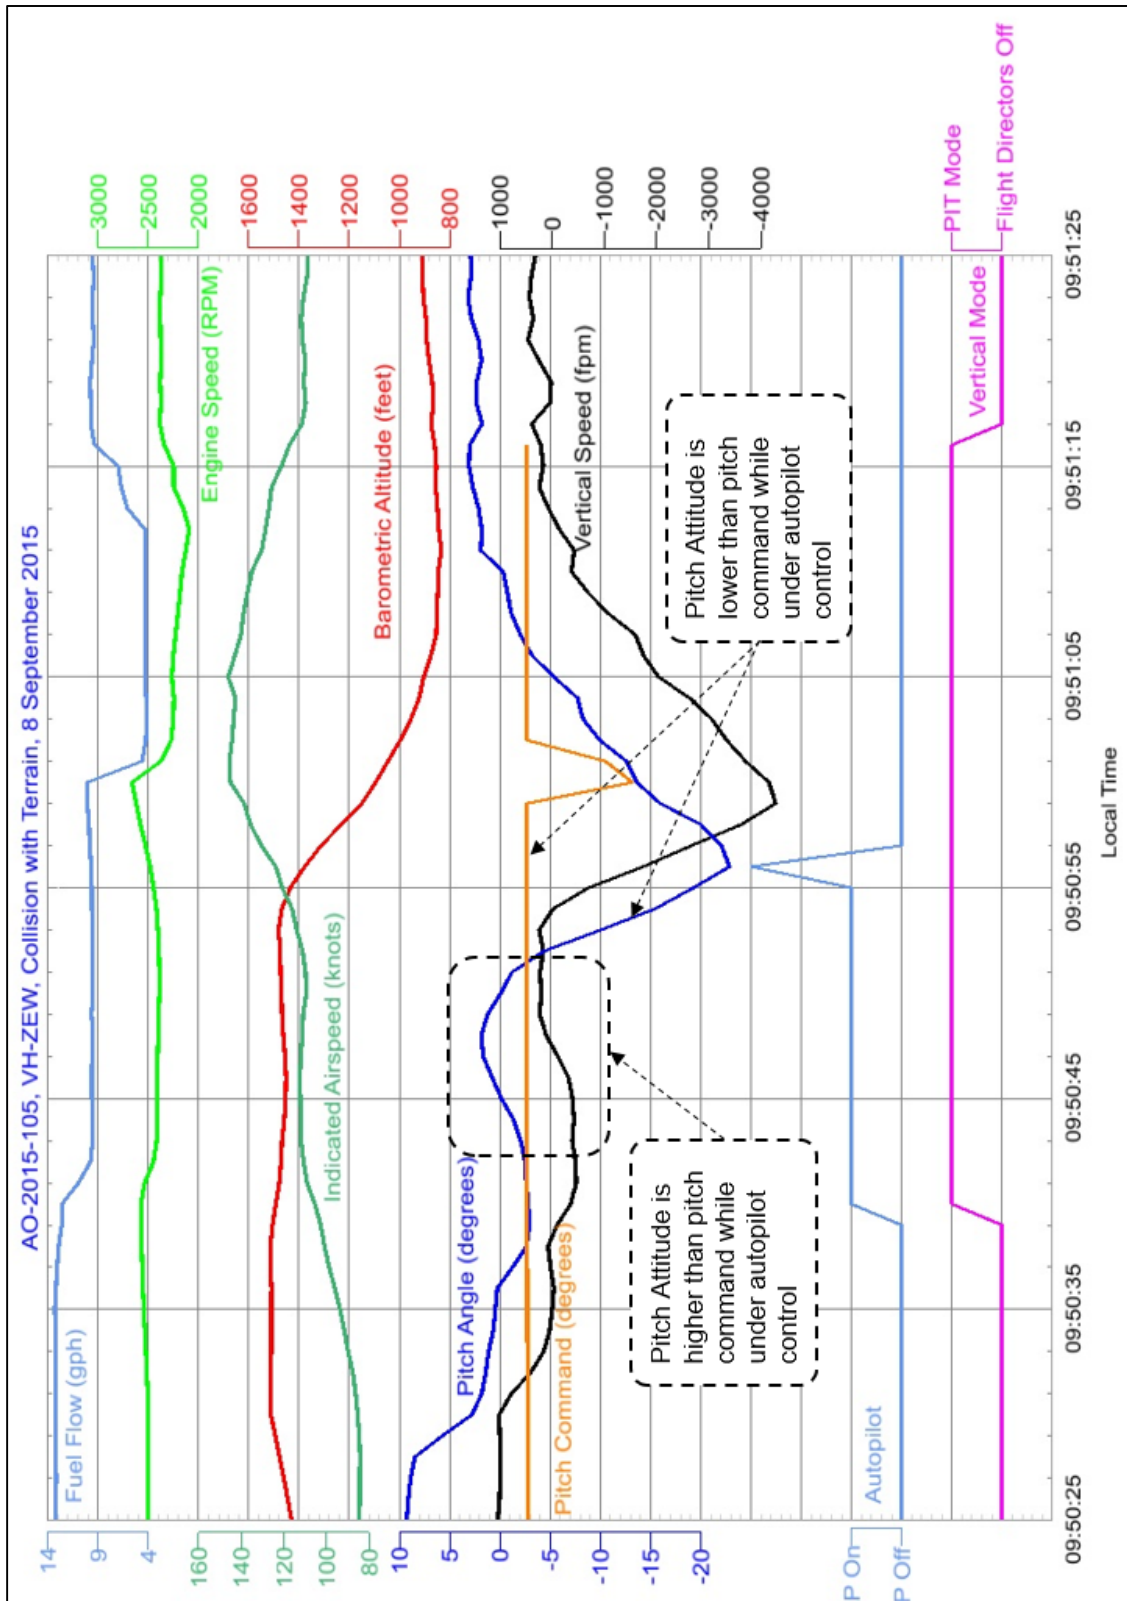
The recorded data from the verification flight was obtained by the ATSB and compared to the accident flight data (Figure 16).

Figure 16: Data from one of the verification flights with application of override force with the autopilot ON in HDG/PIT mode

The verification flights did not completely match the accident flight profile. Some of the conditions varied, such as the autopilot vertical mode, which was constant during the verification flight but not for the accident flight. The initial increase in pitch was also greater in the verification flight and the

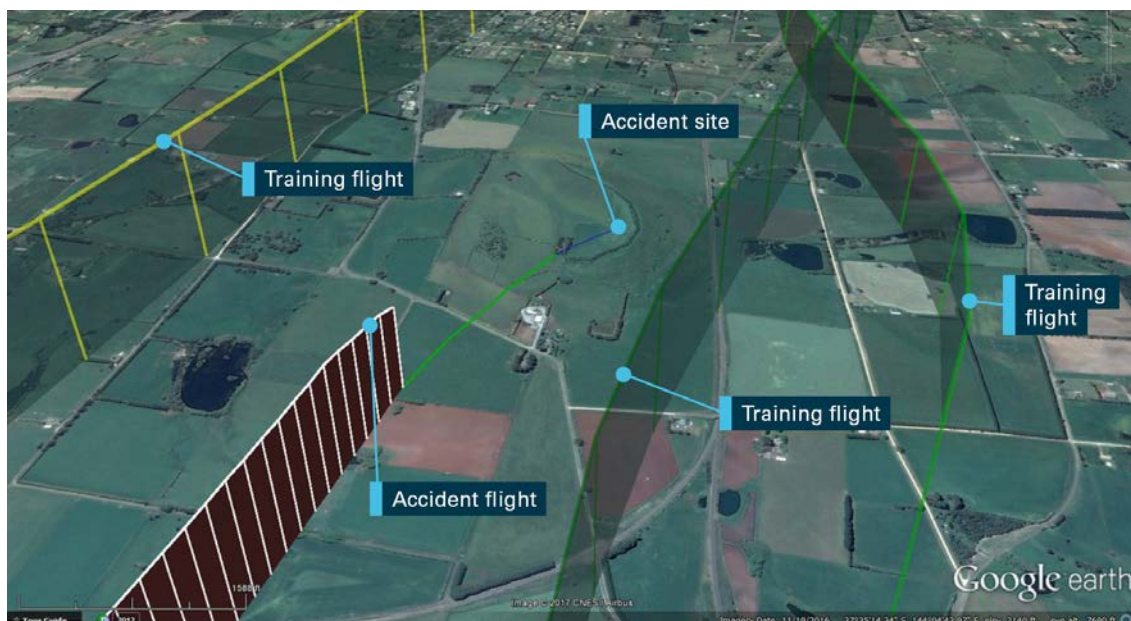
The planned cruise level between Ballarat and Milton Reservoir waypoints was 2,500 ft AMSL. That gave the pilot a ground clearance of 270 ft AGL in the vicinity of the accident site at the flight planned altitude. The flight plan conflicted with the minimum altitude AGL as stipulated by the flight instructor. It was also below the minimum regulatory requirement of 500 ft over unpopulated areas. It should be noted that despite the flight plan, the flight data showed that the pilot was maintaining a height of about 3,000 ft AMSL (770 ft AGL) on the Ballarat Milton Reservoir sector before the rapid descent.

The flight training organisation reported that their training included emphasis on flight adjustments for raised terrain to always comply with the mandated AGL of 500 ft. This included instruction on changes made as part of flight planning to include consideration of that requirements. The accident flight was flown at 3,000 ft AMSL and its flight path was directly over the top of Black Mount. That gave the aircraft a ground clearance of about 800 ft over the high terrain at the aircraft's cruise altitude.

Figure 17: GPS flight track data from the accident flight and three other training flights in the area of Black Mount
