Collision with terrain involving Airbus Helicopters EC135 T1, VH-GKK

10 km NNW Cooranbong, New South Wales | 7 November 2015

ATSB Transport Safety Report

AO-2015-131

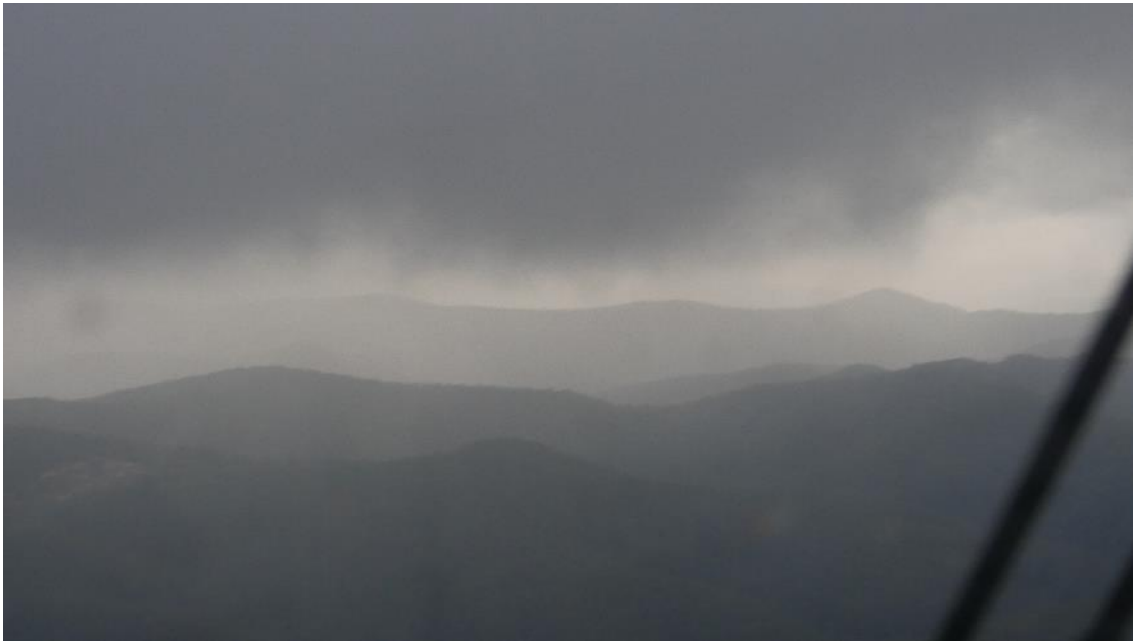
Figure 2: Image of weather conditions recorded at 1817 looking towards the Watagan Mountains

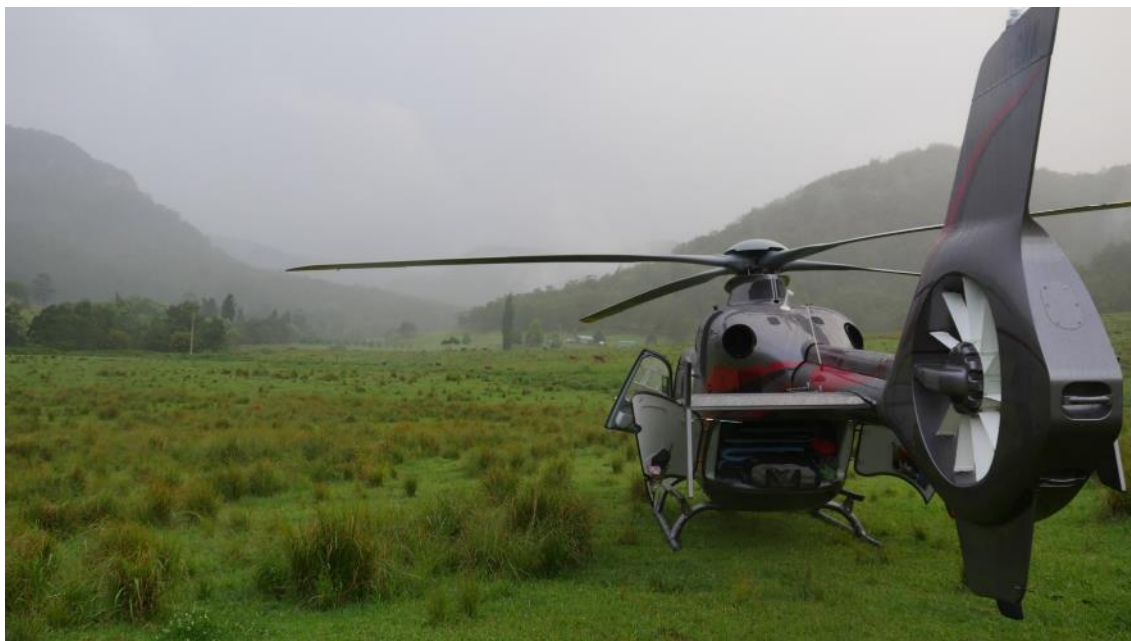
At about 1830, witnesses observed the helicopter return to the valley from the east. The pilot landed the helicopter in an open area within the valley in conditions that witnesses reported as including low cloud, reduced visibility and moderate to heavy rain. One of the passengers took photos of this interim landing site, with two pictures showing the weather conditions at 1901 and 1910 respectively (Figure 4 and Figure 5). During the period that the helicopter was on the ground, the available ambient light varied with the overcast conditions and there was low cloud and drizzle in the area.

Figure 4: Image of VH-GKK at the interim landing site at 1901, facing eastward with obscured, rising terrain in the background

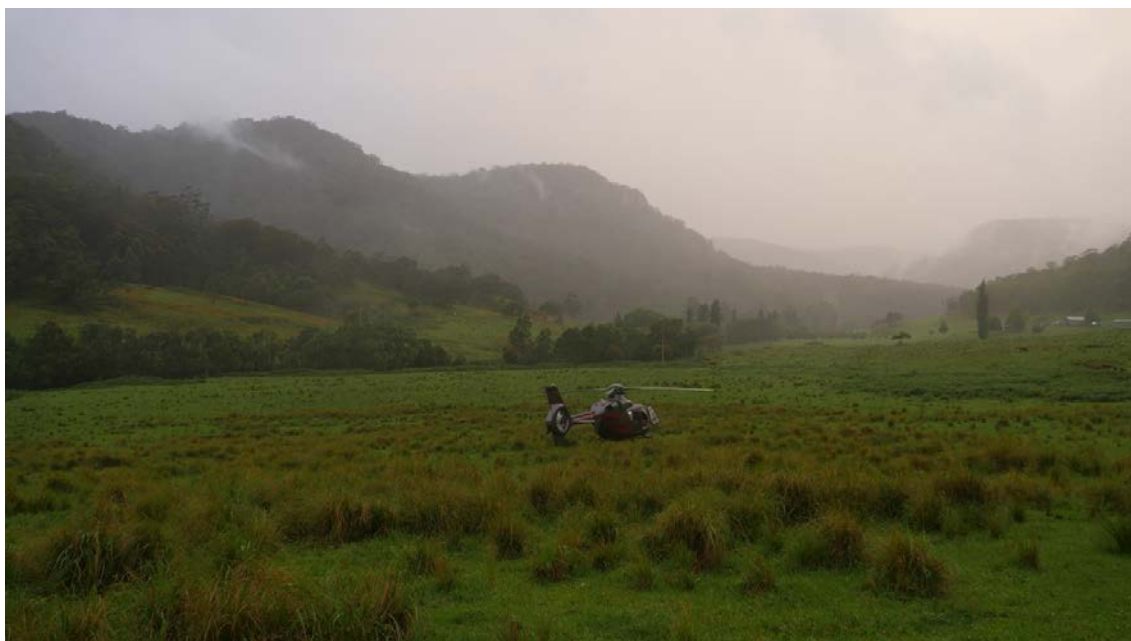
Figure 5: Image of VH-GKK at the interim landing site at 1910

The witnesses noted that the helicopter remained on the ground for about 40 minutes before departing at about 1915. By 1920, the helicopter was observed over a property to the east of the Watagan Creek valley, tracking east toward timbered, rising terrain. The witness reported that the heavy rain had abated to drizzle and the visibility remained low.

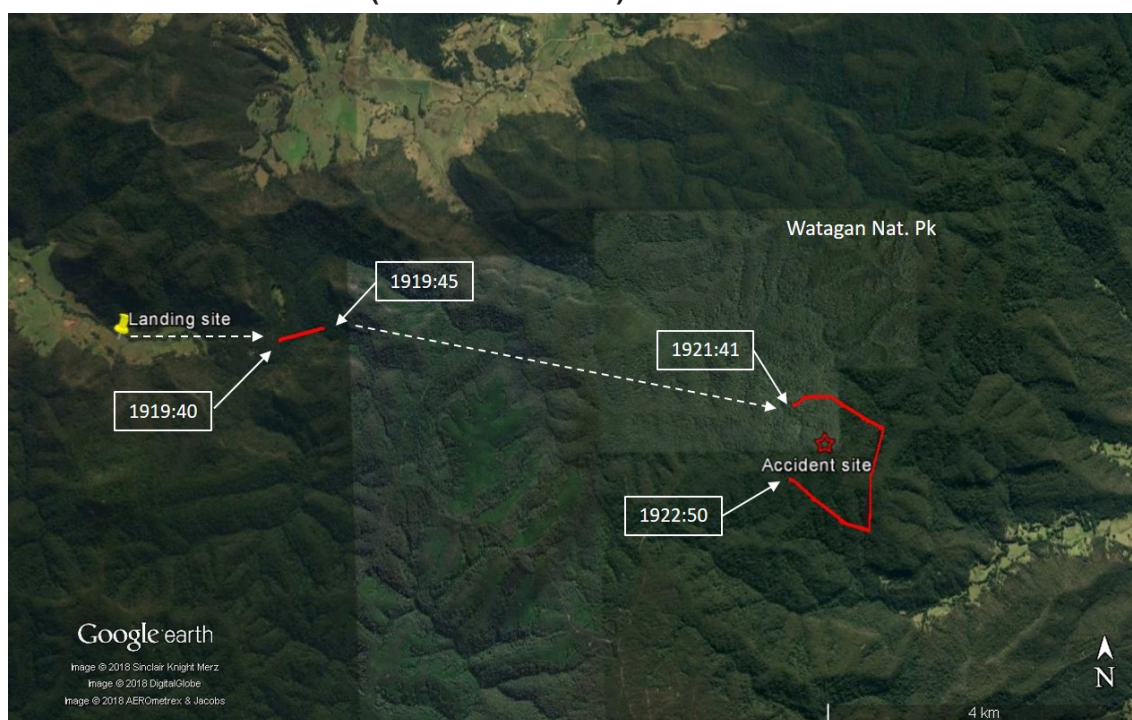
The helicopter had collided with terrain near the top of a ridge on a south-easterly heading and close to the last recorded radar detections at an elevation of 1,340 ft. The time of the accident could not be precisely established but was estimated to have occurred by 1925.

Figure 6: Radar data (solid red line) of the helicopter track after the interim landing with nominal intermediate tracks (dashed white lines) and times

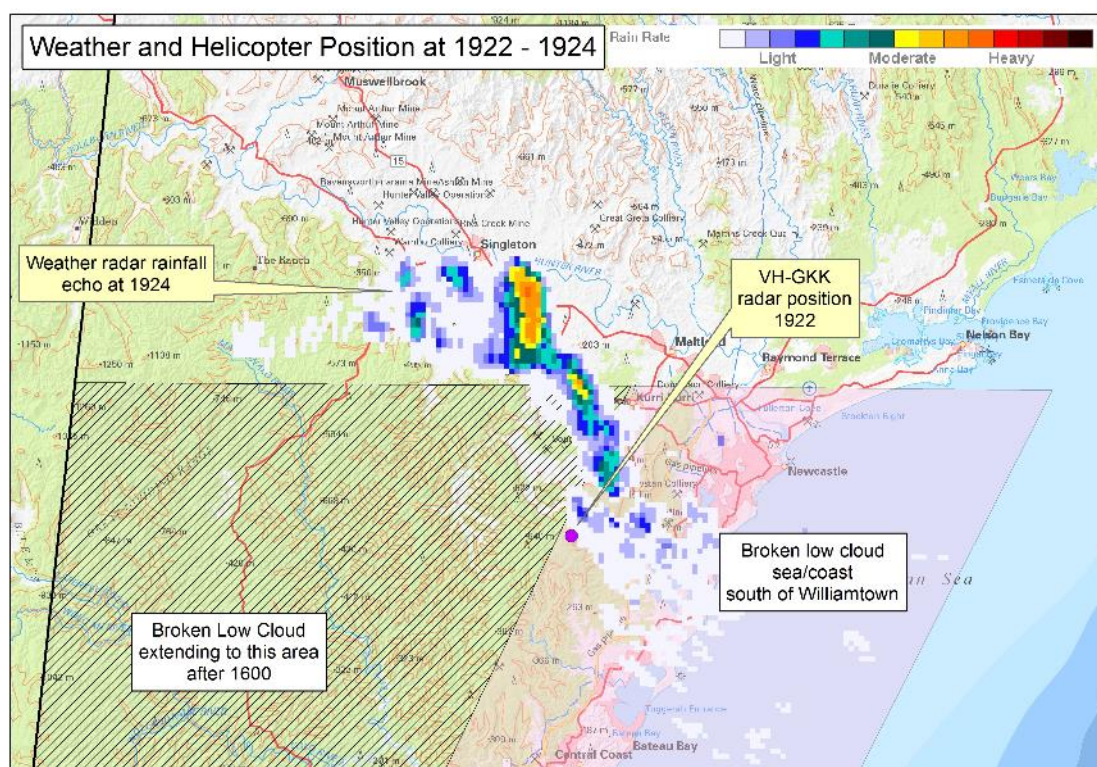
By 1912, the intense elements of the rain/storm front had moved away from the interim landing site but there was still light activity to the east and south-east. When the helicopter was last identified at 1922:50, it was in the vicinity of the light precipitation activity that had moved up the coast and adjacent ranges (Figure 9).

Figure 9: Composite weather image 1922-1924 and position of VH-GKK
