Collision with terrain involving Cessna 206, VH-WZX

Apollo Bay Airfield, Victoria, 31 January 2018

ATSB Transport Safety Report
Aviation Occurrence Investigation
AO-2018-013
Final – 27 April 2018

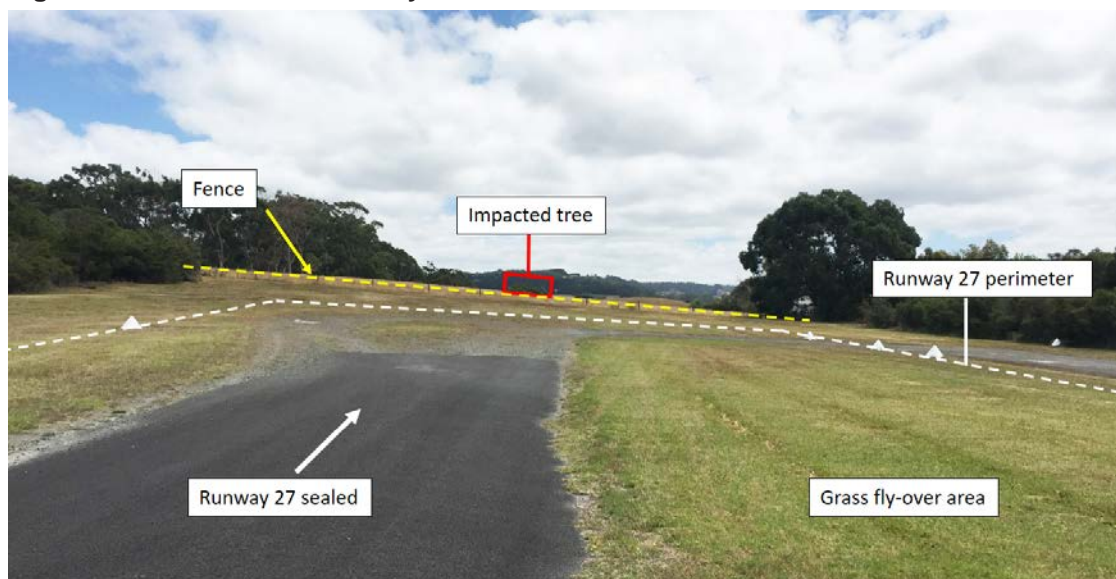
Figure 1: Western end of runway 27

Runway 27 was a 740 m long and 6 m wide sealed runway. A grass fly-over area adjoined the sealed runway along its northern edge (Figure 1). The runway had an overall uphill slope of 2 per cent, however, the slope was not constant along the runway. The first half of the runway had little gradient. About half way along the runway, the slope increased, before increasing further over about the final quarter of the runway. The runway ended on the upslope of a hill. About 35 m from the end of the runway, the airfield boundary was defined by a wire fence. Beyond the fence, the slope gradient reduced over clear ground for about 80 m until reaching the top of the hill. The ground then descended into a valley.

The figure shows the western end of runway 27. The sealed runway and grass fly-over area along with the fence and impacted tree are annotated. Source: Operator, annotated by ATSB

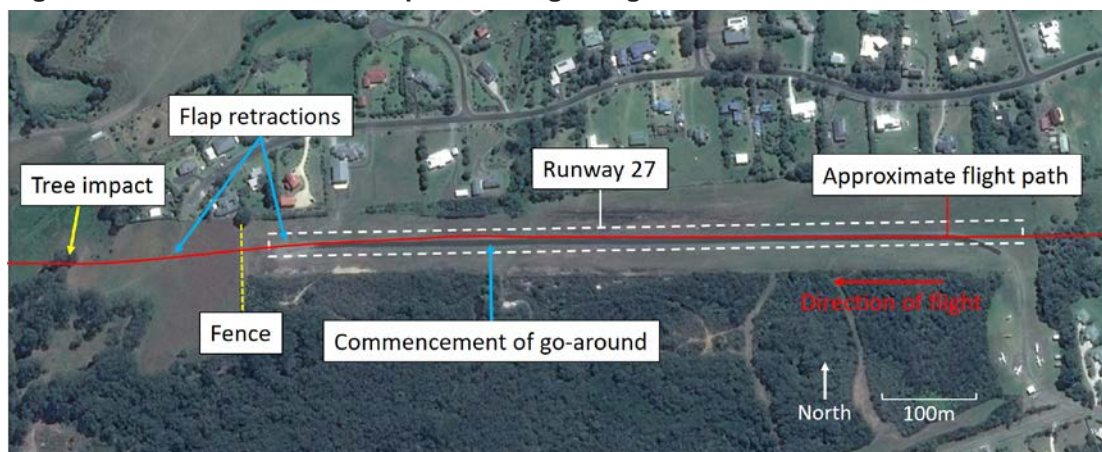
Figure 2: Overview of the attempted landing and go-around

Assessing that insufficient runway length remained to complete the landing, the pilot elected to conduct a go-around (Figure 2). The pilot applied full power and recalled the aircraft nose pitched up to a high attitude. The pilot observed that the aircraft did not climb away from the rising ground as expected, and as the aircraft passed the end of the runway at low height, he retracted the flaps one stage to 20 degrees in an attempt to improve climb performance. The aircraft did not climb sufficiently to clear the airfield boundary fence and the left undercarriage leg struck the fence, sustaining minor damage, including fracturing the brake line.

The figure shows an overview of runway 27, approximate locations of significant events during the incident landing and go-around are annotated. Source: Google earth, annotated by ATSB

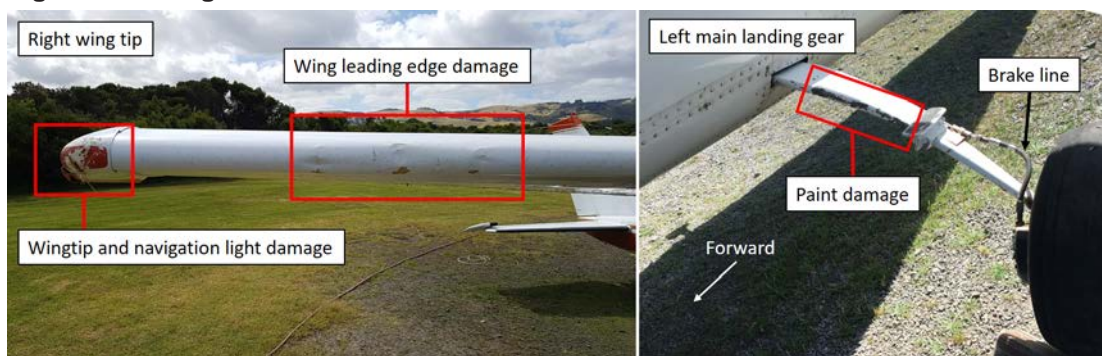
Figure 3: Damage to VH-WZX

No persons were injured during the incident and the aircraft sustained minor damage to the left main landing gear and right wing (Figure 3).

The figure shows the damage to the right wing (left) and left main undercarriage (right). Source: Operator, annotated by ATSB

After the aircraft struck the fence, the pilot did not follow the correct go-around procedure and raised the flaps to 10 degrees before allowing the aircraft speed to increase and ensuring all obstacles had been cleared. The flap retraction resulted in a loss of lift which led to the aircraft descending and impacting the canopy of a tree 225 m beyond the airfield boundary fence.

- For scenic flights requiring runway 27 at Apollo Bay for departure or arrival, the maximum take-off weight has been restricted to 1,563 kg.
