Australian Government
Australian Transport Safety Bureau

Signal control system irregularity

Ballarat, Victoria | 11 August 2016

ATSB Transport Safety Report
Rail Occurrence Investigation
RO-2016-011
Final – 30 April 2018

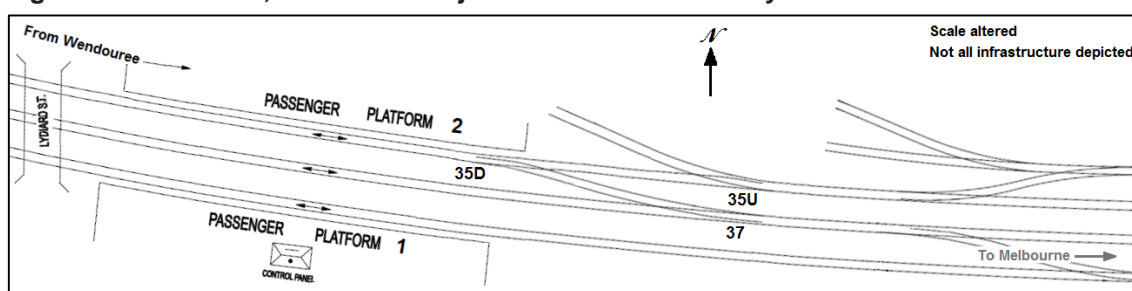
Figure 1: Points 35D, 35U and 37 adjacent to Ballarat Railway Station

To prevent the unintended movement of points, the Signal Maintenance Technician (SMT) in charge of the maintenance group contacted the train controller for the Ballarat location and requested that a Block¹ be applied to motor point Nos 35 (two sets) and 37 (one set) (Figure 1).

Note that the Normal position for points 35U and 35D was for the respective turnouts and not the straight-ahead direction. The Normal position for points 37 was for the straight.

At about 1257, points 35 and 37 moved to meet overlap requirements for the BAT8 to BAT24 route and the full route was established. The previously applied blocks to 35 points (two sets) and 37 points did not prevent their movement during the execution of the route.

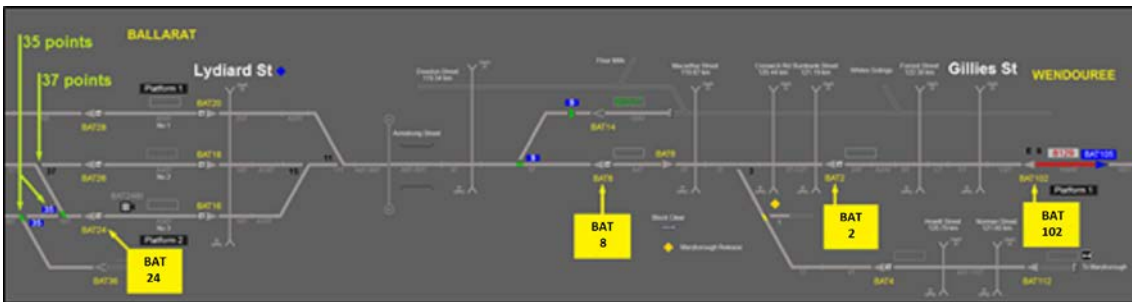
Figure 2: Signal and points status when train 8129 terminated at Wendouree Station

Train 8129 was recorded as leaving Ballarat and then arriving at Wendouree Station at about 1251. At Wendouree, the train was to reverse direction and return to Ballarat Station as train 7130. At this time, 35 points remained Blocked and 37 points were not yet Blocked (Figure 2).

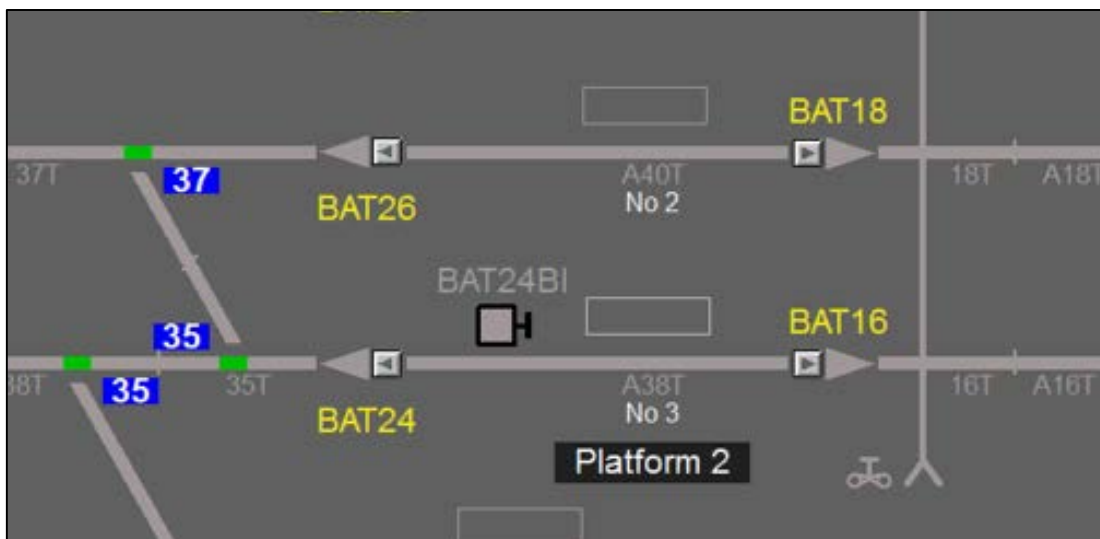
Figure 3: Extract of panel display showing status of 35 and 37 points at 1254:05

A short time later, the recording indicated a number of actions taken by the train controller. Blocking previously applied to 35 points was removed and the points were operated to their Reverse (straight) position, and then the Block re-applied at 1253:43. Then 37 points were operated to their Normal (straight) position and a Block applied at 1254:05 (Figure 3).

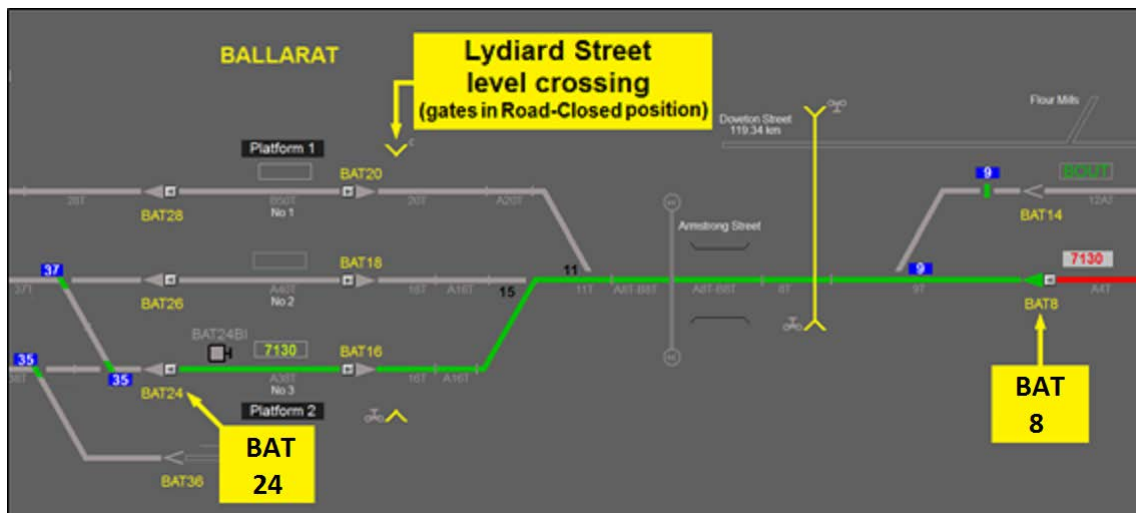
Figure 4: System status when the route from 8 to 24 signal was cleared (green line)

A few seconds later, the TCS recording showed 35 and 37 points had operated and moved to their Normal and Reverse positions respectively. In both cases, the logger recording indicated that Blockings applied by train control had remained, and there was no evidence that the points operation had resulted from a train controller input.

By 1257:48, the system had cleared BAT8 signal for the passage of train 7130. The route was set for the passage of the train to platform 2 at Ballarat Station with 35 and 37 points in their altered positions (Figure 4).

The display shows BAT8 signal cleared for train 7130 to proceed to BAT24 signal (for berthing at platform 2). The Lydiard Street gates are depicted in the Road-Closed position. Blocking facilities (shown in blue) have been applied to both 35 and 37 points.
Source: V/Line TCS recording

The *route-setting* functionality of the TCS system only evaluated the Blocked points between the entrance and exit signals and did not take into consideration the Blocking of points that lay within the overlap. UGL subsequently modified both Factory- and Site-Acceptance test procedures for control of unit-lever relay interlockings to explicitly test the Blocking functionality in overlaps.

- SigView expressions and functionality were modified such that when points are Blocked in a position contrary to that required for a route, then if requested by the train controller the route called will be suppressed by SigView and not stacked

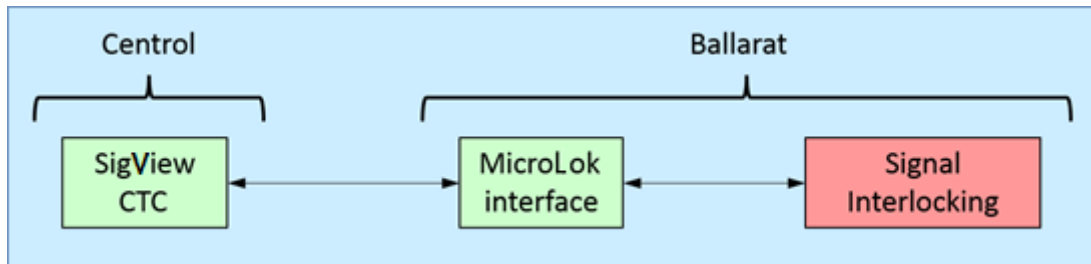
Figure 5: The interface between the SigView, MicroLok and interlocking systems

When CTC was implemented at Ballarat, a MicroLok¹³ computer-based interlocking (CBI) was used to facilitate the interface, allowing the relay interlocking at Ballarat to remain largely unchanged. MicroLok provides the interface between SigView and the relay interlocking (Figure 5).

Combining the points keying functionality with the signal Blocking command had not been implemented for the Ballarat TCS. Consequently, the system did not prevent the interlocking from responding to automatic SigView routing commands for points 35 and 37.
