Grain train 5422N parting and derailment

Parkville, New South Wales | 6 April 2016

ATSB Transport Safety Report
Rail Occurrence Investigation
RO-2016-004
Final – 4 June 2018

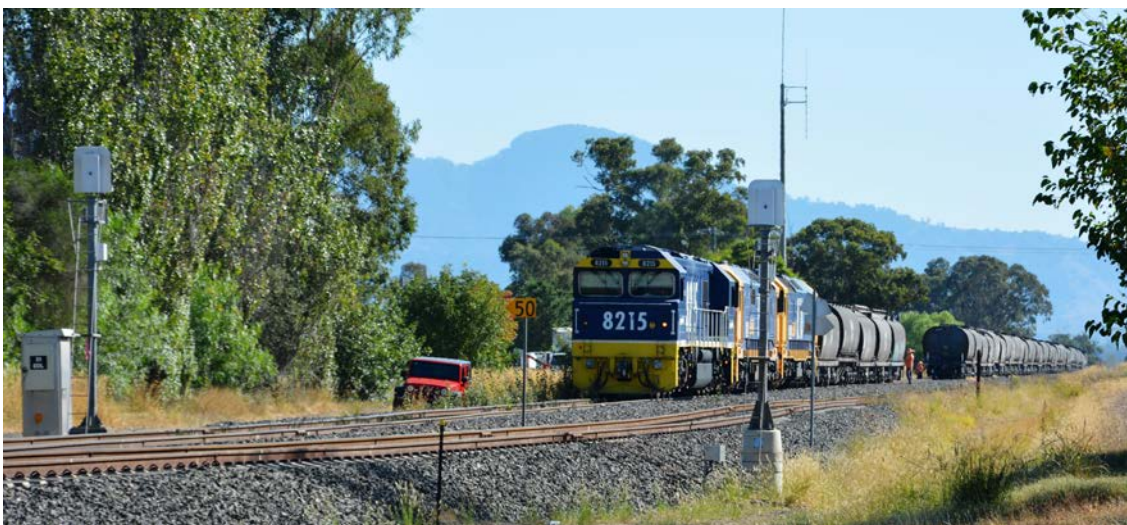
Figure 1: 5422N at Parkville

ATSB observed the train had parted five wagons behind the locomotive (see Figure 1). The draw gear assembly was missing from the rear of the fifth wagon, NGKF 35898X (see Figure 5). The coupler shank was found under the rear axle of the rear bogie of the sixteenth wagon, NGKF 35864R (see Figure 6).

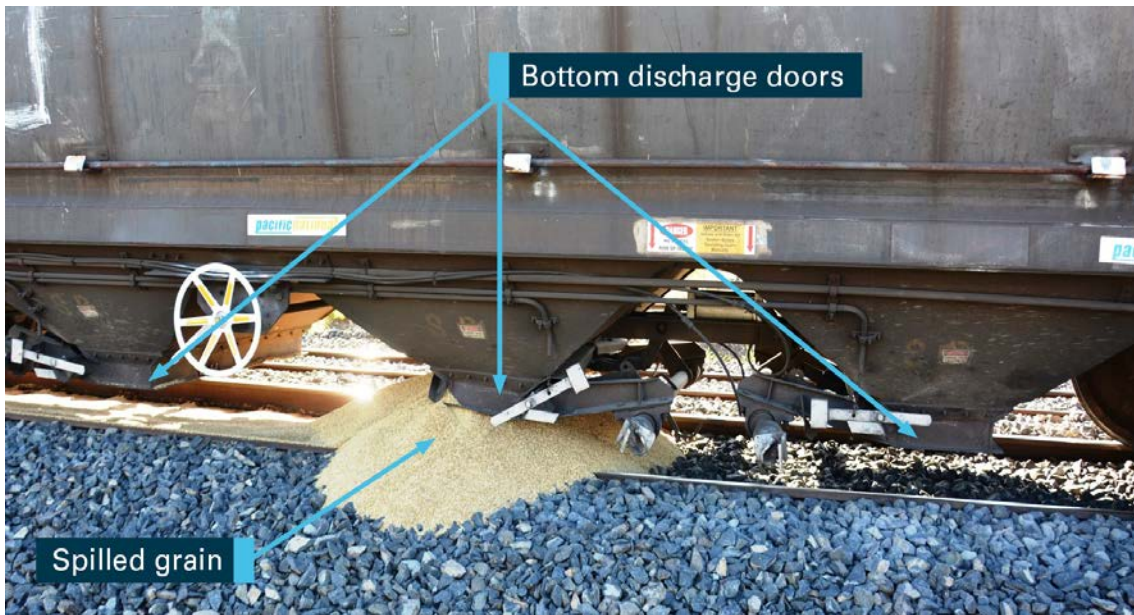
Figure 7: Wagon doors and spilled grain

The bottom discharge doors on 10 wagons had been damaged. Approximately 10 tonne of barley had spilled from the wagons (see Figure 7).

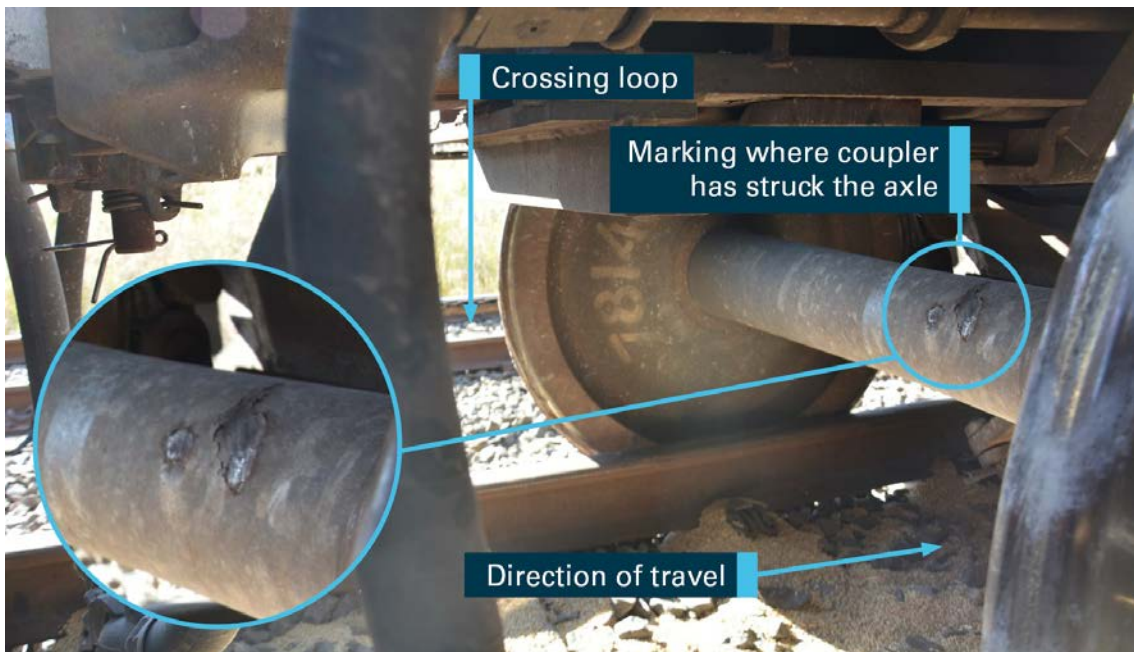
Figure 8: Derailed wheelset

The coupler shank struck the axle of the trailing wheelset on the thirteenth wagon, NGPF 36032J. This resulted in the wheelset derailing near the crossing loop (see Figure 8). The wheelset travelled in a derailed state for approximately 45 m, damaging a number of concrete sleepers, before coming to a stop. (see Figure 9).

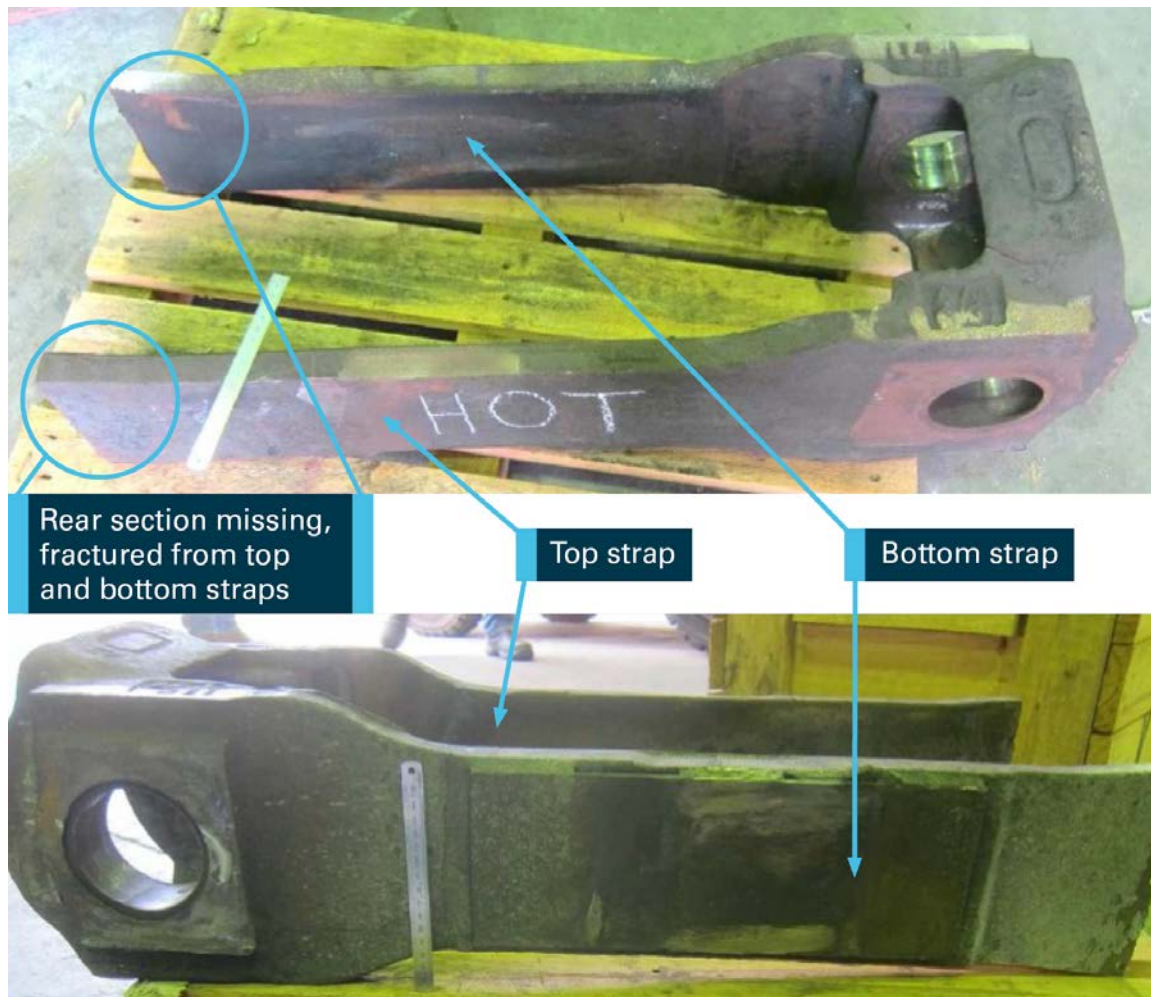
Figure 11: Fractured yoke

The yoke from wagon NGKF 35898X had a manufacture date stamp '10/71'. NGKF wagons were manufactured in 1976. The yoke was approximately five years older than the wagon itself. It was therefore, likely that this yoke was the original yoke fitted to this wagon.

The yoke design had recently been identified by PN as having a finite life due to a propensity to fatigue failure. The tensile strength of the parent metal and the lack of internal rounded relief fillets in high stress areas of the yoke contributed to this issue.

The yoke had fractured at the rear section where the top and bottom longitudinal straps connected with the backing face (see Figure 11).

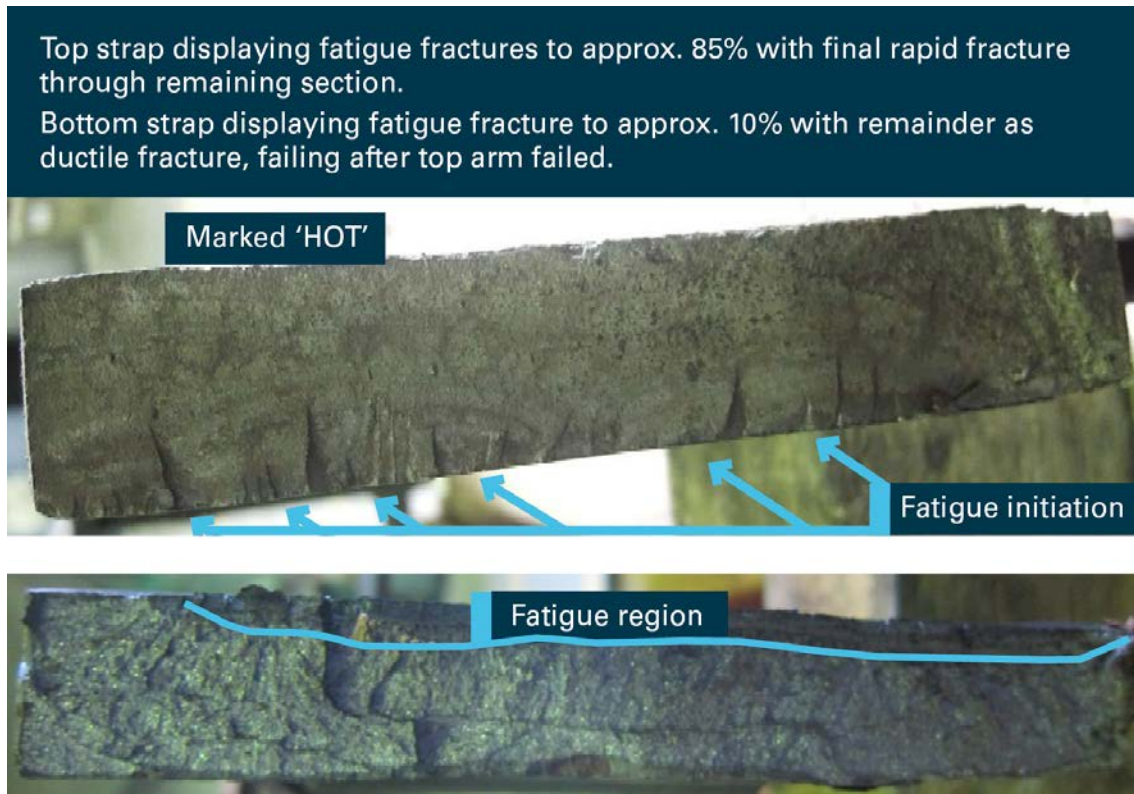
Figure 12: Fracture faces of yoke

PN commissioned Bureau Veritas (BV) to conduct a metallurgical examination to identify the nature of yoke’s failure mechanism. The examination identified that the yoke had failed due to fatigue cracking which had initiated at multiple points on the inner face of the top yoke strap (see Figure 12). Fatigue cracking had progressed through approximately 85 per cent of the material’s cross-section before the ductile failure of the remaining material. The bottom yoke strap subsequently failed with approximately 10 per cent of the material’s cross-section subject to fatigue cracking before the ductile fracture, failing after the top arm failed.

‘it was suspected that the fracture may be due to a material with low toughness properties⁶ being in service for a long time, which was exposed to cyclic stress.’

The BV metallurgical examination focussed on the material properties and while it did not review the design of the component, the report did note that “stresses are concentrated at the critical regions (e.g. radius relief groove, curves, thickness change)”.

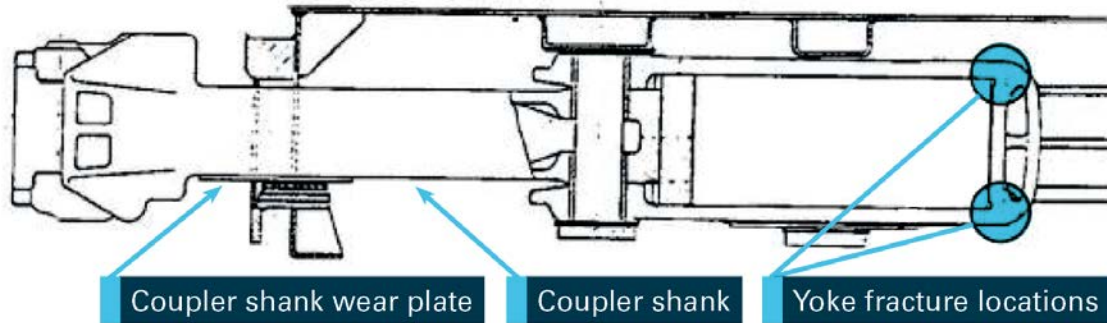
Figure 13: Yoke inspection areas

‘Wagons manufactured before 1980 used lower grade steel in the draft gear castings and do not have a relief fillet in the rear top and bottom inside corners as identified in the picture below (see Figure 13) (i.e. sharp radius). Replace these when found.’

These requirements specified in PN’s WMM suggests the yoke on wagon NGKF 35898X should have been identified and replaced at the last maintenance intervention.

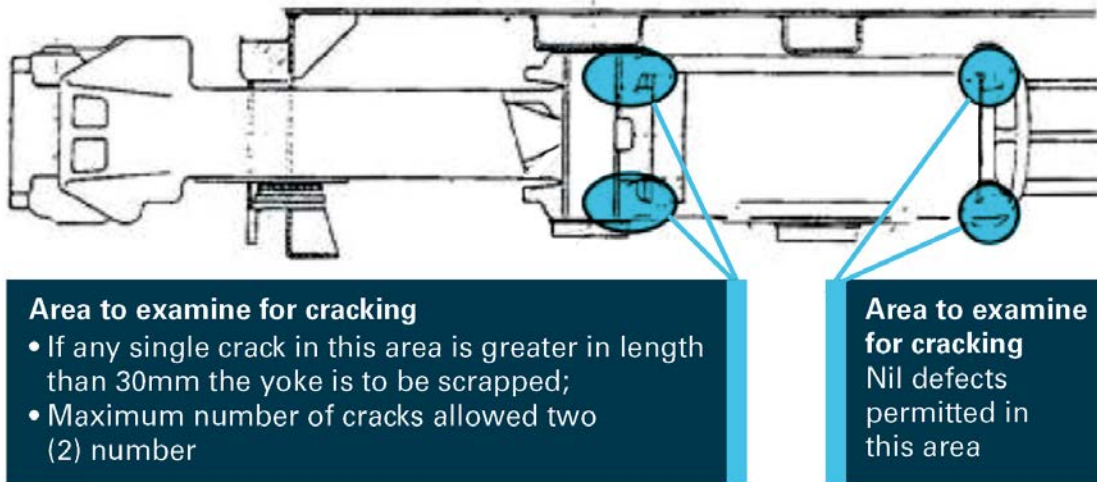
Figure 14: Yoke inspection areas

Additionally, the location of the yoke in situ makes it challenging for the wagon maintainer to identify cracking in the yoke. As pictured in Figure 14, the wagon maintainer is required to inspect the highlighted areas. As Figure 15 shows, the access to view these areas while the yoke is in situ is difficult and potentially restricted by time constraints in the maintenance opportunity.

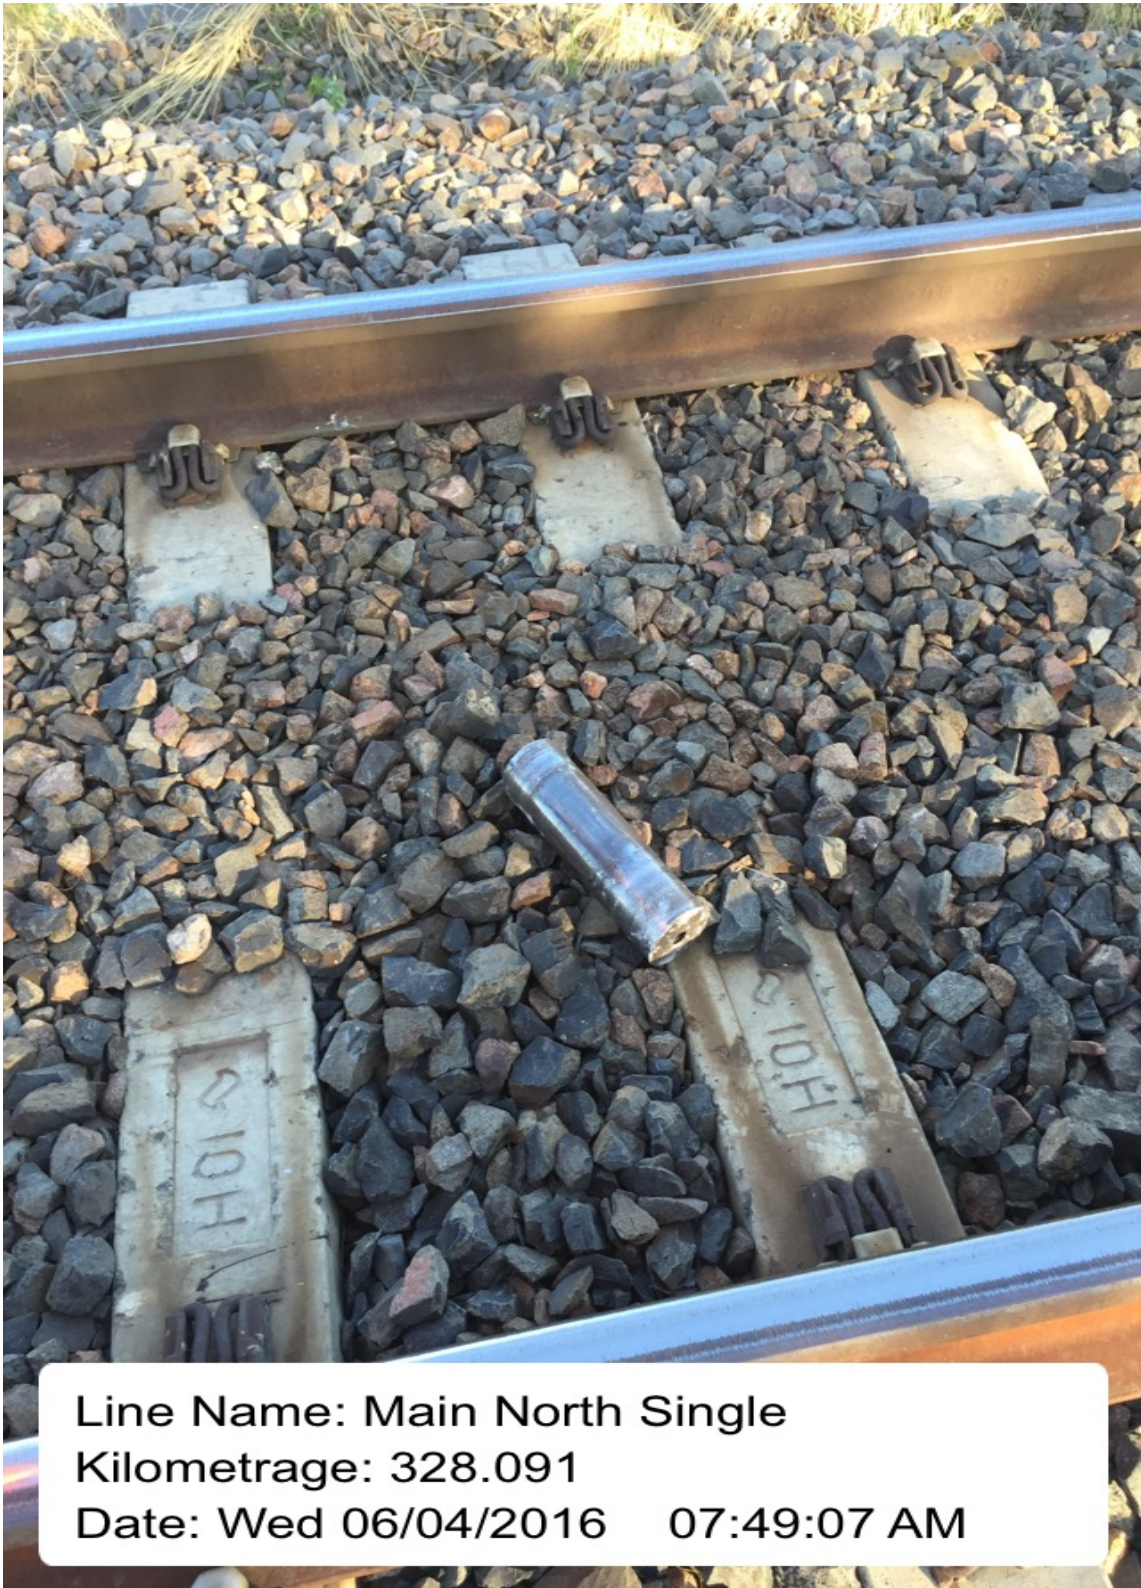
Figure 16: Yoke pin lying in the four foot

The yoke pin was found nearly 6 km before Parkville. There was a constant falling grade towards Parkville and the train driver was using dynamic braking to control train speed. Therefore, the wagons of the train generally remained in a compressed state ensuring the train did not part.

On account from the driver, there is a slight incline after Wingen just prior to the downhill into Parkville. At this point the driver allowed the train to roll freely through the section of track to maintain speed. This coincides with a releasing of the buffering or compressive forces in the draw gear. The yoke pin most likely fell from the train at this point which is where it was found during inspection post incident (see Figure 16).

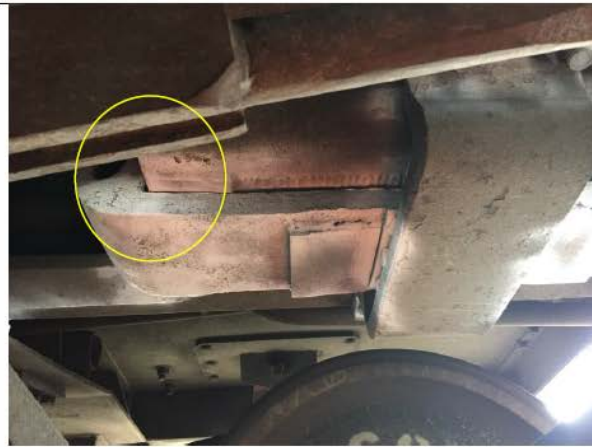
Figure 3 Yoke with no relief fillet

Wagons manufactured before 1980 used lower grade steel in the draft gear castings and do not have a relief fillet in the rear top and bottom inside corners as identified in Figure 12 (i.e. sharp radius). Replaced these when found.
