Australian Government
Australian Transport Safety Bureau

Power plant failures in turboprop-powered aircraft

2012 to 2016

ATSB Transport Safety Report
Aviation Research Investigation
AR-2017-017
Final – 15 June 2018

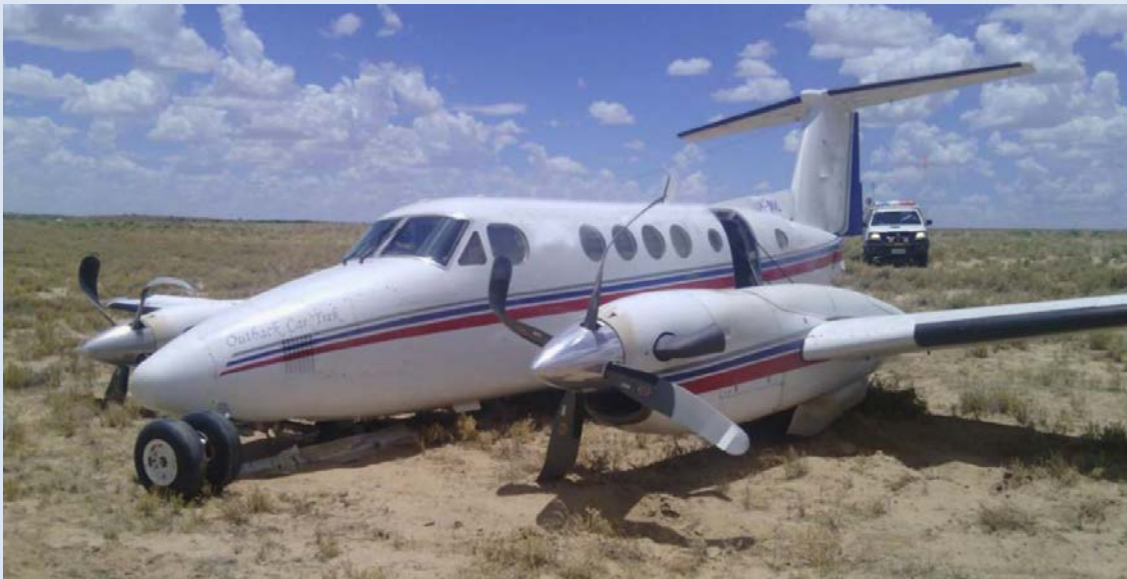
On 13 December 2016, a Beech Aircraft Corporation B200 conducted a flight from Innamincka, South Australia (SA) to Moomba, SA for a medical clinic. On board the aircraft were the pilot and two passengers. On arrival at Moomba, the pilot configured the aircraft to join the circuit. At about the base turn point, the pilot observed the left engine fire warning had activated. The pilot decided to conduct the immediate actions for an emergency engine shutdown. The pilot retarded the left engine condition lever to the fuel shut-off position, paused, then closed the firewall shut-off valve and activated the fire extinguisher.

The pilot continued to fly the aircraft around base, but noticed it was getting increasingly difficult to maintain the right turn. The aircraft had flown through the extended runway centreline when the pilot sighted the runway out to the right side of the aircraft. The aircraft was low on the approach and the pilot raised the landing gear and retracted the flap to reduce the rate of descent. The pilot then lowered the landing gear and continued the approach to the runway from a position to the left of the runway centreline. The aircraft landed in the sand to the left of the runway threshold and after a short ground roll spun to the left and came to rest. There were no injuries, however the aircraft was substantially damaged.

VH-MVL accident site

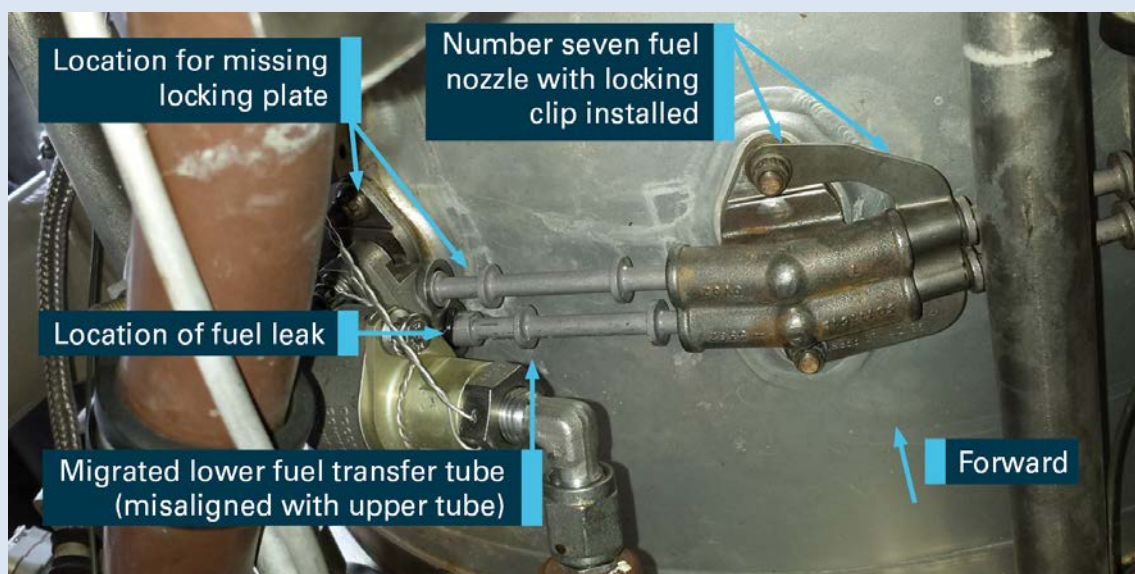
A post-incident examination of the engine found the number eight fuel nozzle locking plate missing (see below). This allowed the fuel transfer tube to migrate out of the number eight fuel nozzle adaptor. There was no damage to the locking plate mounts.

VH-TYV fuel transfer tube and location of the fuel leak

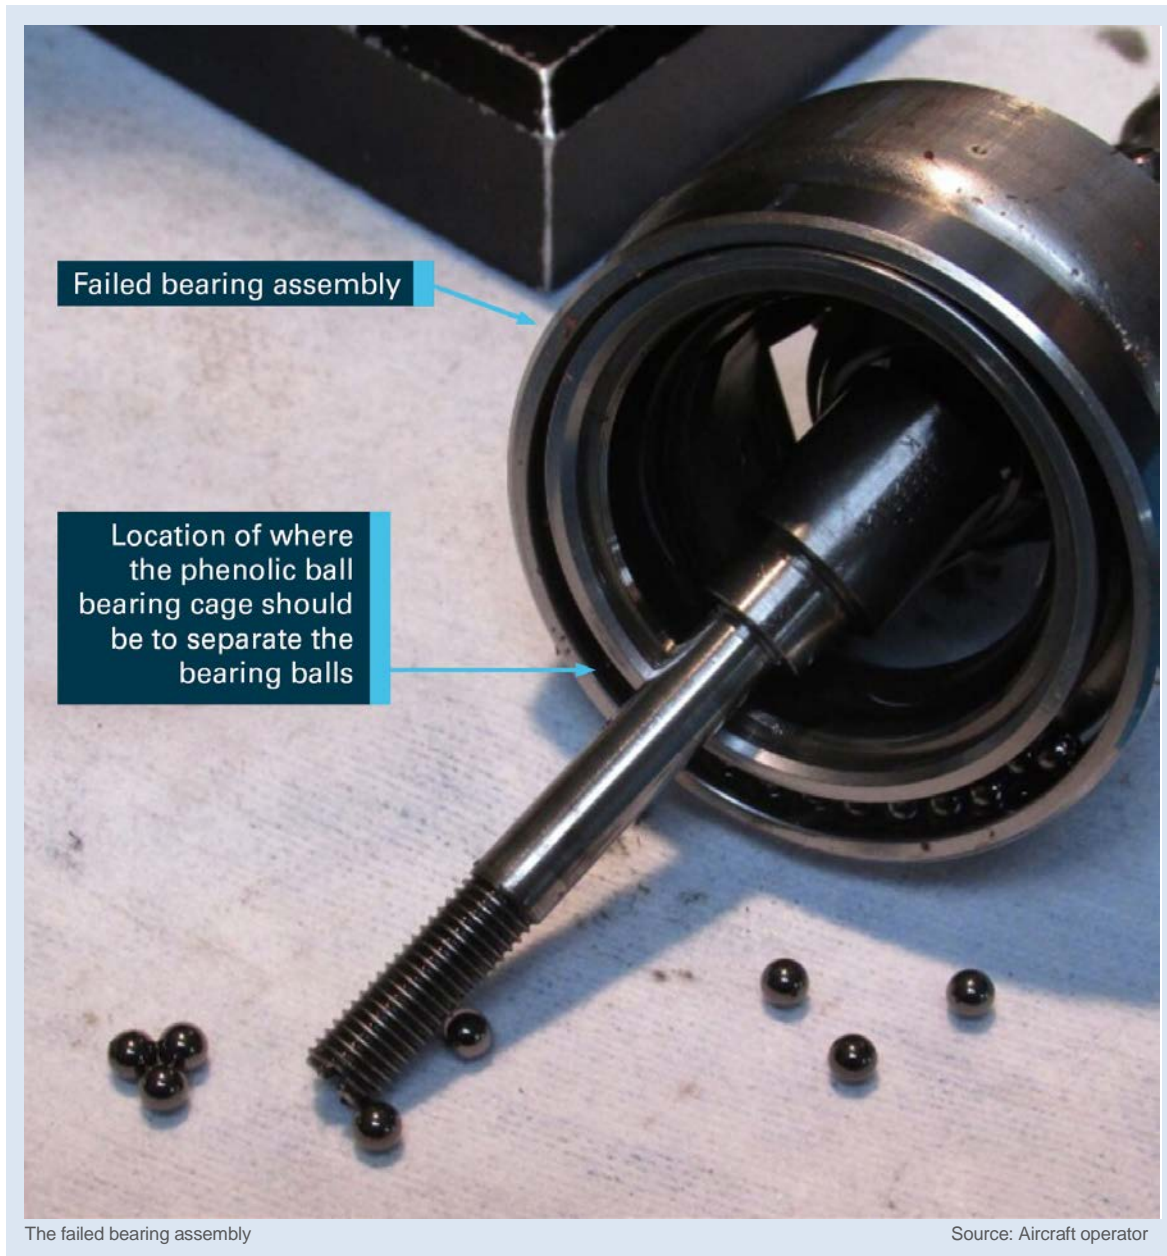
Aircraft maintenance personnel inspected the right engine after the flight and found that the engine's fuel control unit was at fault. An examination of the fuel control unit at a component overhaul facility found that the input drive shaft was not free to move. The fuel control unit was inspected and a bearing was found to have failed. The phenolic bearing cage that separates the bearings was found broken with many small fragments found to be interfering with the operation of the fuel control unit in that area.

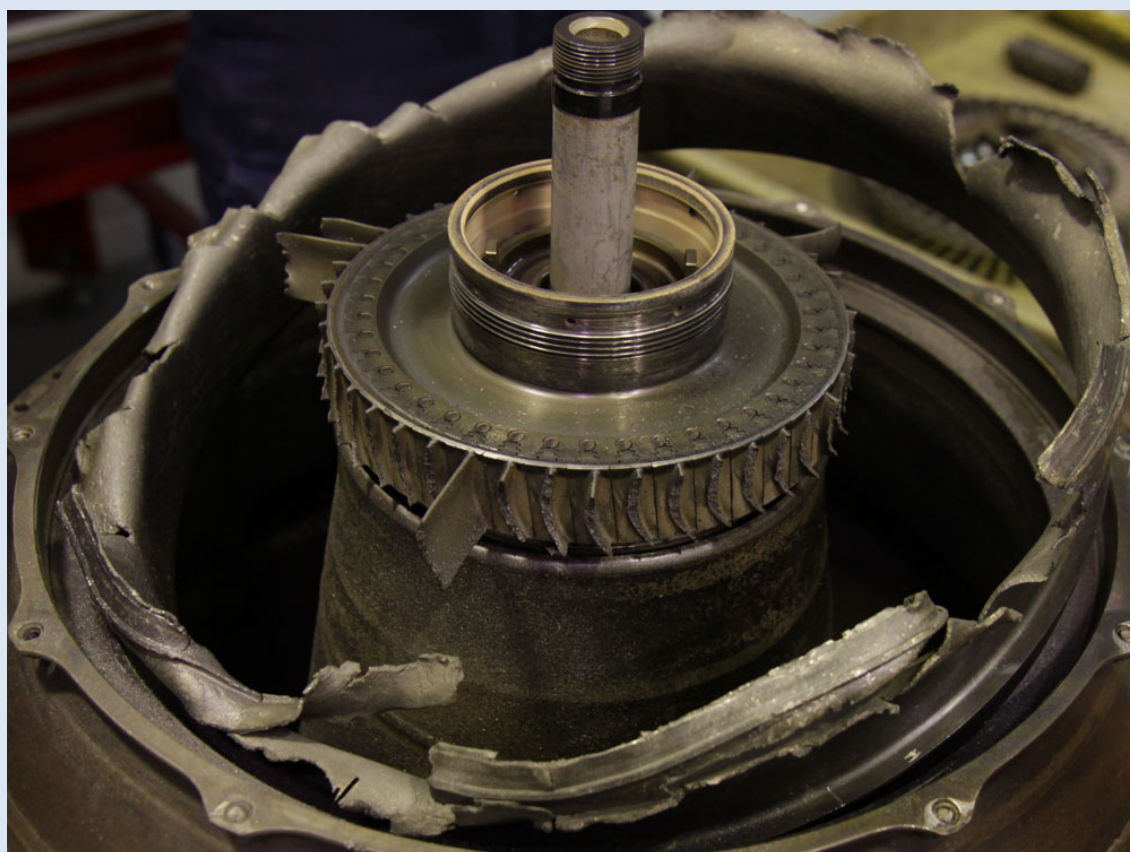
On 12 September 2013, a twin-engine Beech Aircraft Corporation, Model 200 Super King Air was conducting a passenger charter flight from Utirik Atoll to Marshall Islands International Airport (Majuro Atoll). About 40 minutes into the flight, while in cruise to the destination, the pilot observed abnormal oil pressure indications for the left engine and approximately 2 minutes later the engine failed. The crew secured the engine and elected to continue with the original flight plan. The aircraft landed at Majuro Atoll without further incident. The failure of the left engine, a Pratt & Whitney Canada PT6A-41, resulted from fatigue cracking and breakdown of the first-stage sun and planet gears in the propeller reduction gearbox. The specific factors contributing to the initiation of the gear breakdown could not be positively identified.

Remnants of the second stage power turbine disk

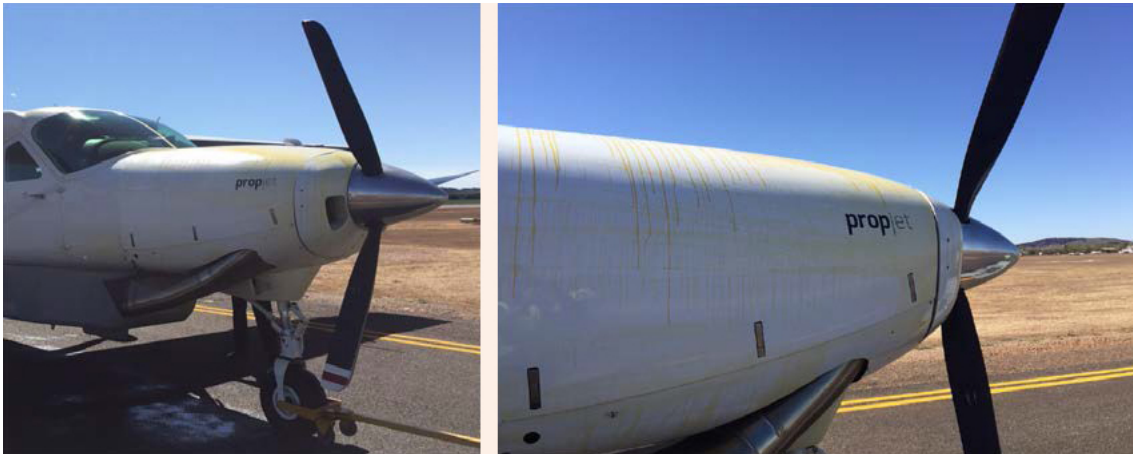
- [ATSB investigation AO-2015-094](#): At about 0930 Western Standard Time, a Cessna 208B, registered VH-LNH, departed Kununurra, Western Australia, on a scenic flight to the Bungle Bungle Range. On board were the pilot and 12 passengers. Soon after take-off, oil began leaking from the engine area, forming an opaque film on the windscreen. The pilot also found that there was insufficient thrust to maintain level flight. Despite substantially limited forward visibility due to the film of oil on the windscreen, the pilot was able to return to Kununurra and land. Subsequent inspection of the aircraft showed that the propeller had feathered and seized. Aside from the apparent damage to the engine/propeller system, there was no damage to the aircraft, and no injuries. Inspection of the engine showed that an oil leak had developed from a join between the oil transfer elbow and oil transfer tube at the forward end of the engine.

Figure 13: Photographs of VH-LNH after the aircraft had landed, with oil visible on the engine cowl and forward fuselage.
