Tail rotor driveshaft failure involving Bell 206, VH-CHO

30 km S of Bathurst Airport, New South Wales, 21 November 2016

ATSB Transport Safety Report

AO-2016-159

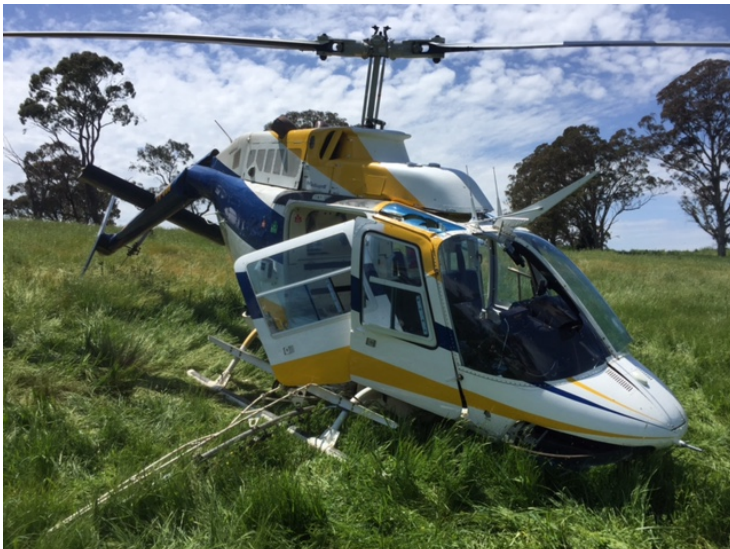
Figure 1: Accident site showing damage to VH-CHO

The electronic locator beacon activated on impact. The pilot and passenger sustained minor injuries and the helicopter was substantially damaged (Figure 1).

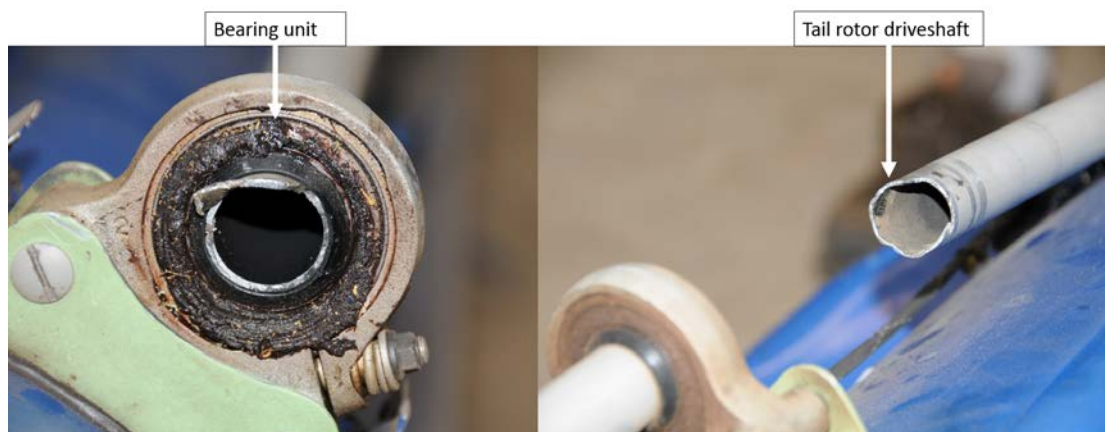
Figure 2: Fractured tail rotor driveshaft

The tail rotor driveshaft had fractured at the No. 2 bearing (Figure 2).

The tail rotor blades were undamaged in the impact, which indicated that they were probably not rotating when the helicopter collided with the ground. There were scrapes inside the tail rotor driveshaft cowling, which indicates that the shaft was probably rotating when it fractured.

The helicopter manufacturer inspected the tail rotor driveshaft and found that it fractured as a result of fatigue cracking. The origin of the fatigue was associated with an area of corrosion pitting, intergranular corrosion and associated cracking on the outside surface of the driveshaft tube, around both sides of the second hanger bearing inner ring location. The driveshaft was otherwise found to comply with the manufacturer's requirements.

- The tail rotor driveshaft tube fractured as a result of fatigue cracking that likely originated from corrosion pitting on its outside surface. This resulted in a loss of tail rotor authority.
- The helicopter was low and slow when tail rotor authority was lost, limiting the time available for the pilot to assess the circumstances and manage the forced landing.
