AVIATION  
SAFETY  
DIGEST

100

DEPARTMENT OF TRANSPORT - AUSTRALIA

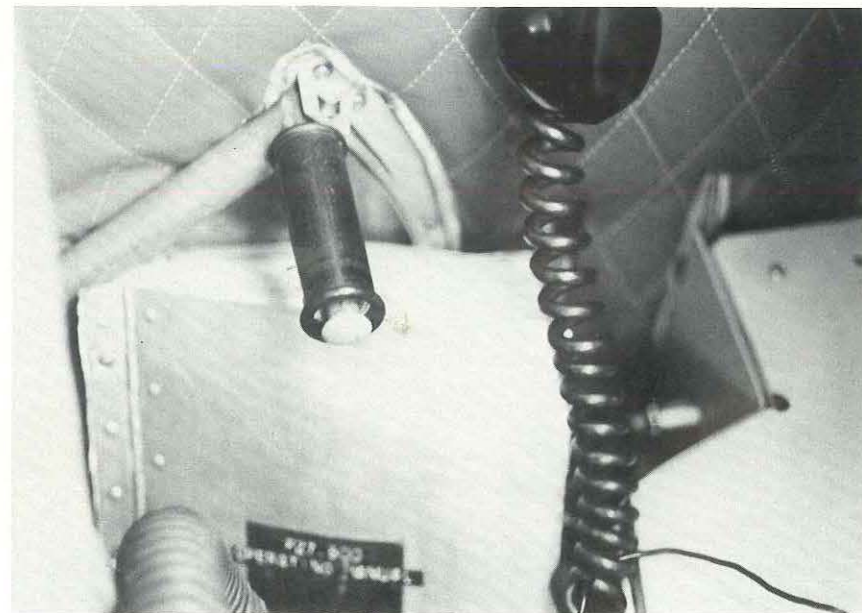
*The area behind the left-hand seat showing how the aircraft's operations manual applied pressure to the gust lock lever handle when the manual was forced into an upright position by rearward movement of the seat.*

flight position, the manual could be positioned in such a way that, when the gust lock handle was lowered, the manual prevented the handle reaching its full down position and engaging in the unlocked detent. Yet in this position all the controls were free and the power levers were not baulked. Furthermore, when the seat was slid back from its forward position, the consequent rearward and upward movement of the manual pushed the gust lock handle fully up so that it engaged in the locked detent.

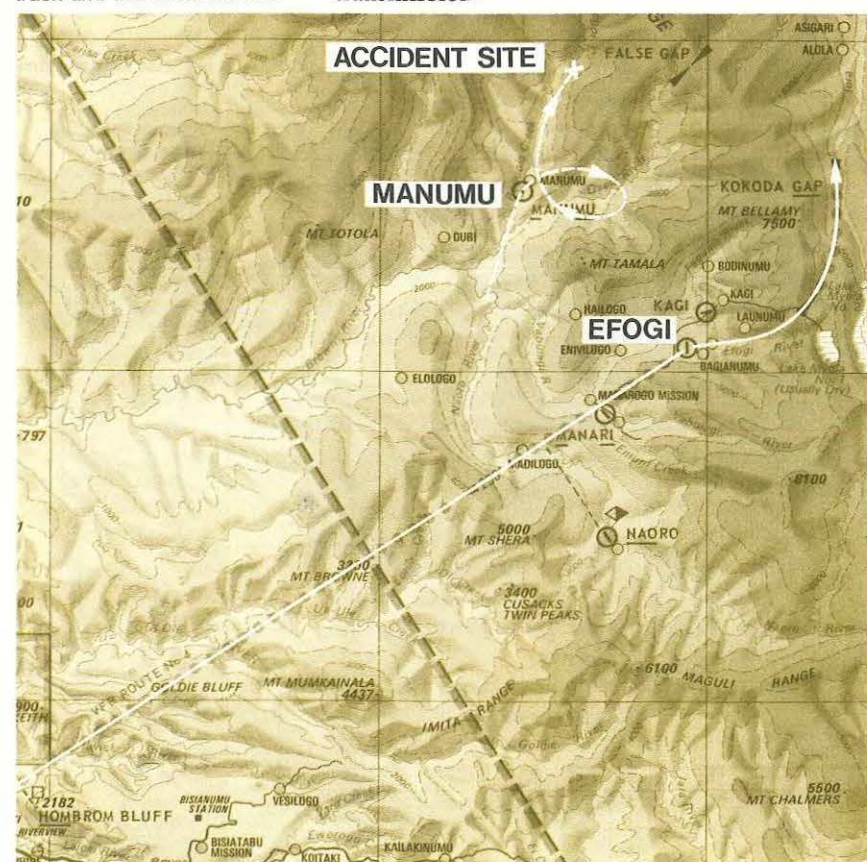
A section of the Port Moresby Visual Terminal Chart showing the Aztec's flight planned track and the accident site.

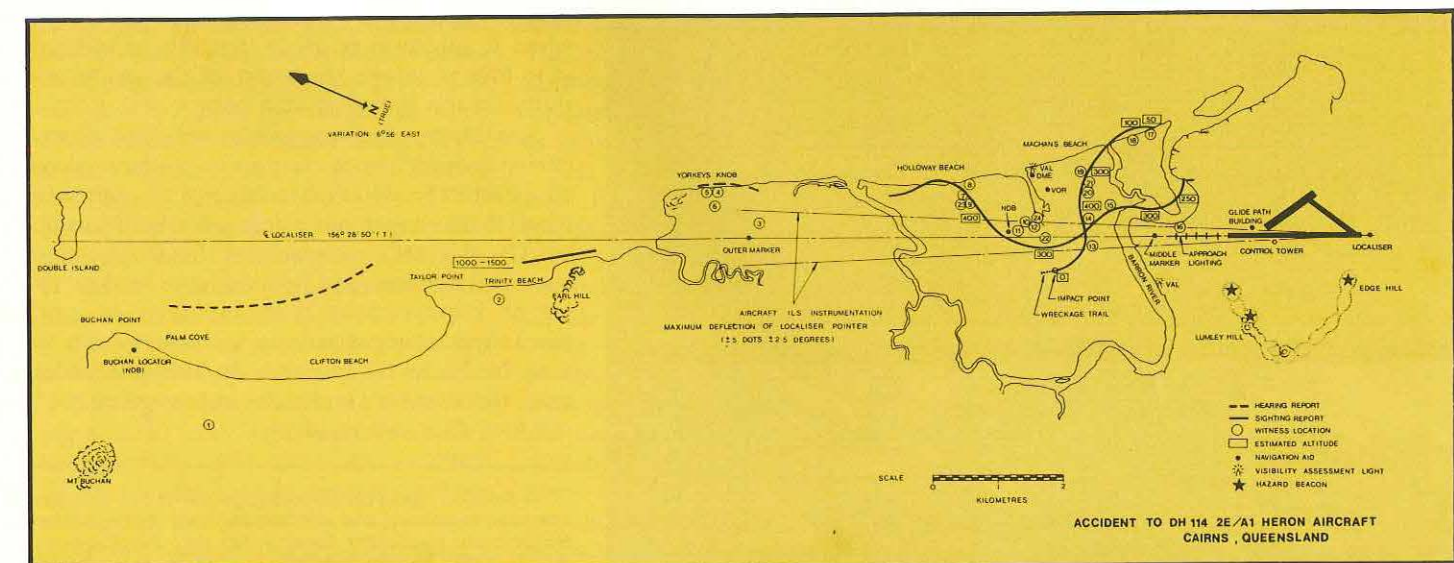
The witness evidence clearly indicates that, after reporting leaving the Buchan Locator, the aircraft did not conform precisely with the ILS procedure, nor subsequently, after the captain found he was unable to continue with the landing, with the missed approach procedure. The witness evidence suggests that, shortly after commencing the final approach, the captain reverted to flying the aircraft by visual reference and continued to do so until the aircraft crashed. There is no doubt that the

*Reconstruction of the aircraft's final flight path as determined from witness evidence.*

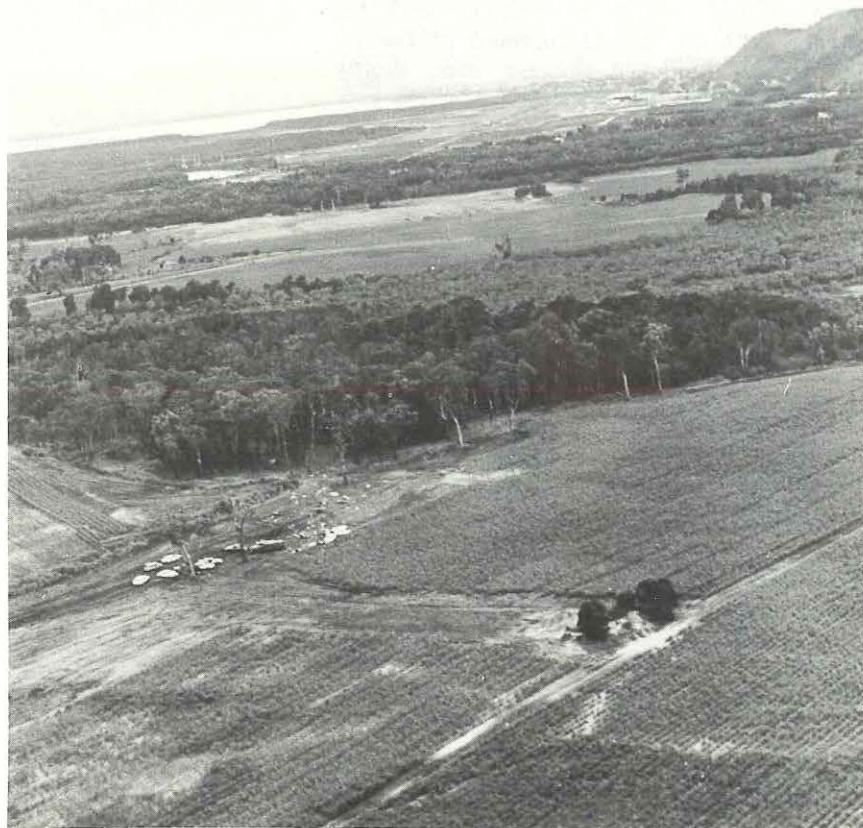
The site of the crash was a little less than three kilometres from the threshold of runway 15 on a bearing of about 333 degrees true. The aircraft had first struck the tops of trees twenty metres high in a nose-down attitude whilst steeply banked to starboard, the impact heading being approximately 332 degrees true (i.e., away from the airport). After cutting a swathe through the trees, the aircraft had struck an adjoining cleared area of ground and broken up. From the point of first impact, the wreckage trail extended for about 180 metres.

Aerial view of accident site looking in the direction of Cairns airport. The direction of impact was in a direction towards the right of the camera.

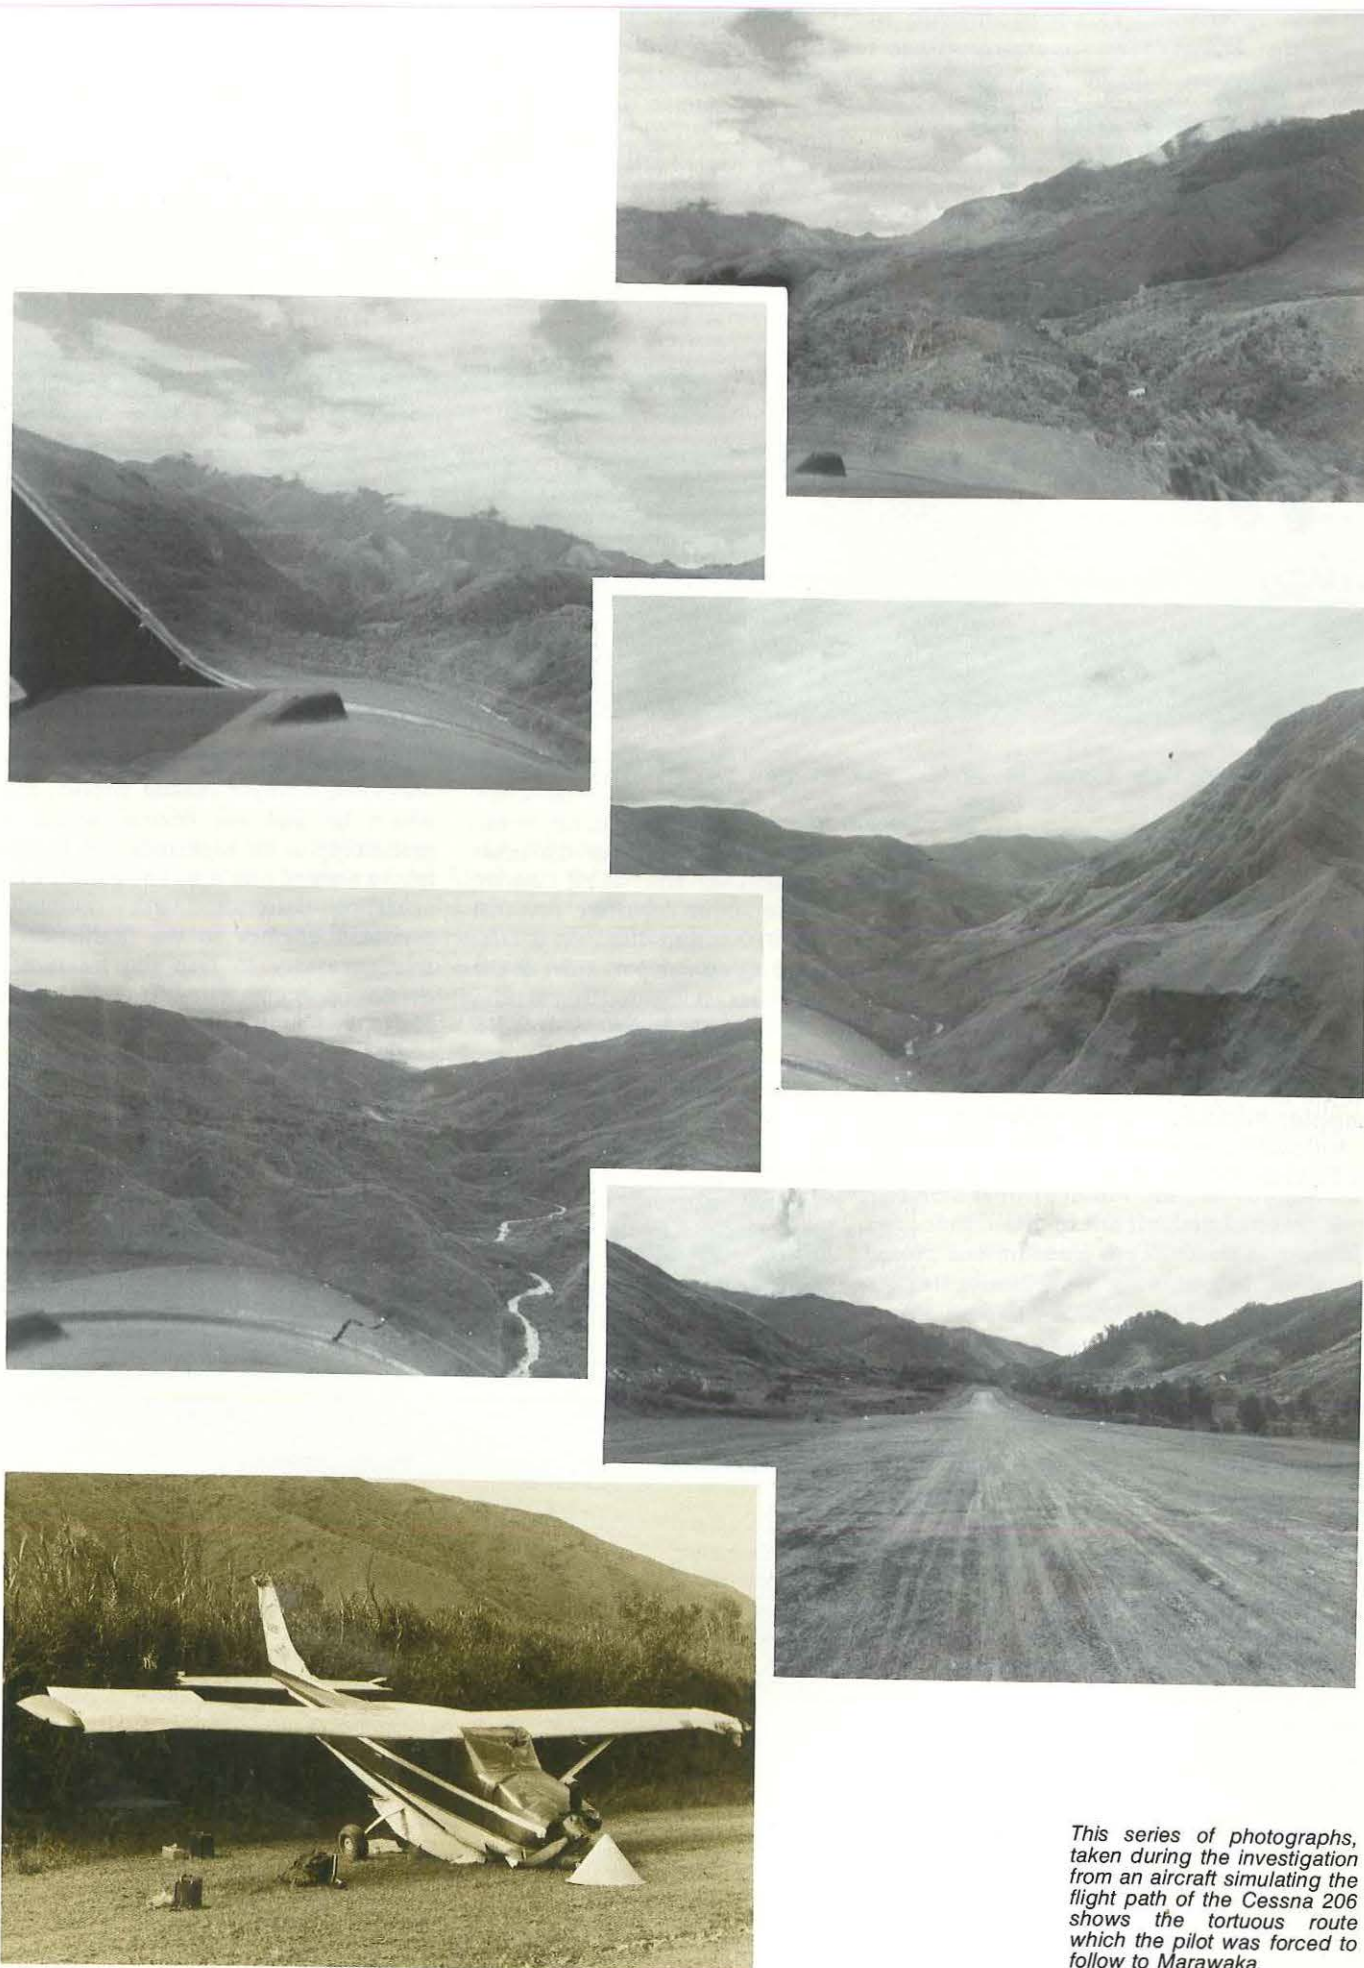
*This series of photographs, taken during the investigation from an aircraft simulating the flight path of the Cessna 206 shows the tortuous route which the pilot was forced to follow to Marawaka.*

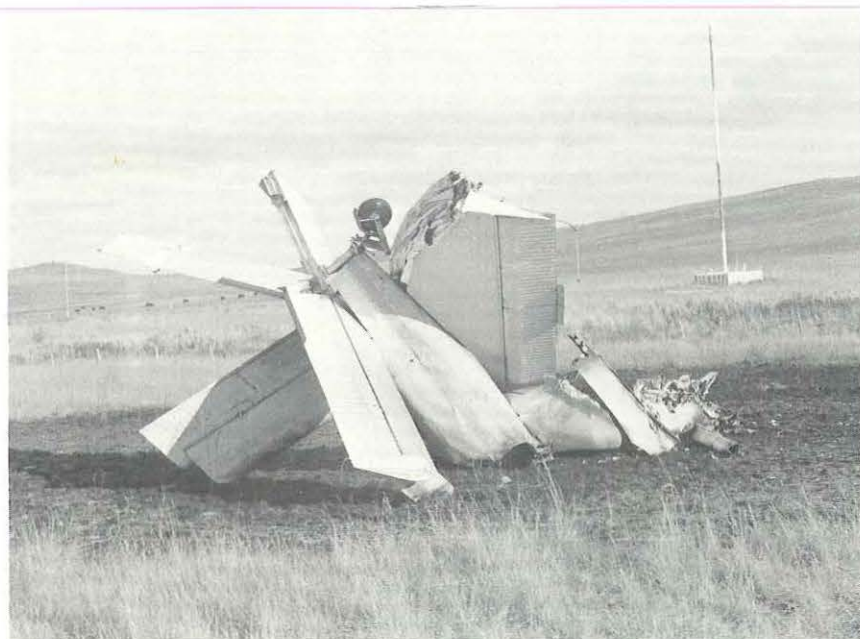
Burnt-out wreckage of the Pilatus Porter. The damaged transmitter mast can be seen in the background.

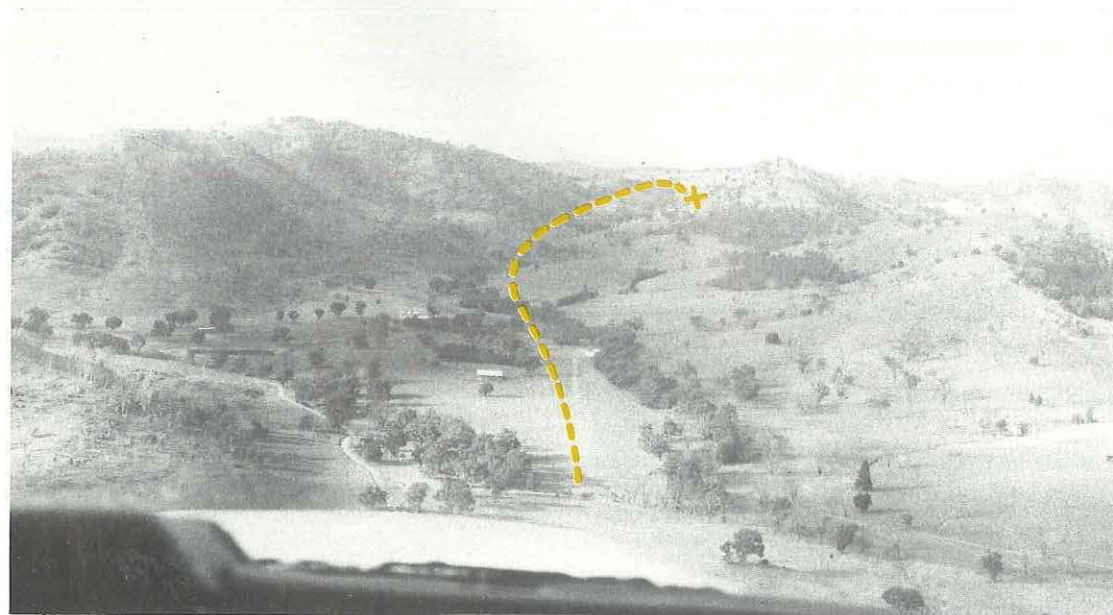
An aerial view of the accident site showing the strip on which the Cessna attempted to land, and the aircraft's subsequent flight path.
