COMMONWEALTH OF AUSTRALIA
DEPARTMENT OF CIVIL AVIATION

AVIATION SAFETY DIGEST

OCTOBER, 1953

Prepared by The Accident
Investigation and Analysis Branch

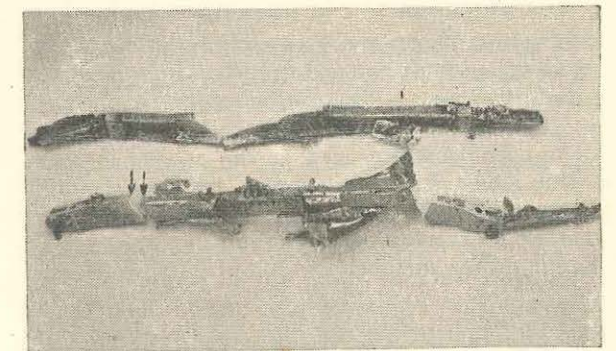
The centre section main spar of VH-AQO sustained substantial damage in the accident, the upper member being in two major pieces (with a portion of one missing) and the lower member in three pieces. Most of the sheet metal web had been torn away. The various pieces of the assembly in the original relative positions are shown in Fig. 1.

Figure 1.—Fractured Portions of Centre Section, Main Spar Boom, assembled in their original relative positions. Port side of assembly is at left, starboard side at right. Arrows indicate fracture surfaces illustrated in Figures 2 and 3.

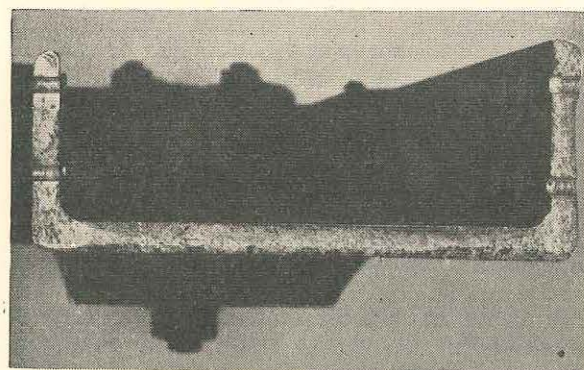
Figure 2:—

Fracture surface on outboard portion of lower channel member 11 inches from port end of centre section showing fatigue-cracking in near rib of channel (left).

As shown in Figs. 2, 3 and 4 fatigue-cracking had originated at a rivet hole in the rear rib of the lower channel section. Visual, radiological and fluorescent examination of the rivet holes in the corresponding area at the starboard side of the lower member, showed no evidence of similar cracking in this region. There was no evidence of fatigue-cracking at any other rivet hole in either member.

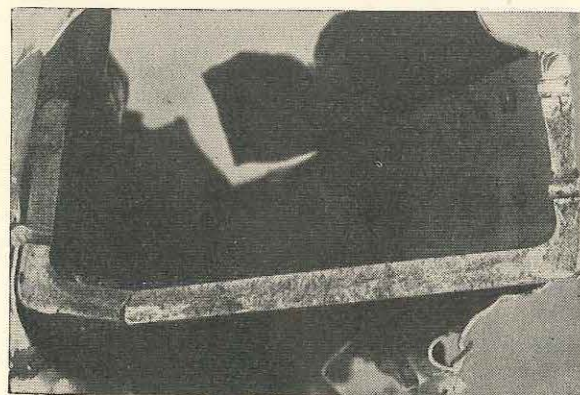
Figure 3:—

Fracture surface on inboard portion of lower channel, mating with fracture shown in Fig. 2.

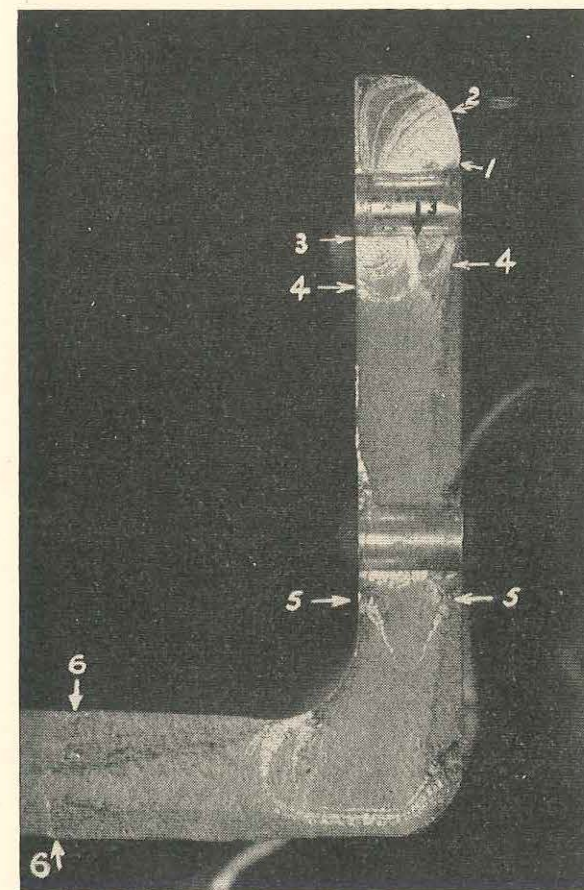
Examination of the zone in which fatigue-cracking had developed (see Fig. 4) showed that cracking had progressed, prior to failure of the structure, by alternate slow and rapid propagation, to such an extent that the crack covered the full depth of the channel rib and extended about $\frac{3}{4}$ inch into the base of the channel (as measured on the outer surface); the mechanism of its development can be traced in detail by reference to Fig. 4. A primary fatigue crack originated at the outer end of the upper rivet hole (arrow 1 in Fig. 4) and progressed through about 30 per cent of the section between the rivet hole and the edge of the rib. At that stage, a rapid jump from the then extremity of the fatigue crack occurred, this rapid crack occupying the dark band indicated by arrow 2 in Fig. 4. This was followed by further slowly progressing (fatigue type) cracking, a further rapid crack, then more fatigue-cracking and so on until the full section above the rivet hole had cracked through. (The zones of fatigue and rapid cracking can be seen in Fig. 4 as alternate bright and darker bands respectively). Further fatigue cracks originated at the lower surface of the upper rivet hole (arrows 3 in Fig. 4). These cracks appeared to have originated after the primary crack and to have developed contemporaneously with it. They had progressed by the same mechanism of alternate slow and rapid propagation to reach the extent indicated between arrows 4 (Fig. 4). From the line indicated by these arrows, the crack spread rapidly through the remainder of the section down to the lower rivet hole. Slow (fatigue) cracking then commenced at eight separate origins along the lower surface of the lower rivet hole and progressed for a distance of $\frac{1}{32}$ inch approx. at which stage rapid cracking over a length of about $\frac{1}{4}$ inch occurred. This was followed by a further small amount of fatigue cracking (the bright V-shape mark indicated by arrows 5) and rapid cracking to the lower corner of the channel. Then followed more alternate steps of slow and rapid cracking, this stage being shown by the series of alternate bright and darker rings at the corner zone of the fracture. A further small zone of slow cracking (arrows 6) was present in the base of the channel at a position about $\frac{3}{4}$ inch from the corner; this was the final position of fatigue-cracking and represented the extremity of the crack which existed prior to complete failure of the assembly.

Figure 4.—Fracture Surface of Rear Rib of Lower Channel Member, showing extent of fatigue cracking. Numbered arrows refer to mechanism of crack development described in text of report.
